Cultural Heritage
Evaluation Report

**Cultural Heritage Evaluation
Report: West London Dyke
Master Repair Plan**

Part of Lot 16, Concession 1 and
Part of Lot 16, Concession 2
former Township of London,
Middlesex County,
now City of London, Ontario

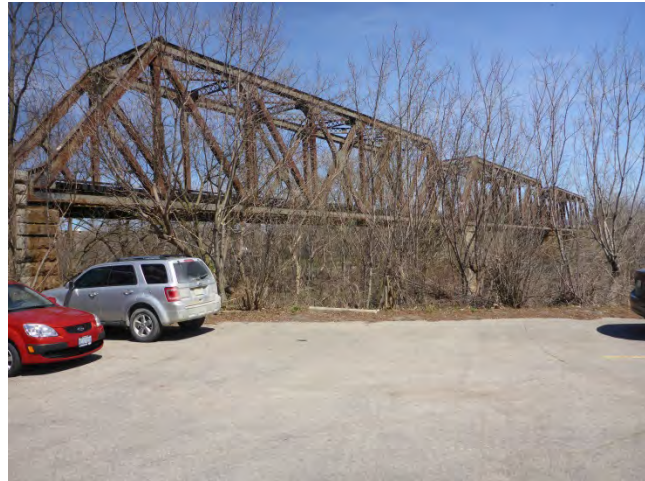
The resource includes a steel truss railway bridge

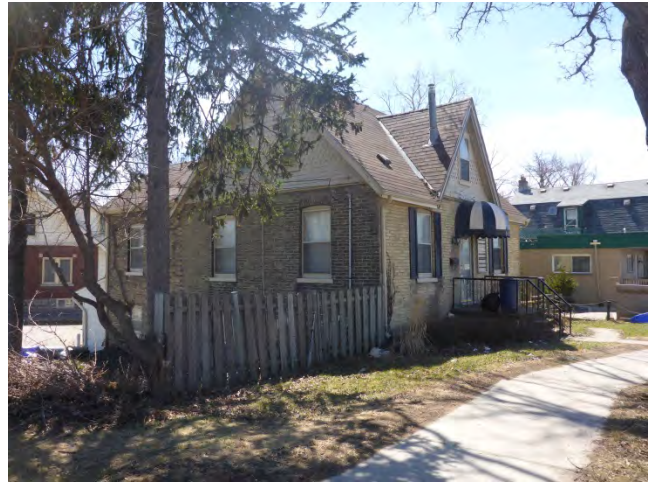
The property contains a residence.

The residence is a one and one half storey cross gable structure with a centre gable window. The residence has half yellow brick/half modern siding and sits on an undetermined foundation. The residence has a centre gable window with fish scaling shingles. On the front symmetrical façade of the residence, there is a front door with a circular awning that is placed in between two windows with green shutters. There are two large windows on the east side of the residence. At the rear of the residence is a front gable wing with multiple windows.

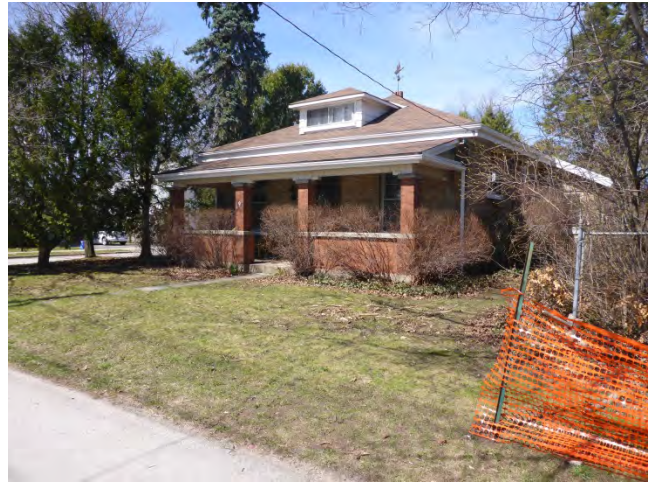
The property contains a residence.

The residence is a one and one half storey front gable structure with a low hipped roof. The red brick residence sits on a concrete foundation. A hipped dormer window protrudes from the roof of the residence, facing St. Patrick Street. Two windows and a door are situated underneath a full width covered porch. The porch has half-brick walls and is supported by brick piers.

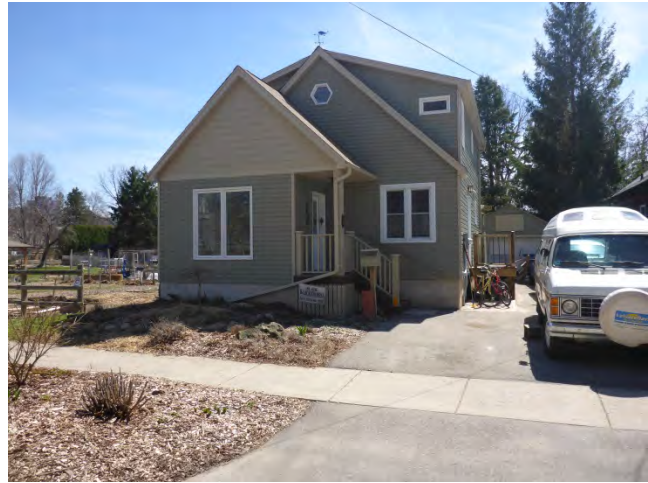
The property contains a residence.

The residence is a one and one half storey multi-front gable structure with modern siding that sits on a concrete foundation. The residence has a projecting front gable that contains an entry door facing west. Multiple modern windows are visible on the front façade.

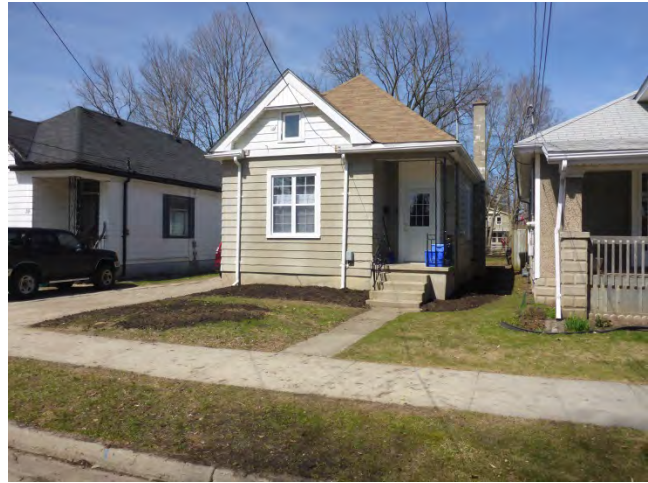
The property contains a residence.

The residence is a one storey structure with a hipped roof and a front gable window. The residence has modern siding and sits on a concrete foundation. On the front façade of the residence, there is a decorated front gable, a window and front door situated within an inset porch. A brick chimney stack is visible on the west side of the building.

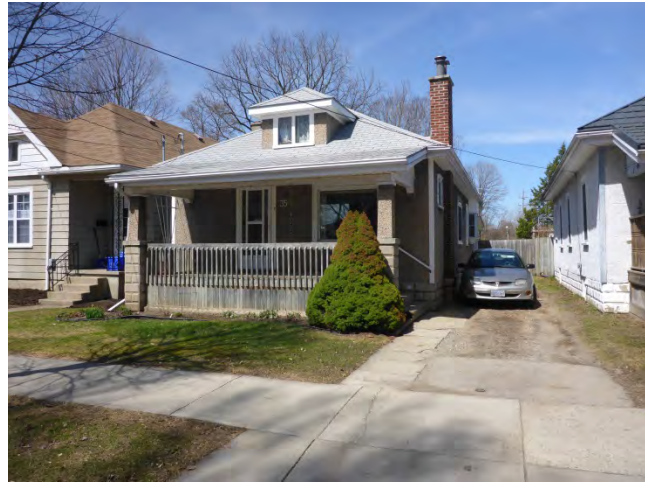
The property contains a residence.

The residence is a one and one half storey hipped roof structure with a hipped dormer window. The residence has brick siding and sits on a concrete foundation. A full front covered wooden porch and concrete pillars are situated on the front façade of the building along with a front door and a single pane window. A brick chimney stack is present on the building's west façade.

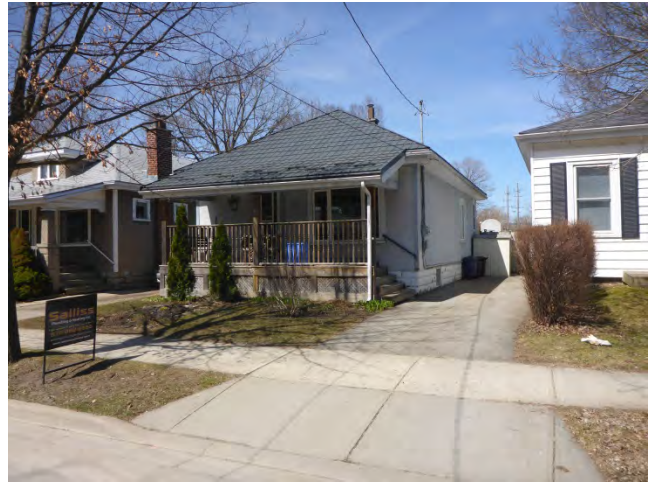
The property contains a residence.

The residence is a one storey structure with a hipped pyramidal low pitched roof. The residence has modern siding and sits on a rusticated concrete block foundation. A covered full width wooden porch that contains a front door and an offset window with three panes fronts the residence.

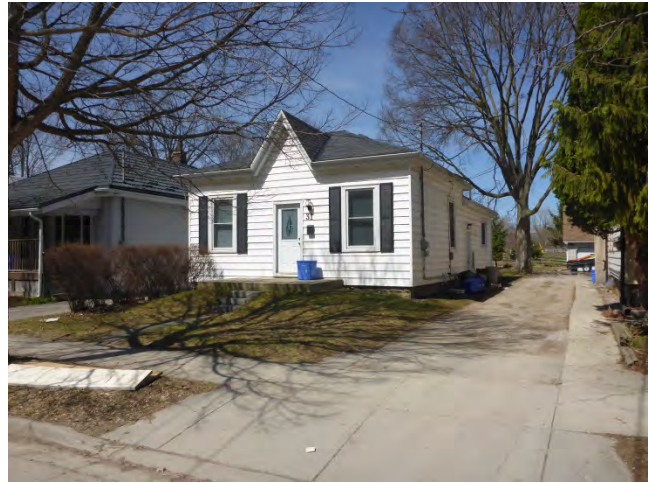
The property contains a residence.

The residence is a one storey hipped roof residence with a low pitched roof and steeply pitched centre gable. The residence has modern siding and sits on a concrete foundation. The front façade of the residence is symmetrical in design with two equal sized windows with dark shutters on either side of the centered front door. At the rear of the residence is a front gable addition with multiple windows.

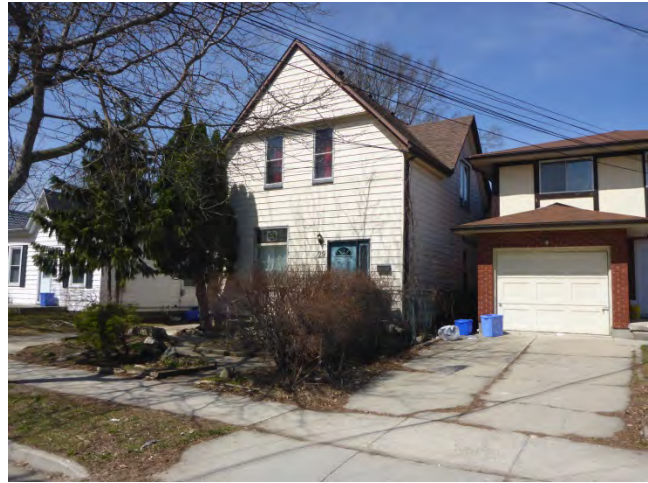
The property contains a residence.

The residence is a one and one half storey front gable structure with a steep pitched roof. The residence has modern siding and sits on a concrete foundation. On the west façade of the residence is a gable containing a steeply pitched gable window. On the front façade there are two upper storey windows, one lower storey window and a door with sidelight.

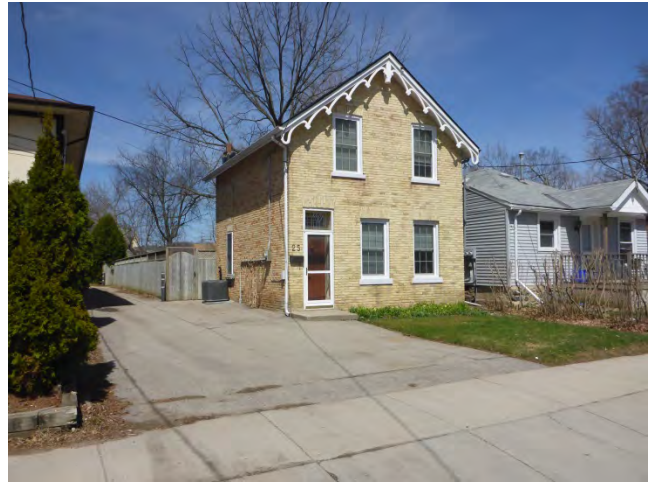
The property contains a residence.

The residence is a one and one half storey front gable structure with a medium pitched roof. The yellow brick siding residence sits on an undetermined foundation. The gabled roof has decorative bargeboard detailing. The front façade has two upper storey windows, two lower storey windows, and a door with transom light.

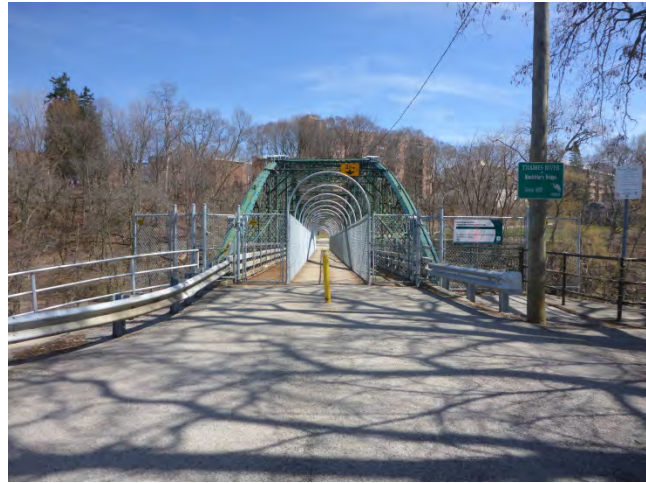
The Blackfriars Street Bridge is a single span reinforced wrought-iron bowstring bridge that connects Blackfriars Street from the western bank of the Thames River to Ridout Street north at the eastern bank of the Thames River. It is designated under Part IV of the *Ontario Heritage Act* and is the oldest remaining of its kind.

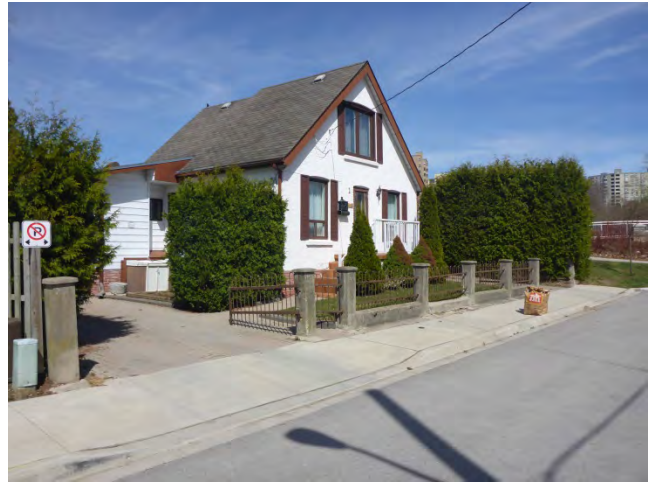
The property contains a residence.

The residence is a one and one half storey front gable structure with a steep pitched roof and white painted brick siding. The residence sits on a brick foundation. On the front façade, there is an upper floor window under the pointed gable, two lower storey windows, and a front door. The windows have dark coloured trim and shutters. The residence has a small front porch with aluminum railings and concrete steps. There is a modern one storey addition with a window attached to the west side of the residence. A fence with concrete supports and iron railings is situated on the front of the property.

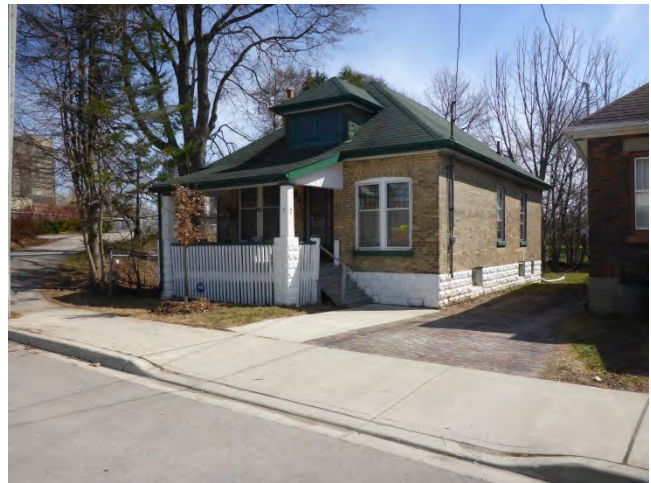
The property contains a residence.

The residence is a one and one half storey structure with a pyramidal hipped roof with a hipped dormer. The brick residence sits on a rusticated concrete block foundation. A front covered porch with white wooden railings and wooden steps, two windows, and a front door are situated along the front façade of the residence. On the west side of the residence, there are two windows along with three basement windows. A chimney stack is visible on the east side of the residence.

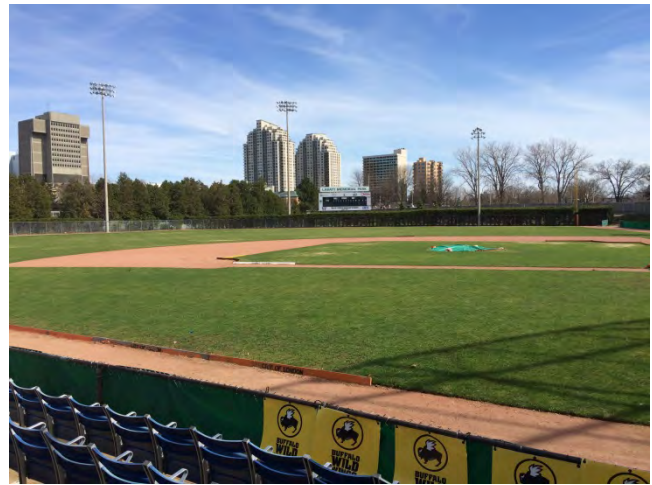
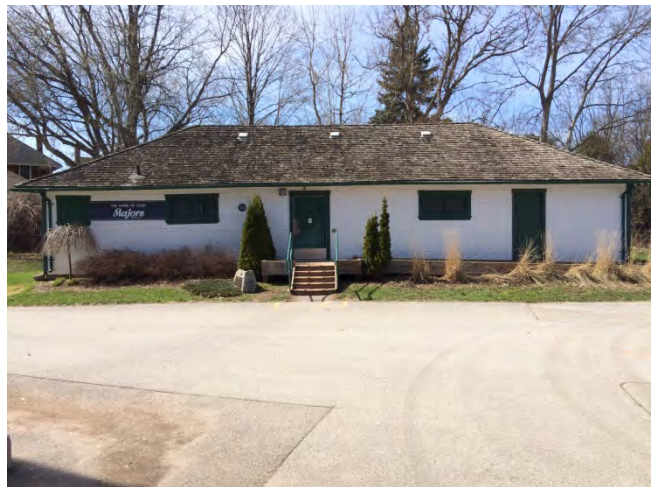
The clubhouse is a one storey side gable lumber building with a low pitched hipped roof. On the front façade, there are two doors and two rectangular windows.

The flood of 1937 swept away the original grandstand and outbuildings, which were replaced with the existing frame team clubhouse. The London Army team won the Canadian Sandlot Congress title in 1943 and 1944. On September 29, 1948, the London Majors won the World Sandlot title over the Fort Wayne Generals, with the fielder Russ Evon ("Ruthless Russell" or "Russell the Muscle") and catcher Jack Fairs. The London Majors continue on in the Inter-County League as the longest-serving tenant of Labatt Park. The Class AA London Tigers, an affiliate of the Detroit Tigers, played here from 1989 to 1993 and won the Eastern League championship in 1990. In 1990, the park won the "Beam Clay Award" as the best natural grass ballpark in North America.

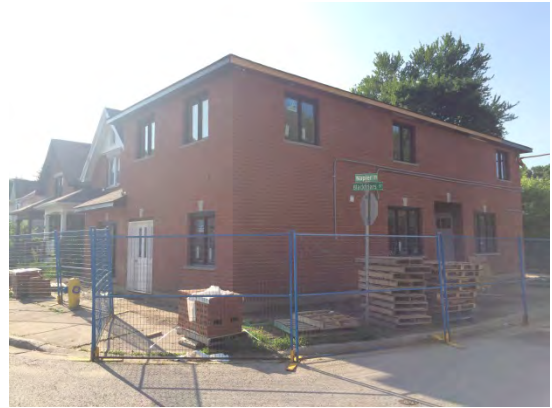
The property contains a multi-residential building.

The multi-residential building is a modern two storey, hipped roof, red brick structure that sits on a concrete foundation. Two modern doors and multiple windows surround the residence.

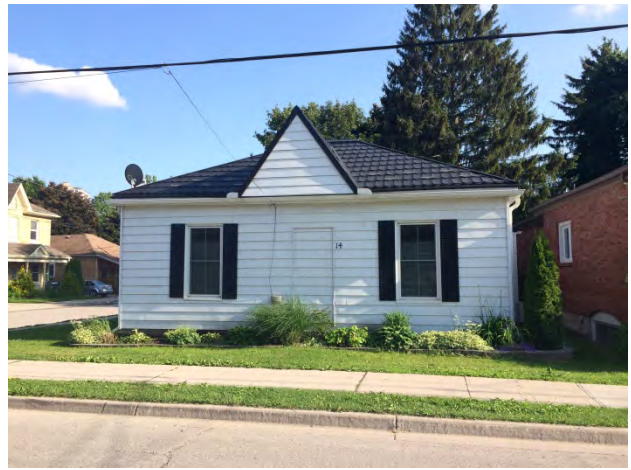
The property contains a residence.

The residence is a one storey cross gable structure with a low pitched hipped roof with a steeply pitched centre gable. The residence has modern siding and sits on a concrete foundation. The facade that faces Blackfriars Street has two windows with dark shutters and a visible outline of where a door was once located, but is now bordered in siding.

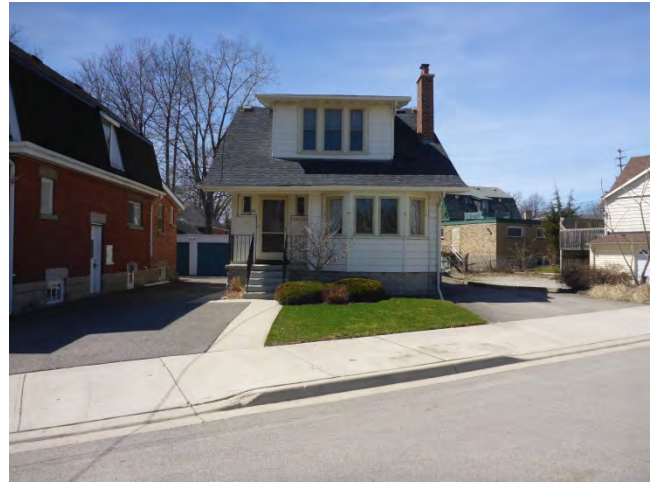
The property contains a residence.

The residence is a one and one half storey side gable structure with a medium pitched roof. A shed dormer window with three panes protrudes from the roof, facing Argyle Street. The residence has modern siding and sits on a rusticated concrete block foundation. On the front façade, there is a four pane bay window and an inset porch with a door and two small windows. A brick chimney stack is visible on the north side of the residence.

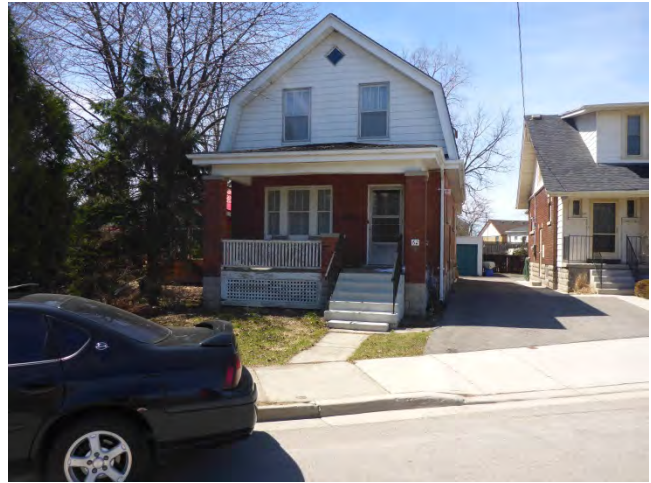
The property contains a residence.

The residence is a one and one half storey front gable structure with a steep pitched gambrel roof. The residence sits on a rusticated concrete block foundation and has brick exterior on the lower storey and modern siding on the upper storey. On the front façade of the upper storey are two windows and one small attic window. On the lower storey underneath a covered porch that is supported by brick columns is a three pane window and a front door.

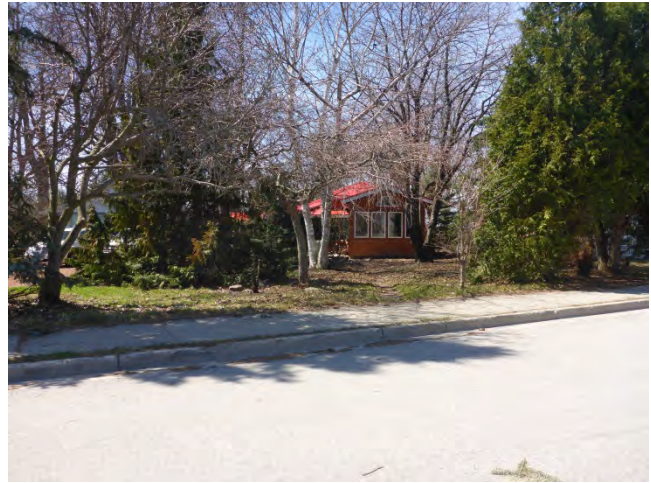
The property contains a residence.

The residence is a one storey cross gable structure with a low pitched red shingle hipped roof. The residence has timber siding and sits on an undetermined foundation. On the front façade of the front gable, there are multiple modern windows.
