Public Information Centre (PIC) West London Dyke Erosion Control Municipal Class Environmental Assessment

Why are we doing this study? Problems and Opportunities

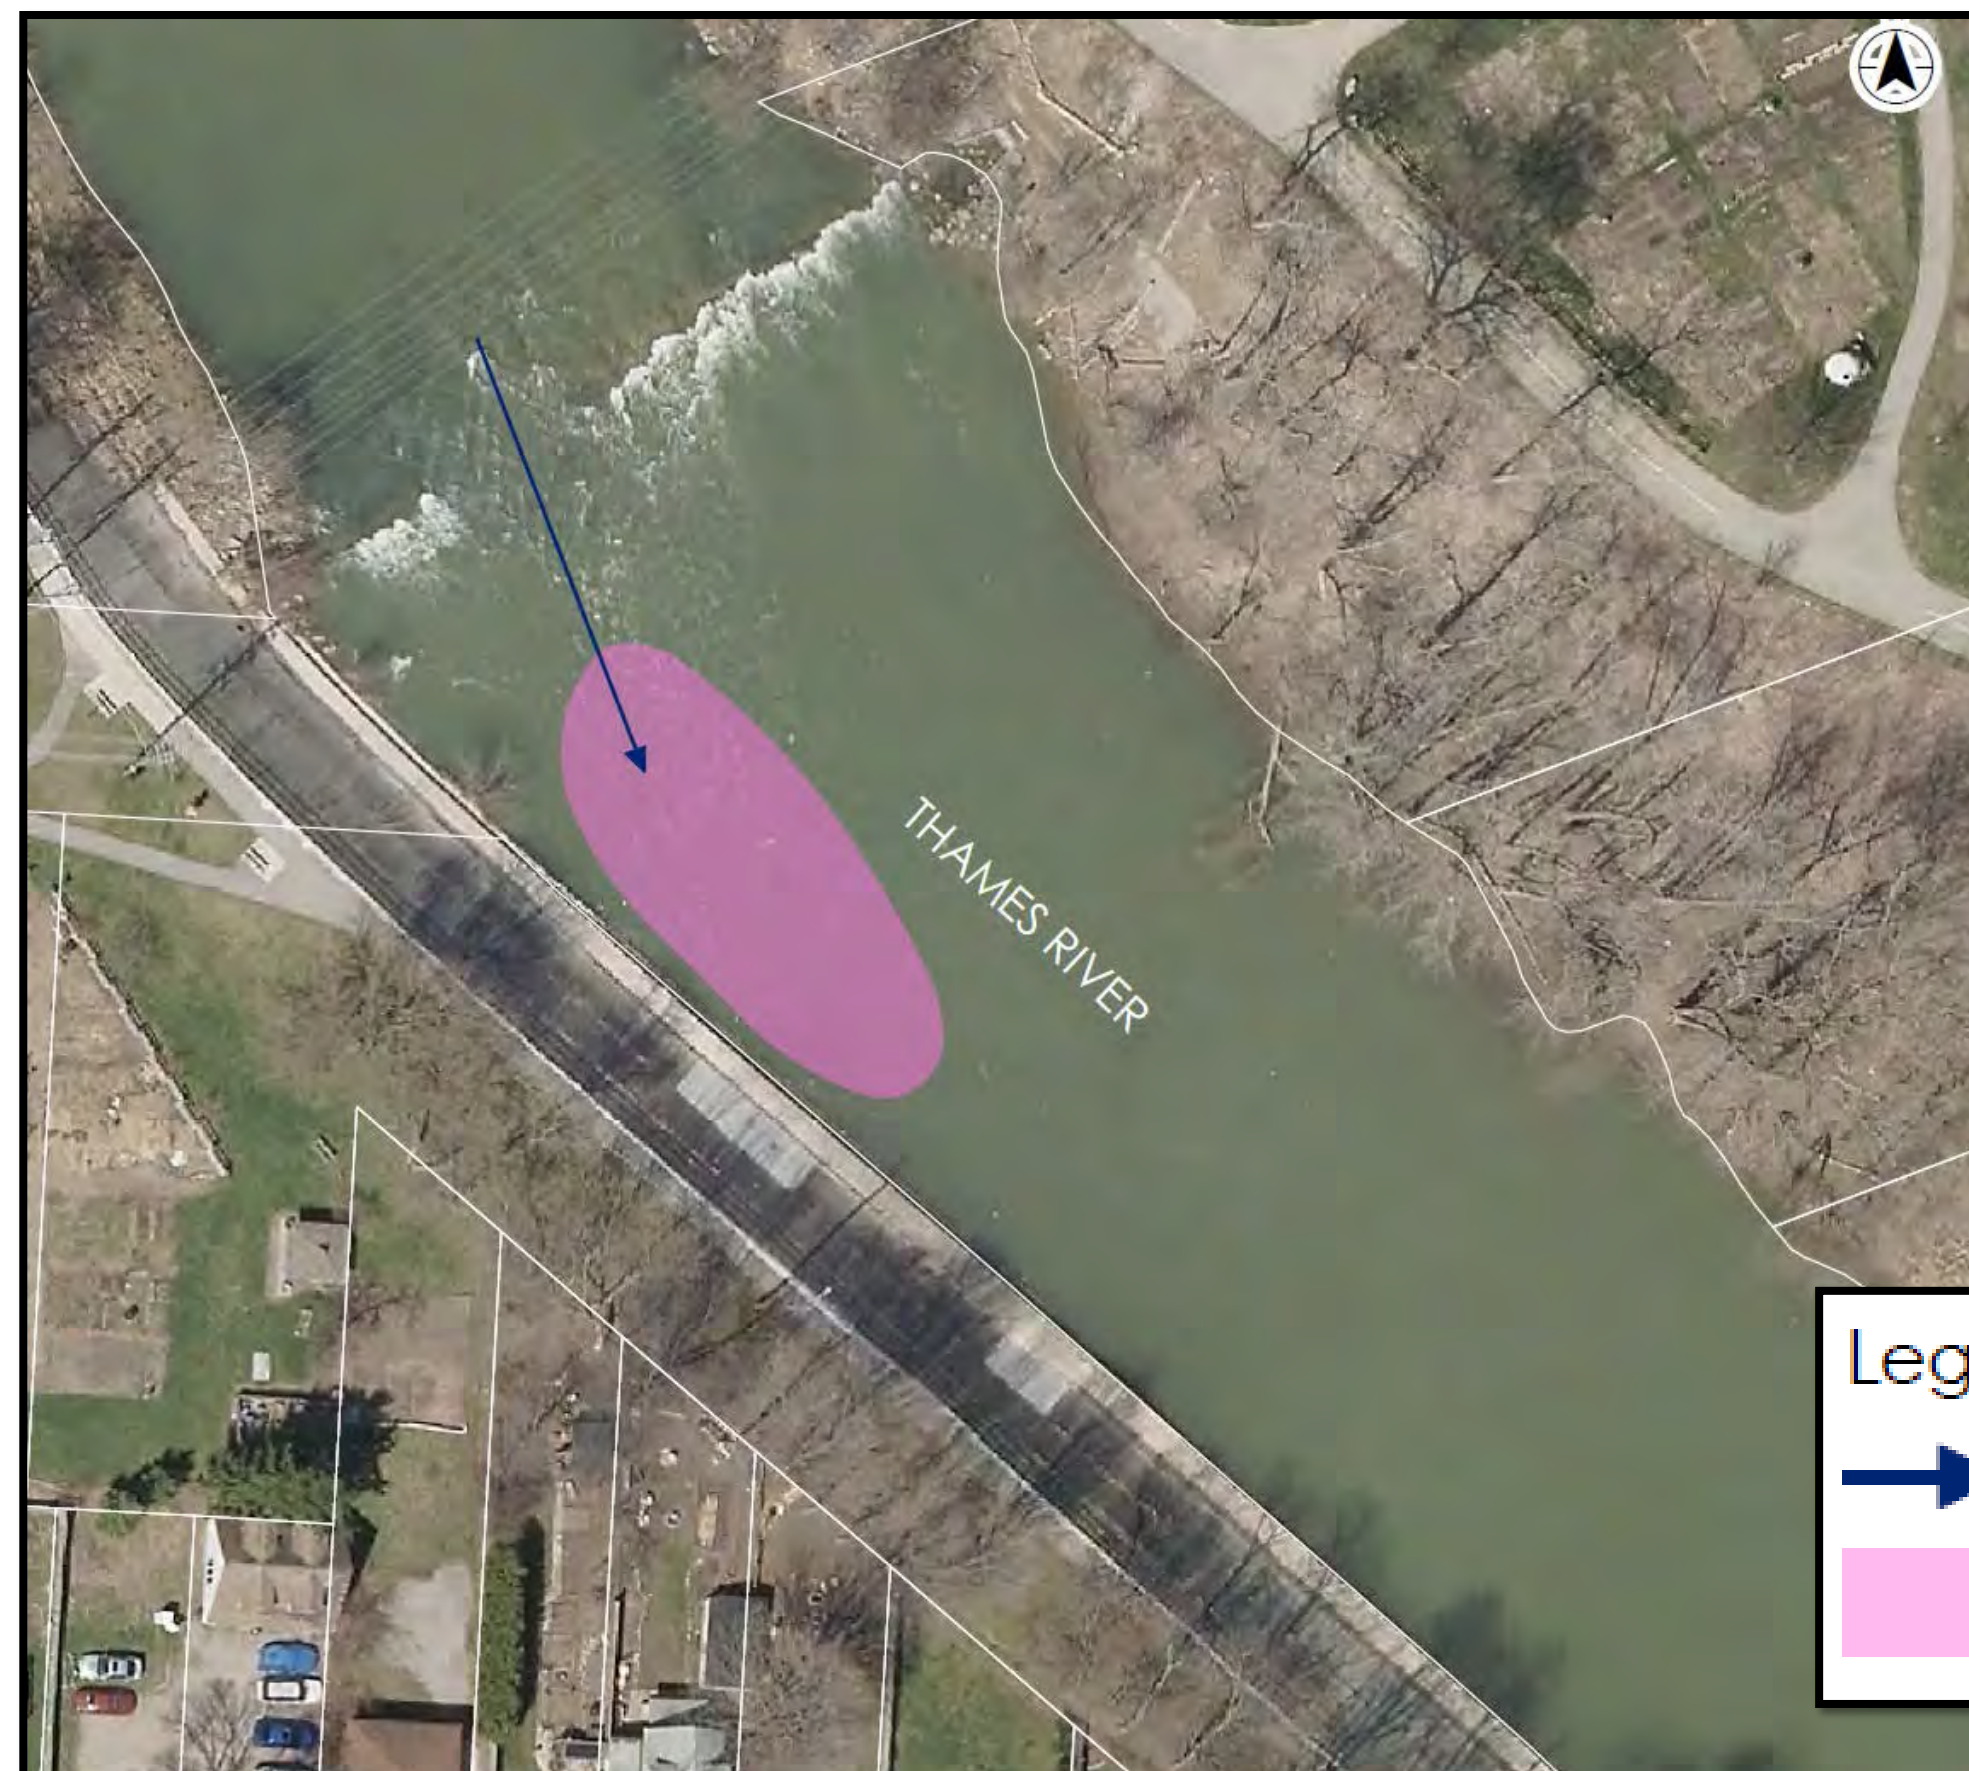
Ann Street Site

While undertaking the West London Dyke (WLD) Master Repair Plan, two locations of erosion (or scour) were identified. Existing structures within the river in each location are directing flows towards the west bank, causing erosion at the toe of the WLD:

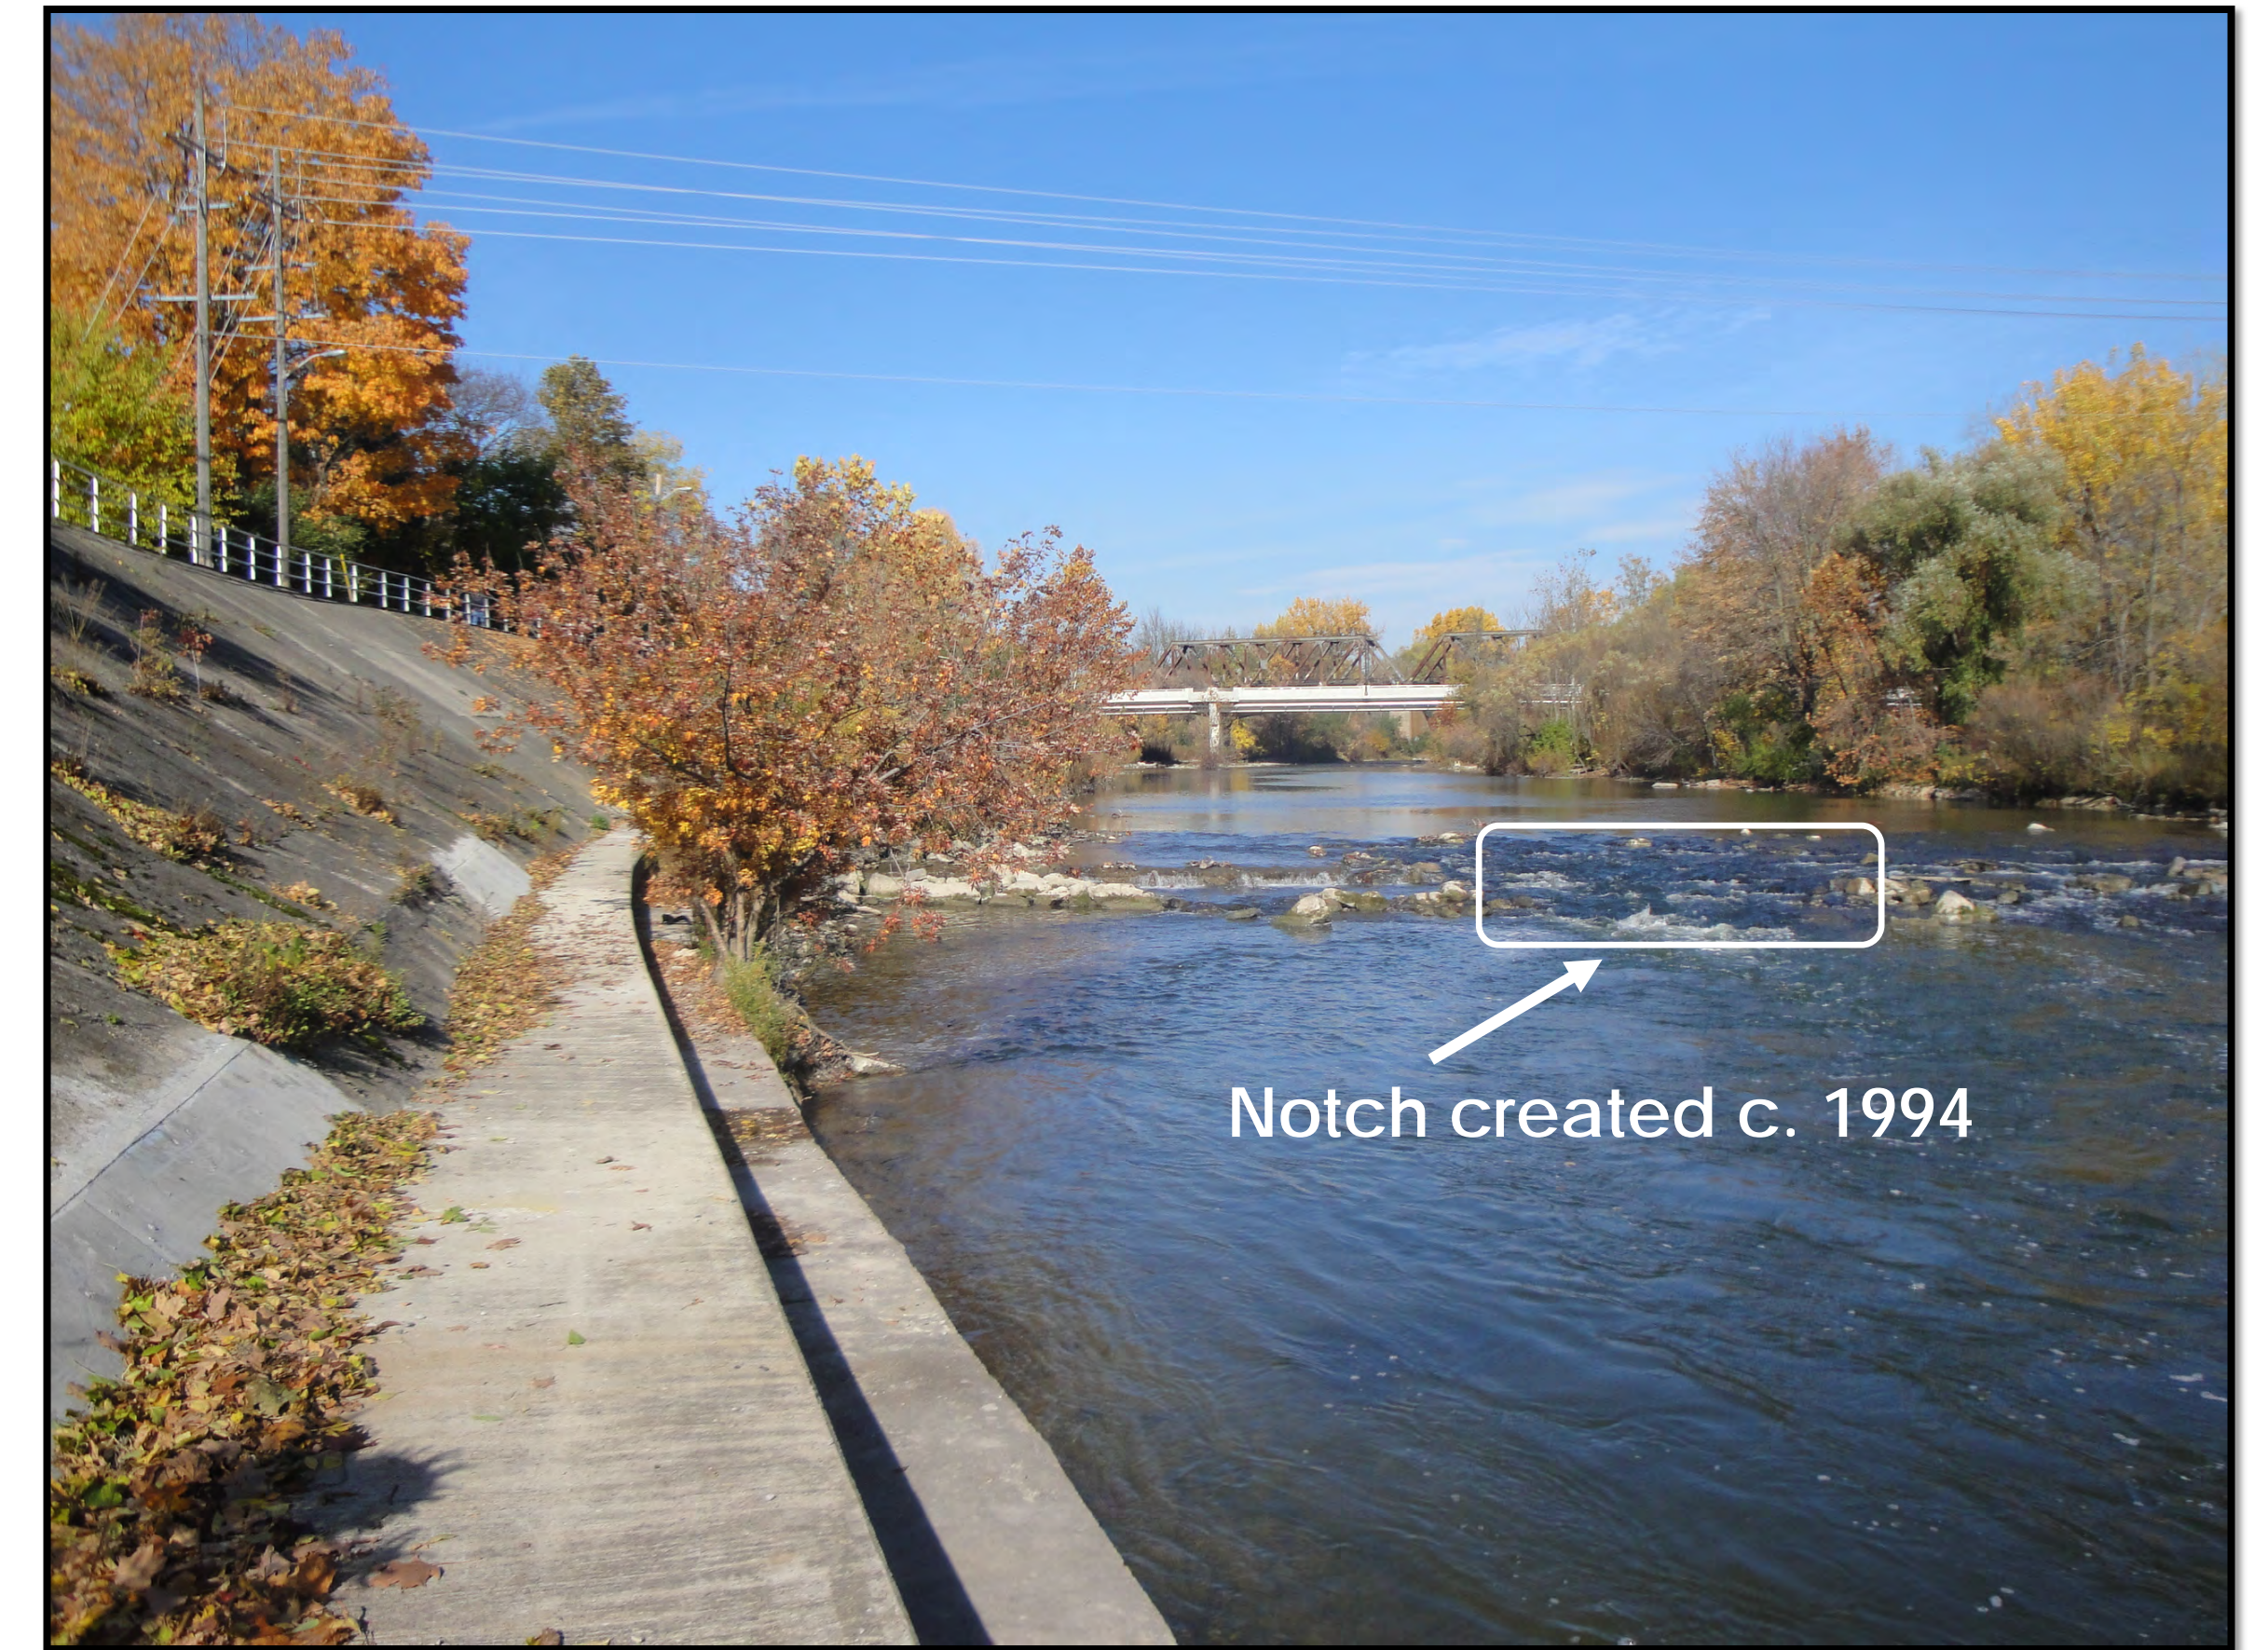
- An abandoned concrete-encased sanitary sewer crosses the Thames River between Ann Street and St. Patrick Street, forming a weir (a portion of pipe was removed, and the rest filled with concrete c. 1994).
- This sewer was replaced in 1994 with a deeper, twinned sewer. The new sewer crossing is located just upstream of the abandoned crossing.
- Riffles exist both upstream and downstream of the weir crossing.
- This is a popular spot for fishing, and the existing notch provides boaters a place to practice traversing a mini-rapid.

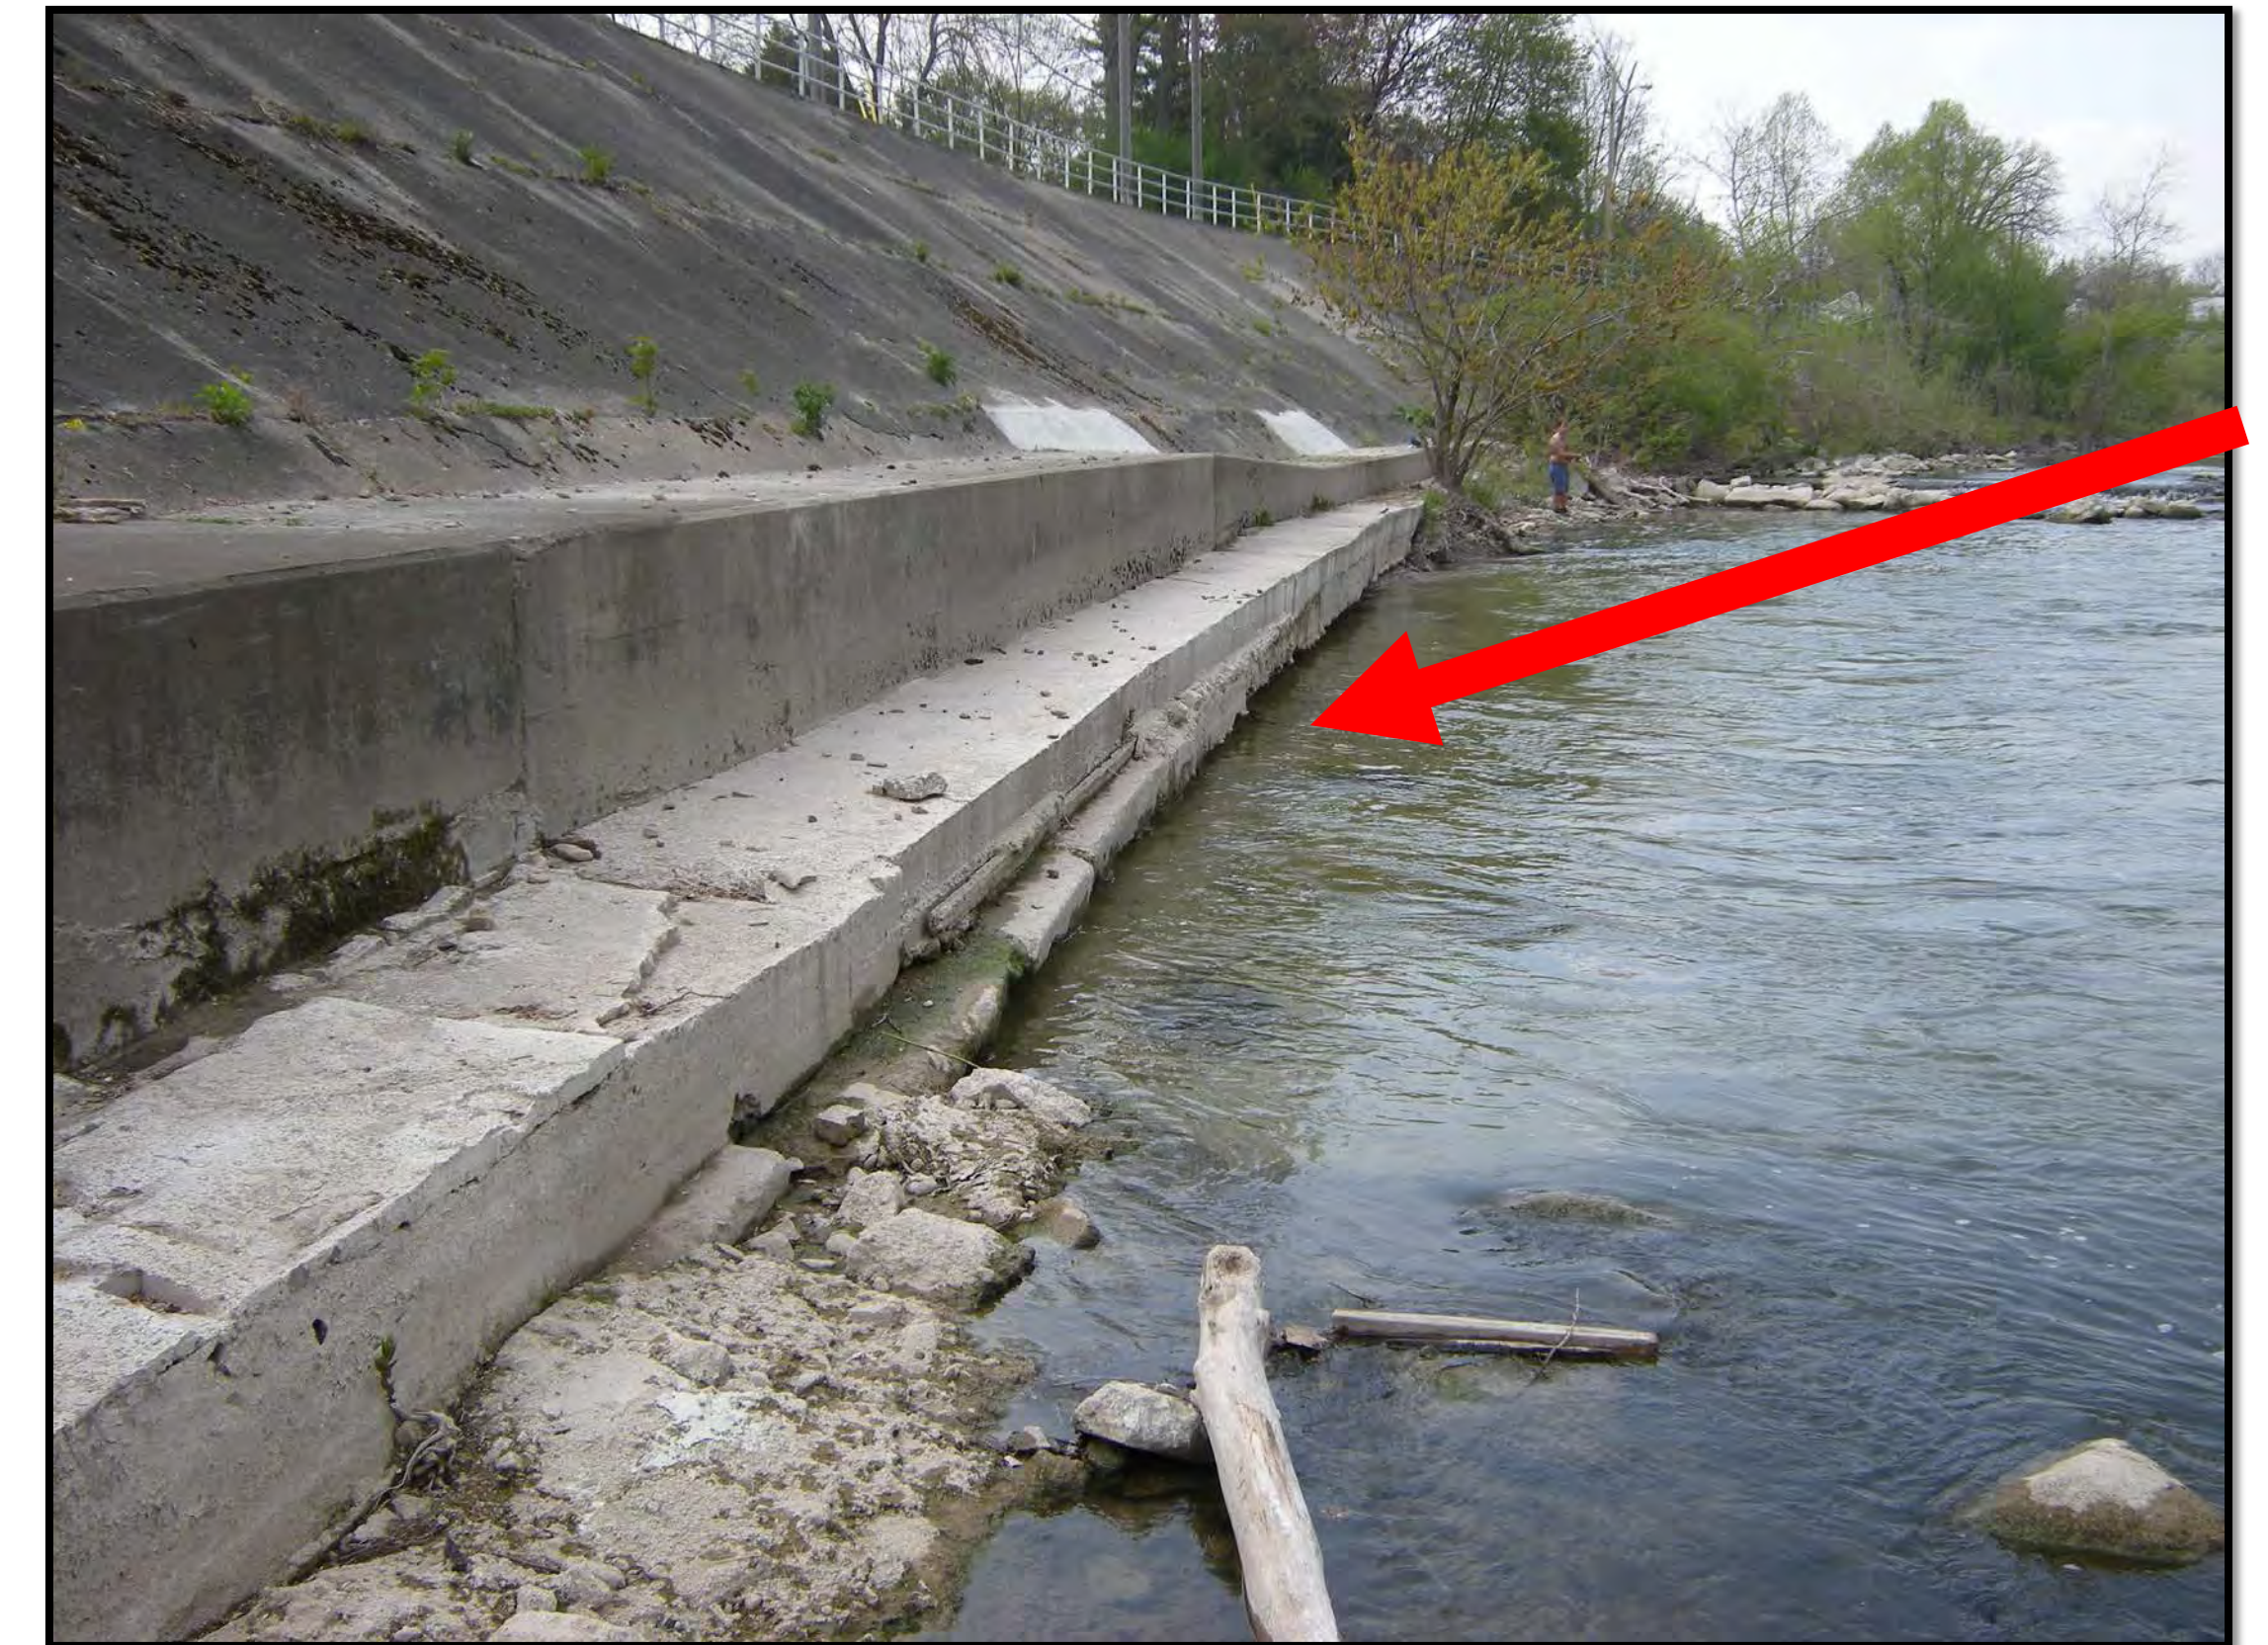
As-Built drawing from the Ann Street Crossing, 1994

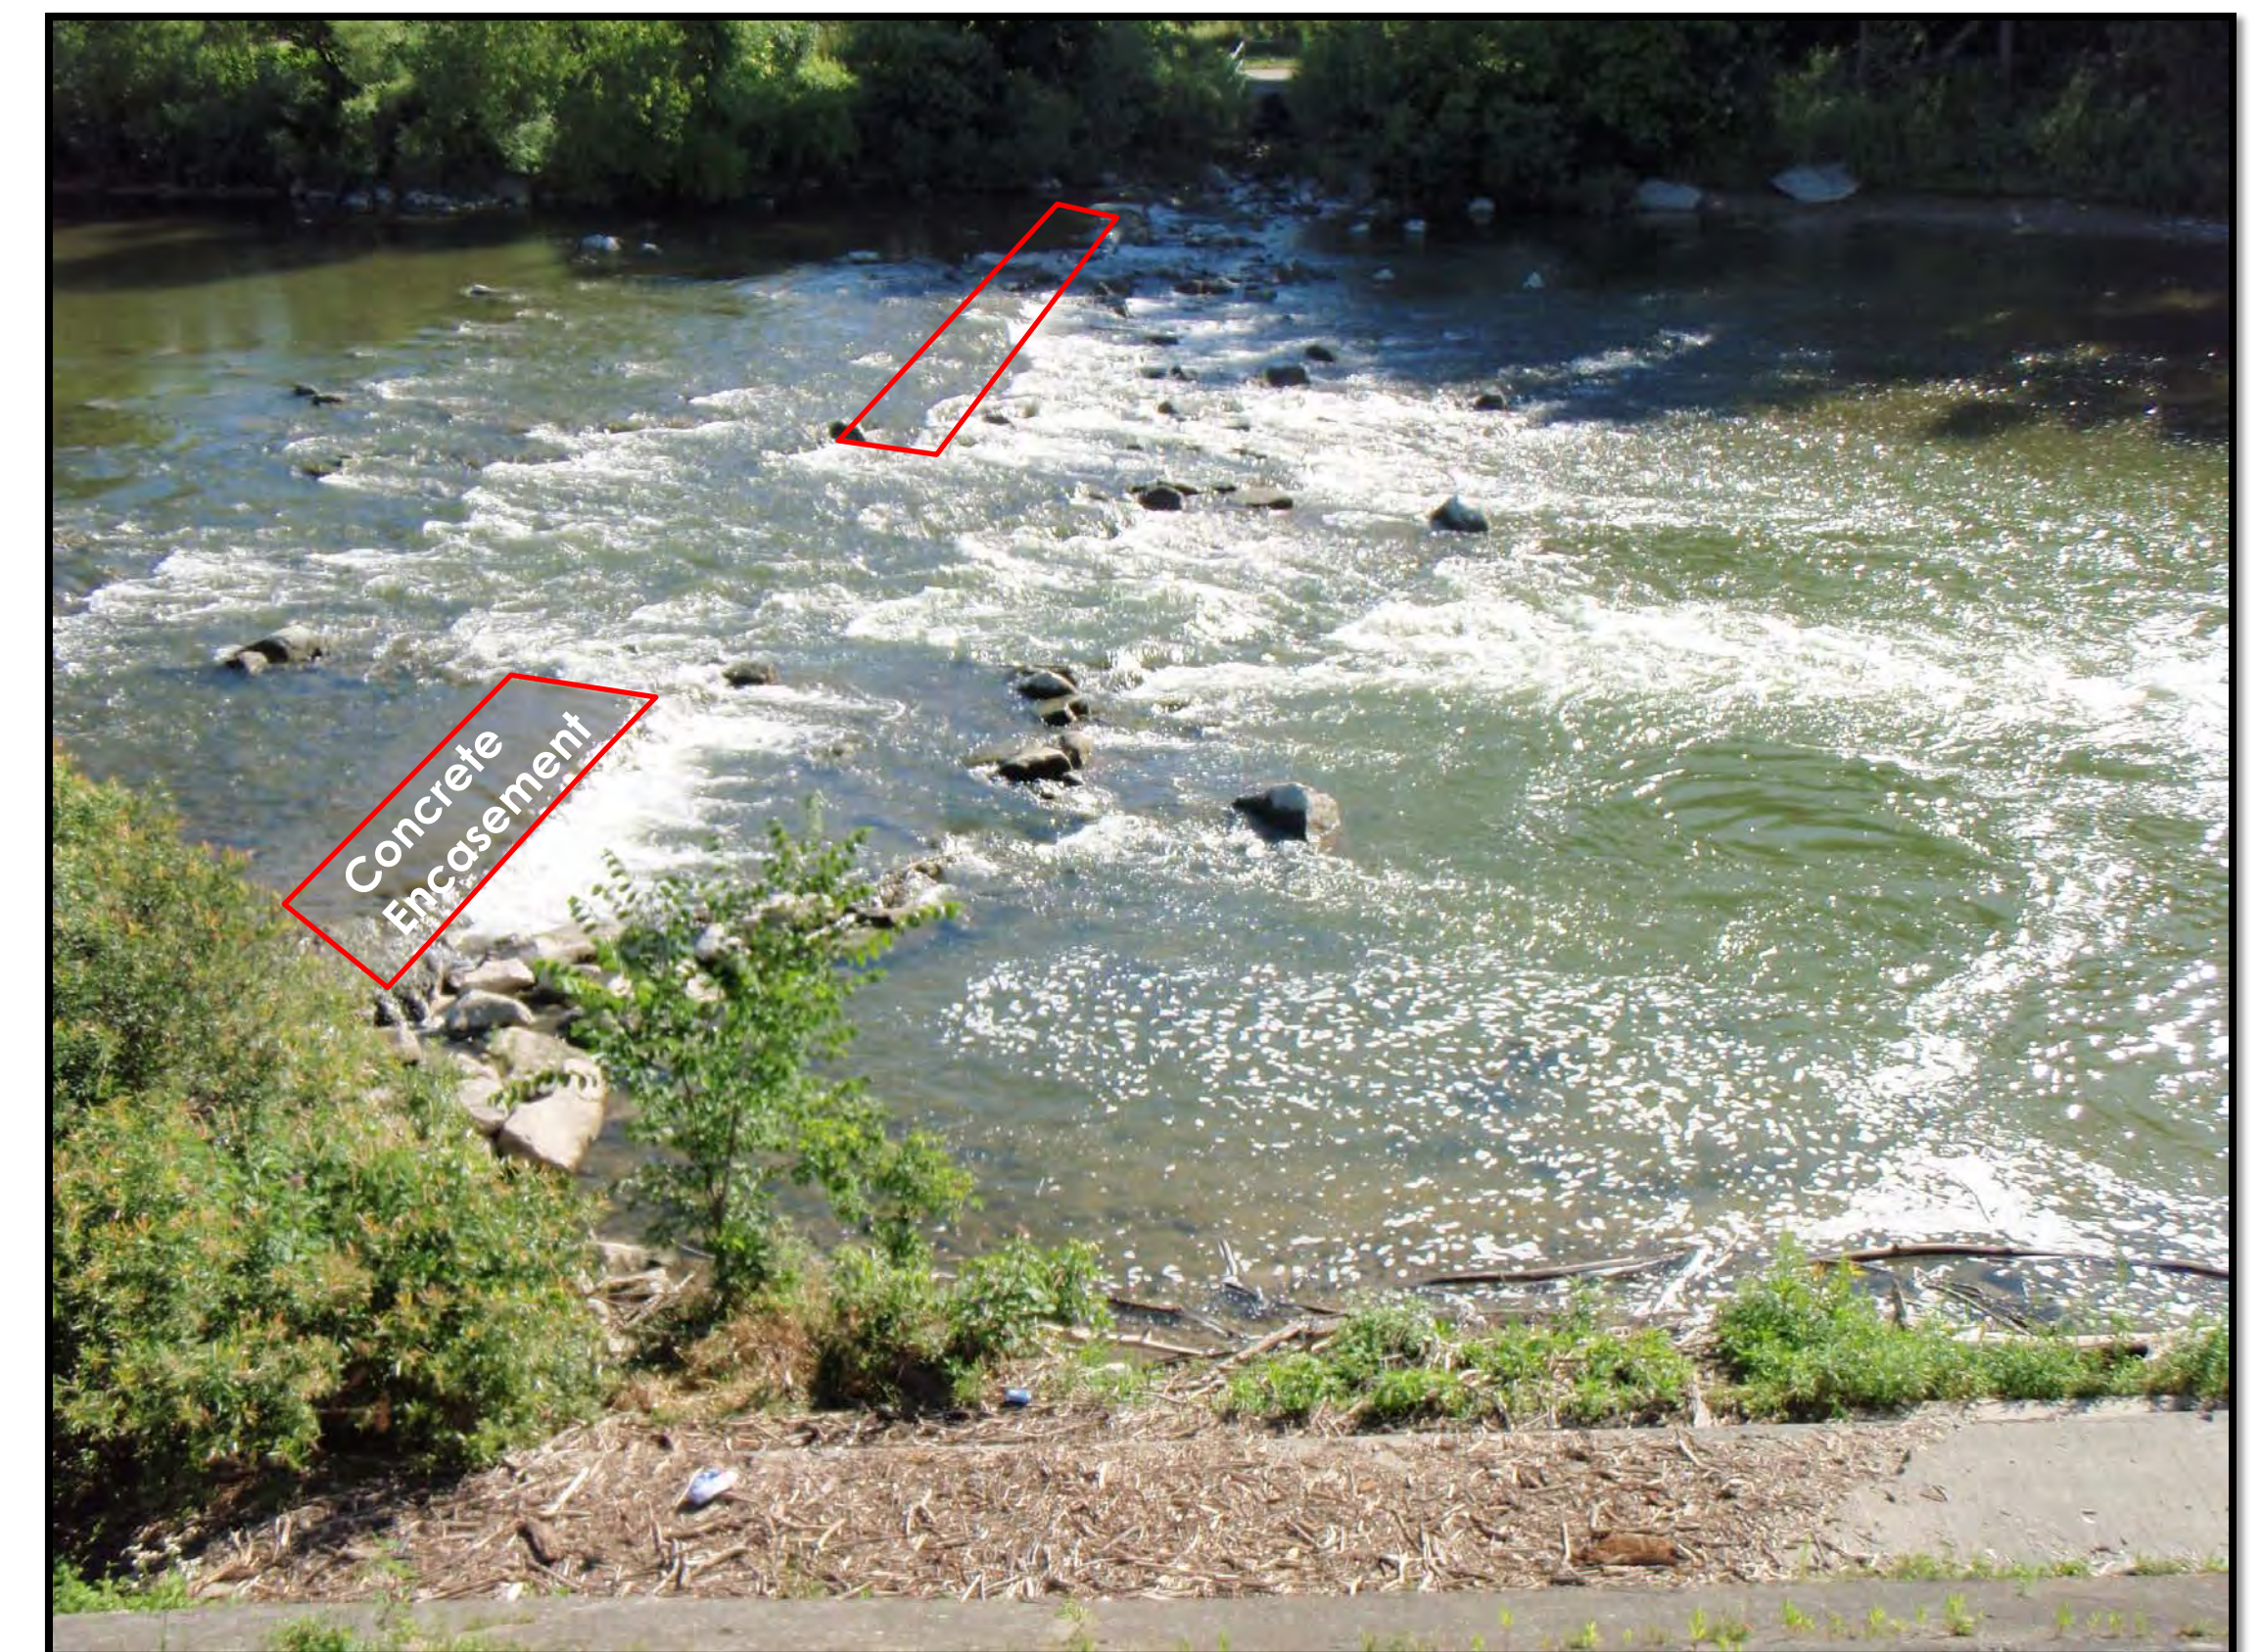
For graphic representation only
not to scale

Ann Street Site – Conceptual Cross Section

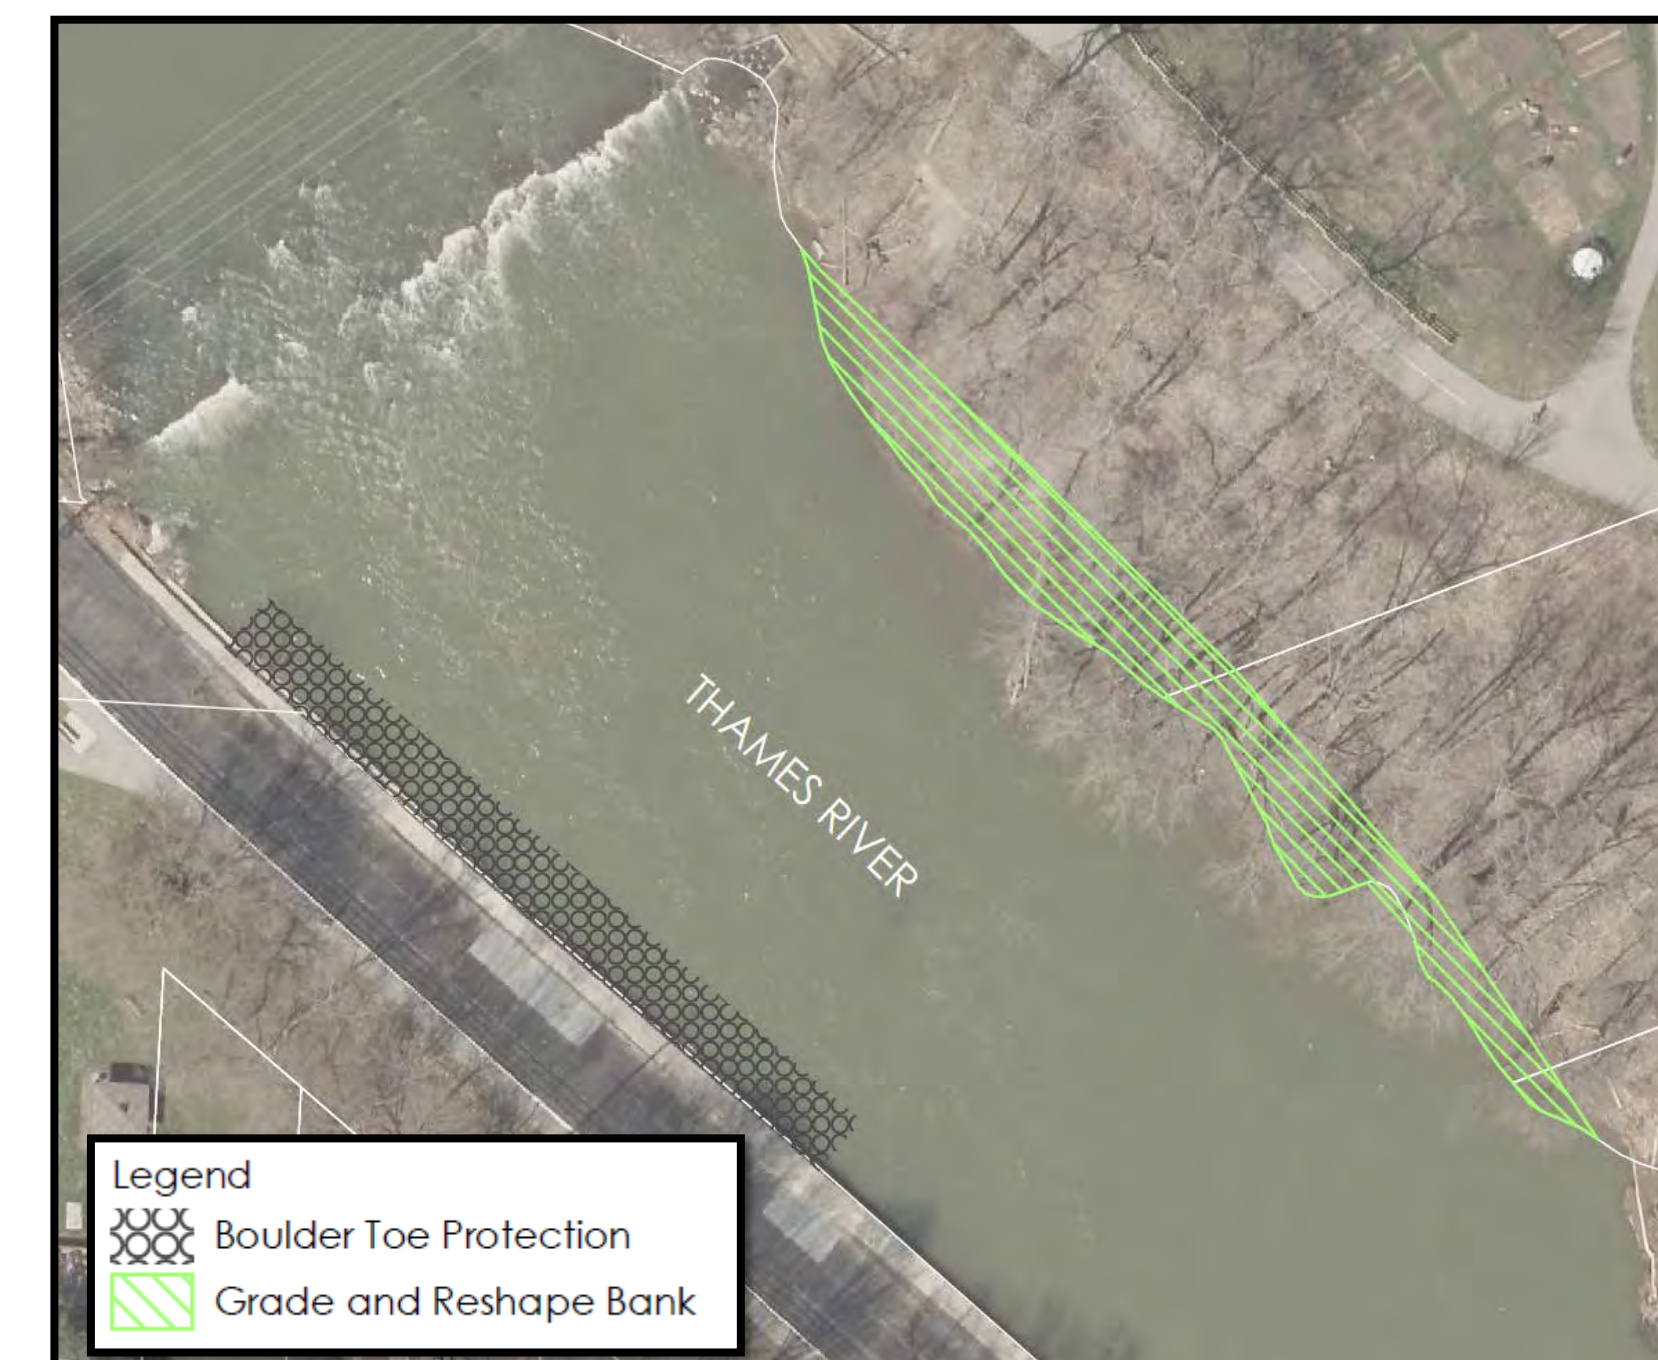
Alternative 3 – Boulder Toe Protection

Boulders would be installed along the toe of the dyke, for a stretch of approximately 60 m. Treatment would be approximately 5 m wide. Under this alternative, grading and reshaping the east bank is recommended to compensate for the reduction in river cross section from the installation of boulders.

Ann Street Site
Modification to Weir Structure and Boulder Toe Protection

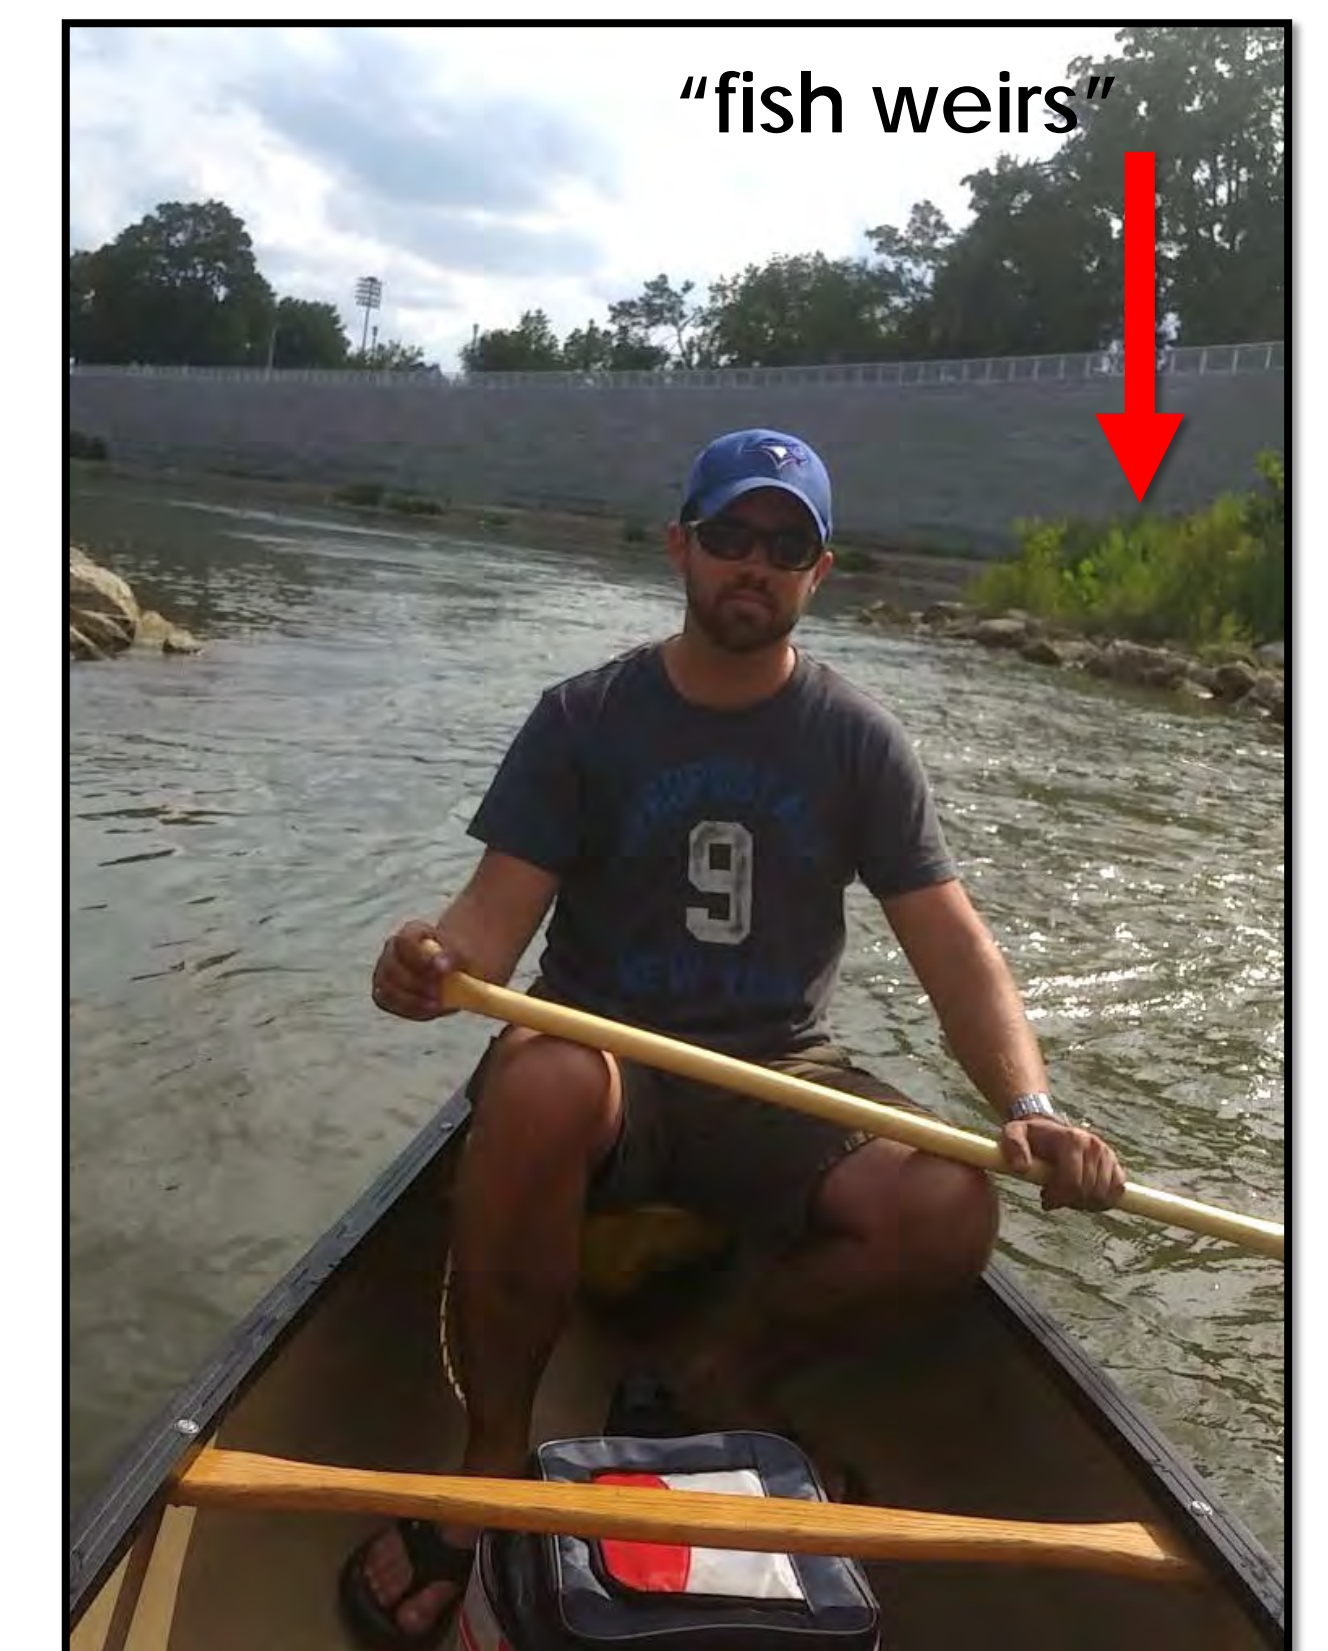
- The Ministry of Natural Resources and Forestry (MNRF) installed rocks features (referred to as fish weirs) c. 1980's to improve fish habitat and passage in the area.
- This is a popular spot for fishing (and boating).
- The potential exists for species at risk, and species of special concern turtles in this area of the river.
- This area is just upstream of the Forks of the Thames – an area of focus for the One River Master Plan Environmental Assessment and Back to the River. Any recommendations for shoreline improvements will need to be coordinated with those projects.
