Public Information Centre (PIC) West London Dyke Erosion Control Municipal Class Environmental Assessment

Why are we doing this study? Problems and Opportunities

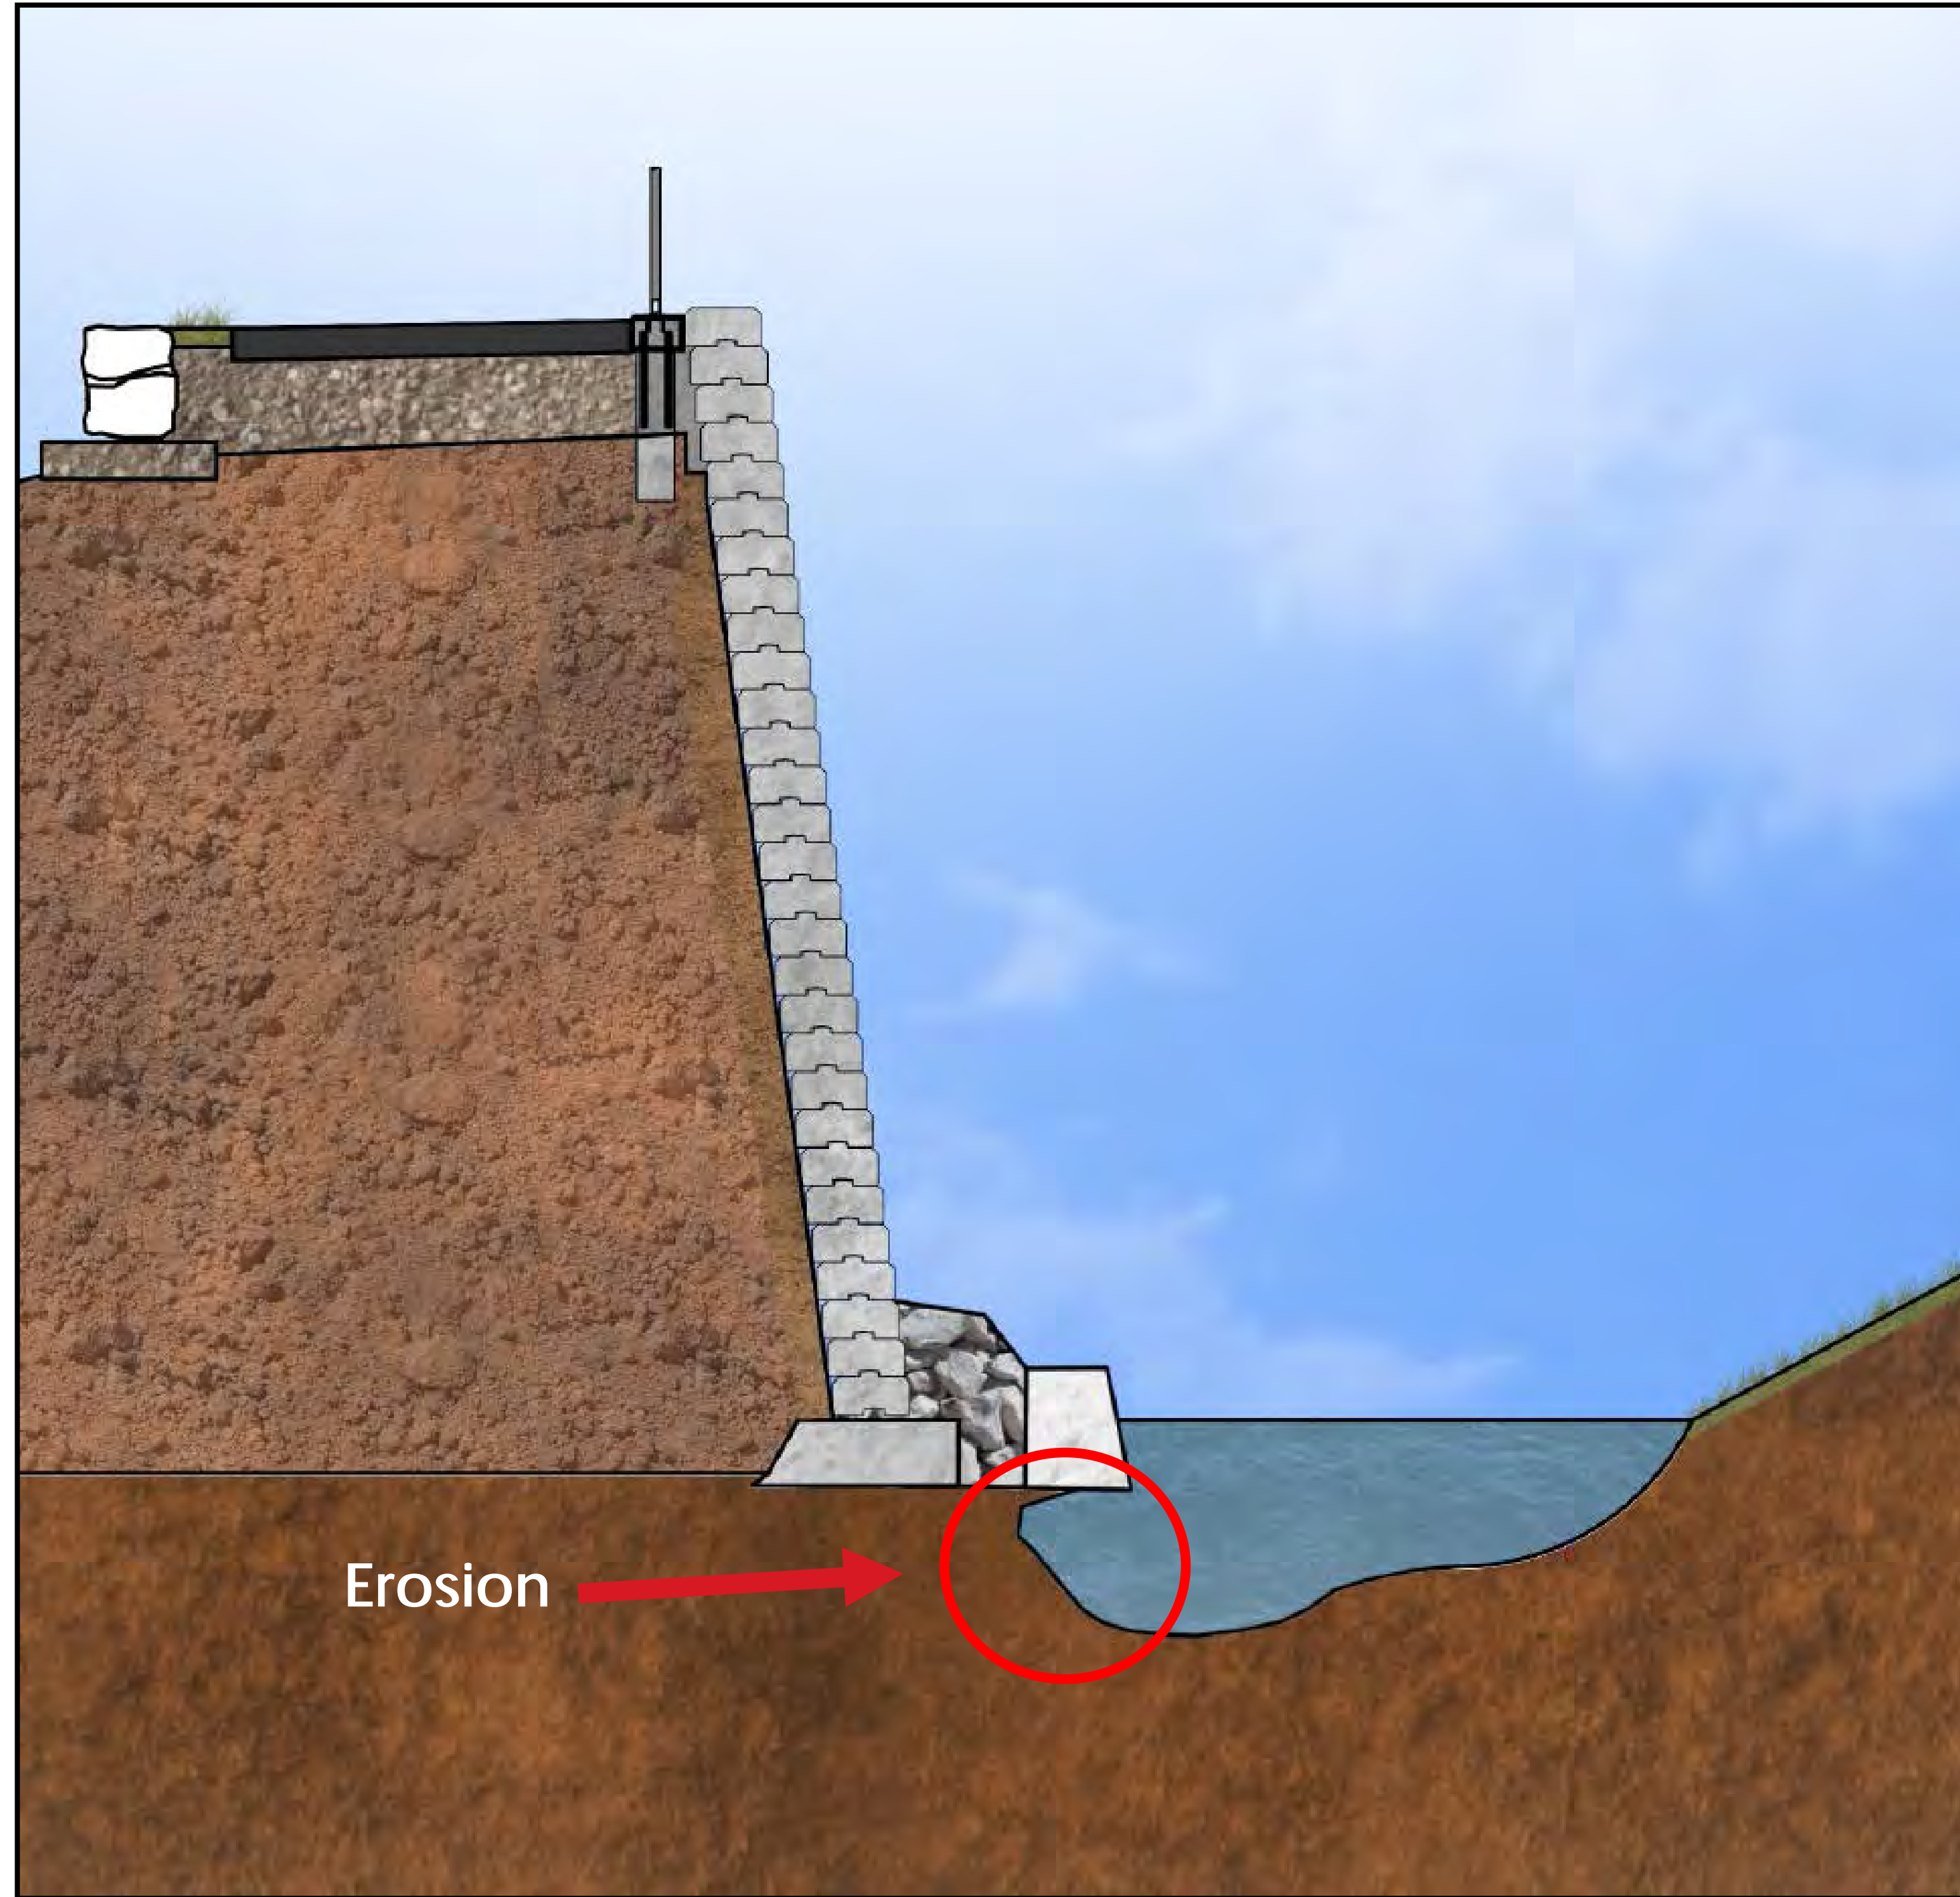
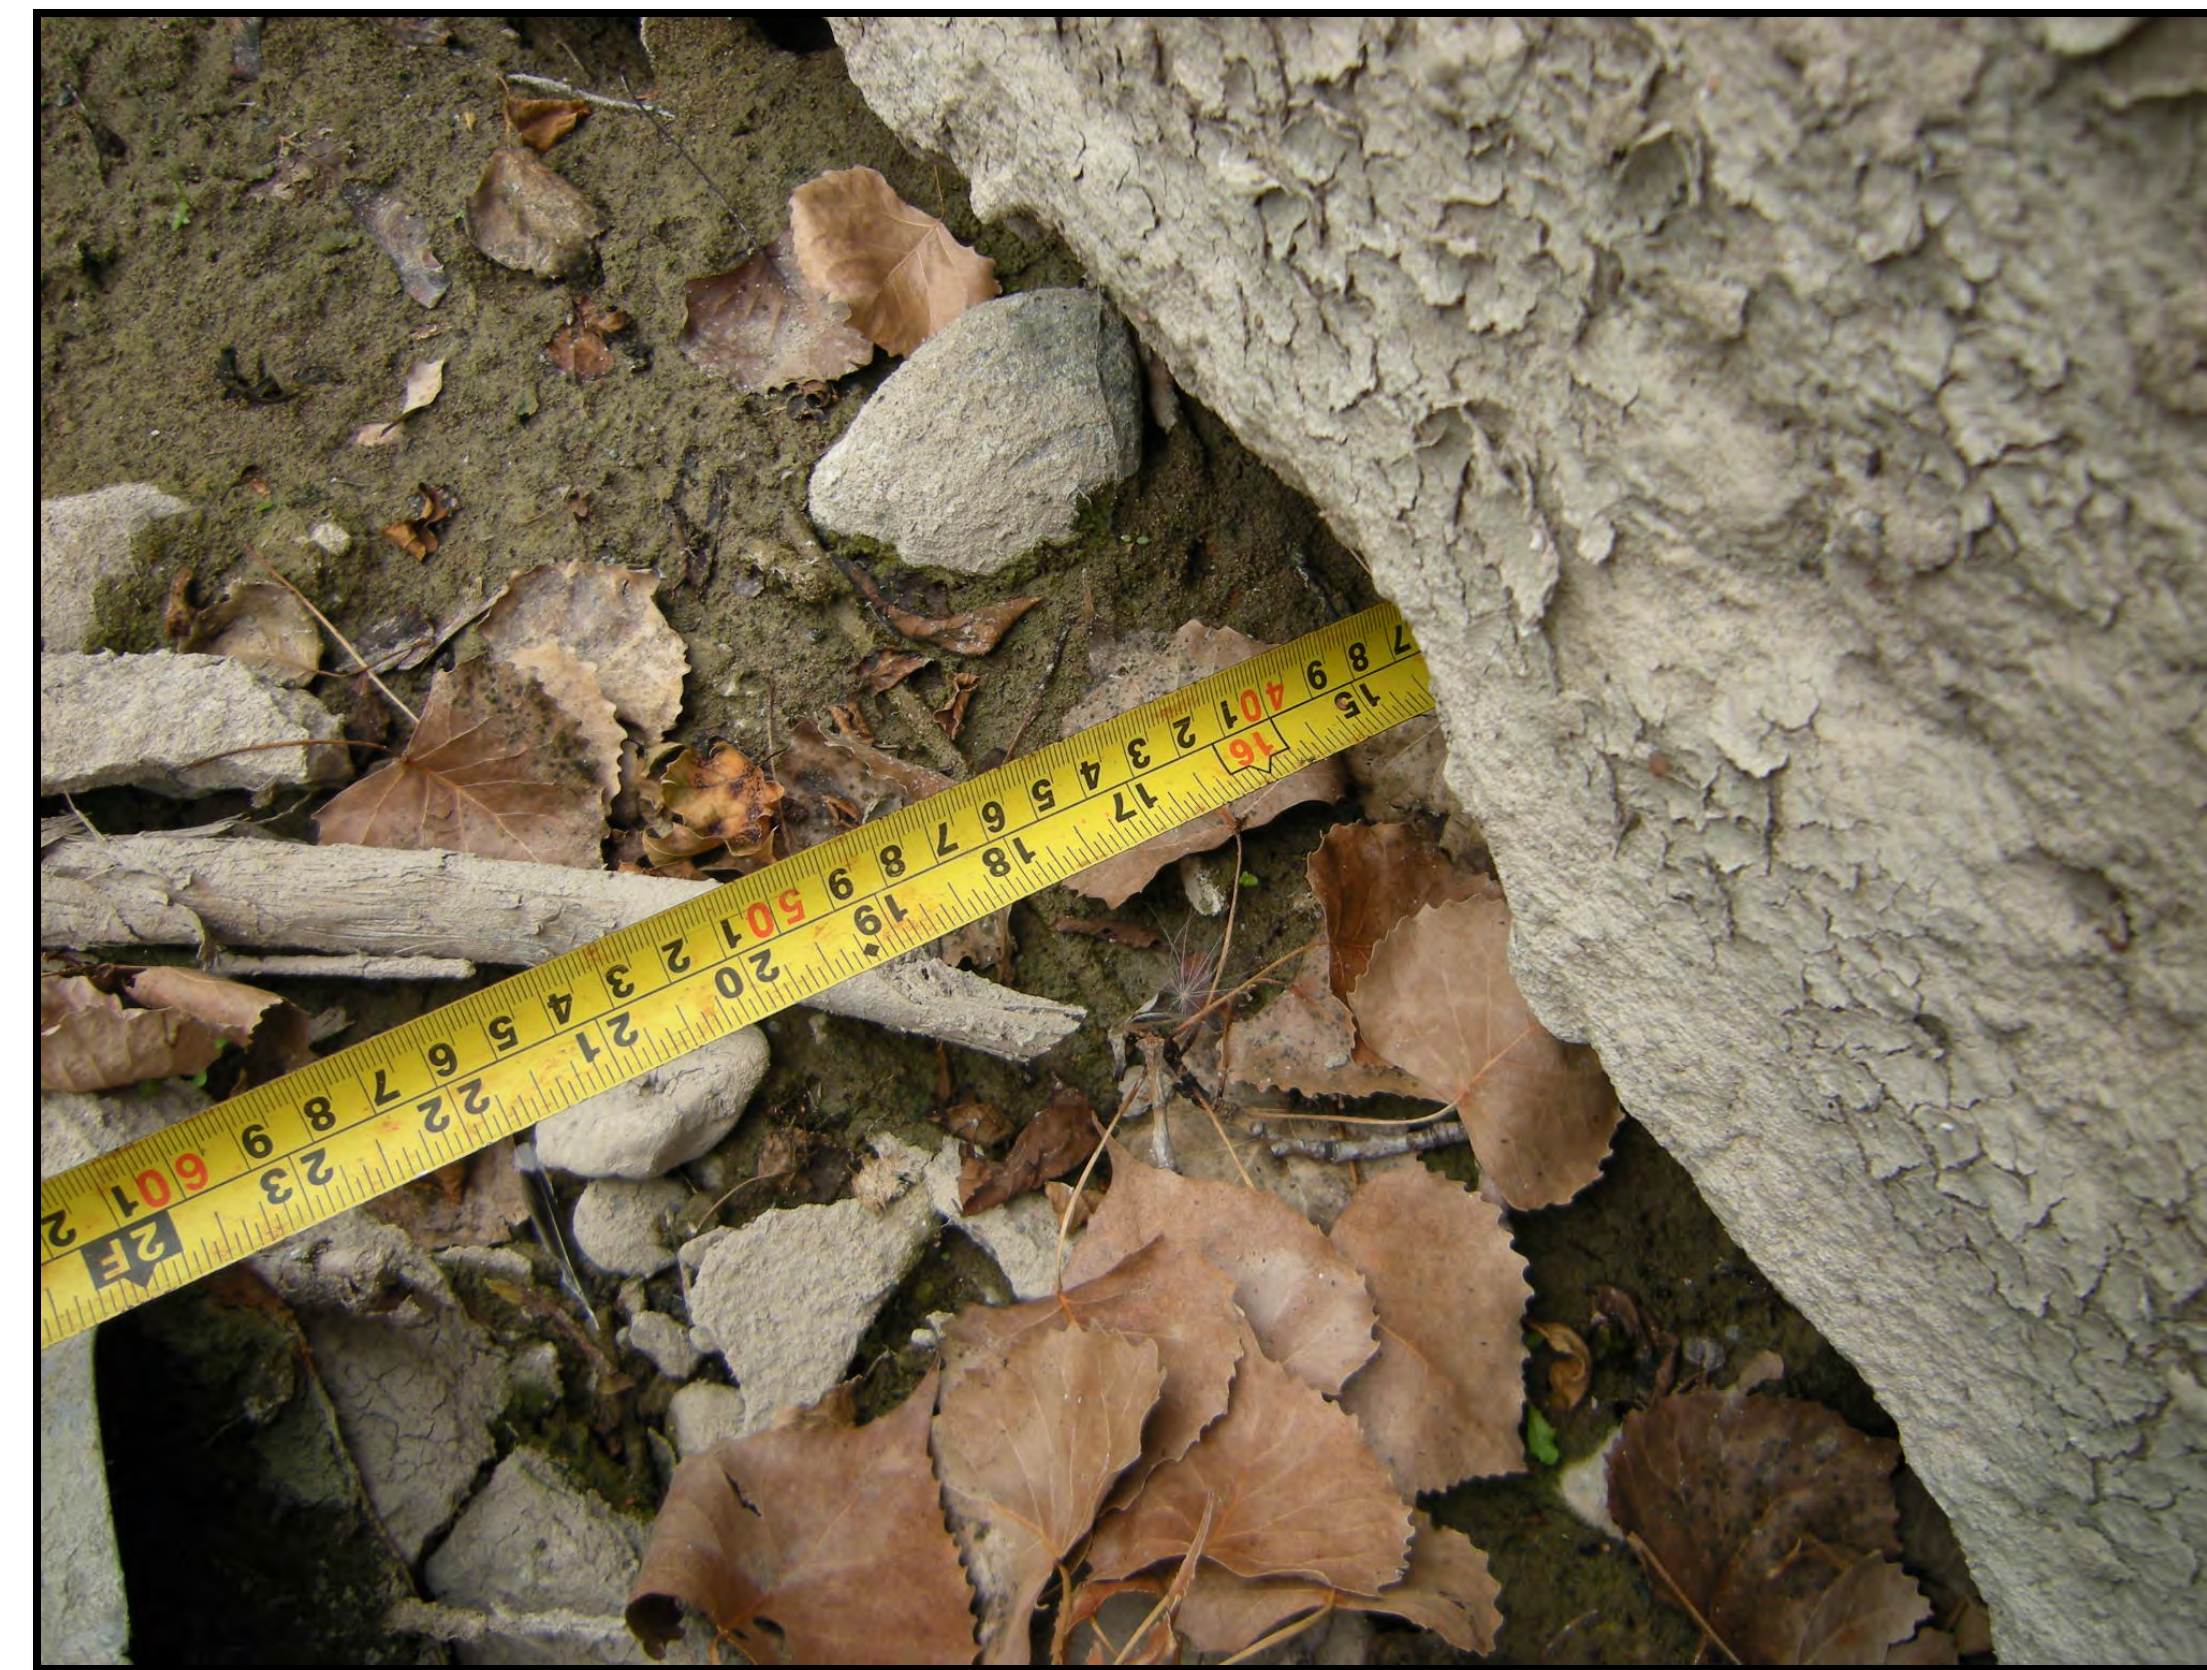
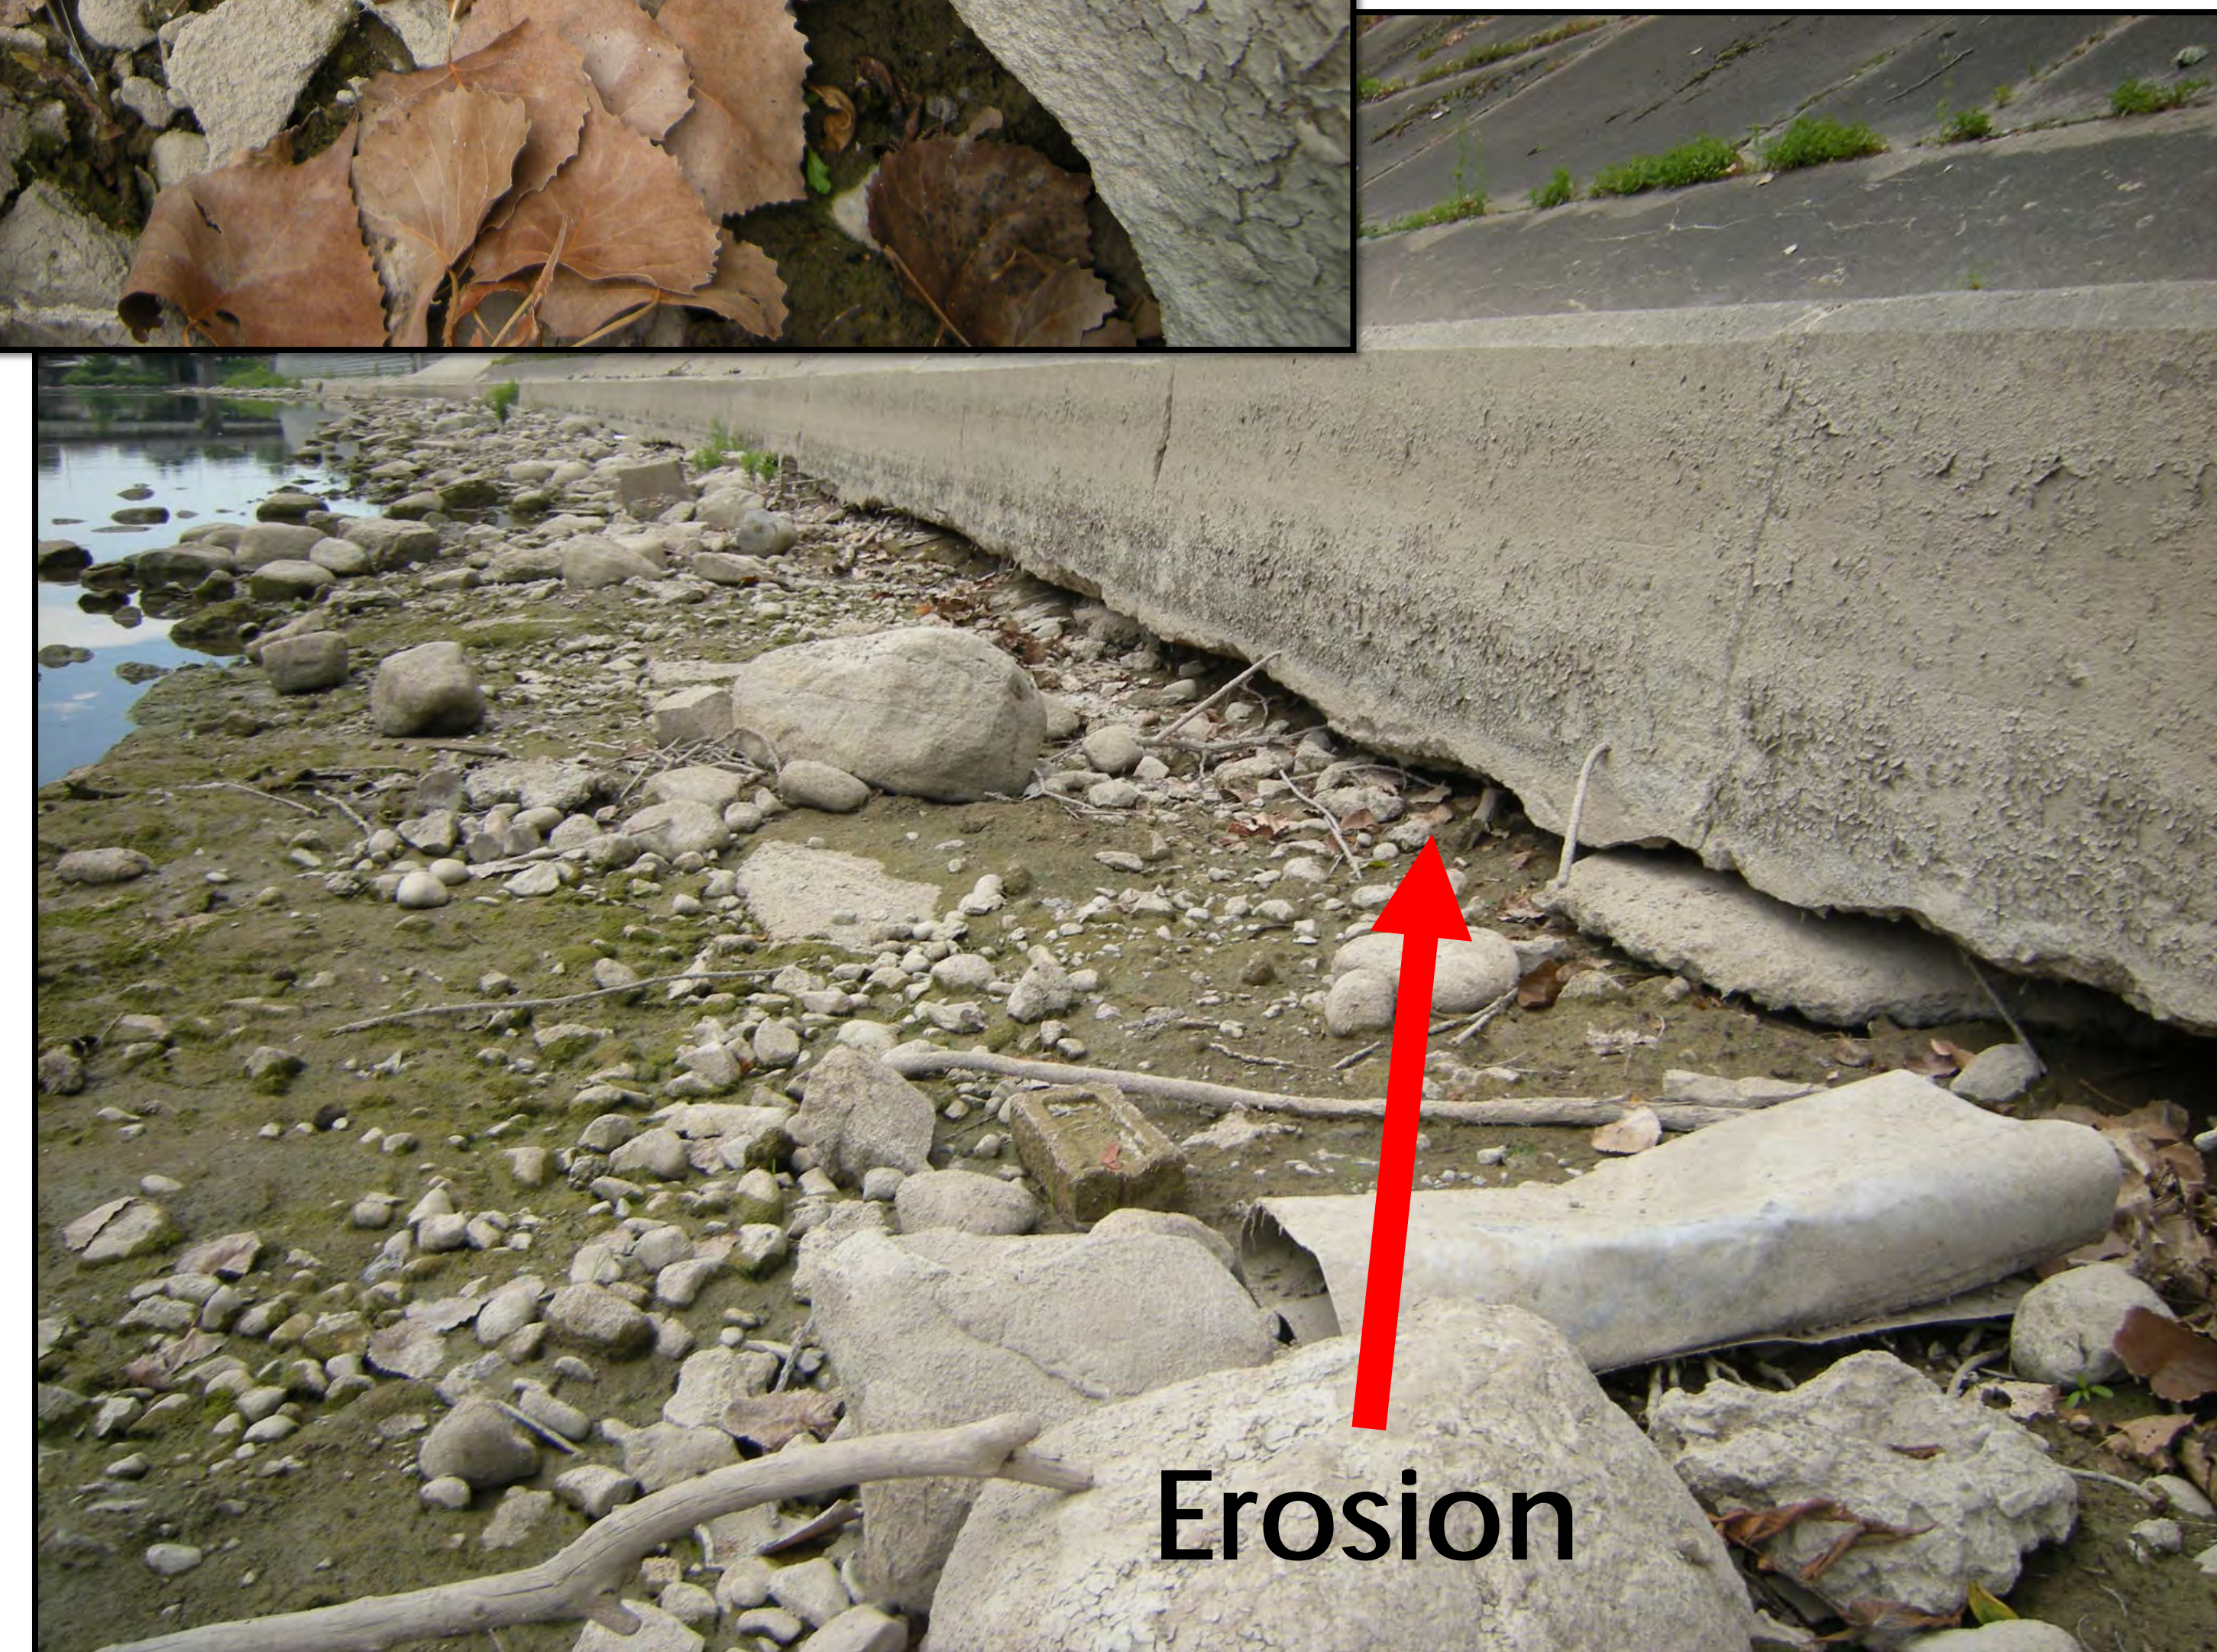
What does the erosion look like? Harris Park Site

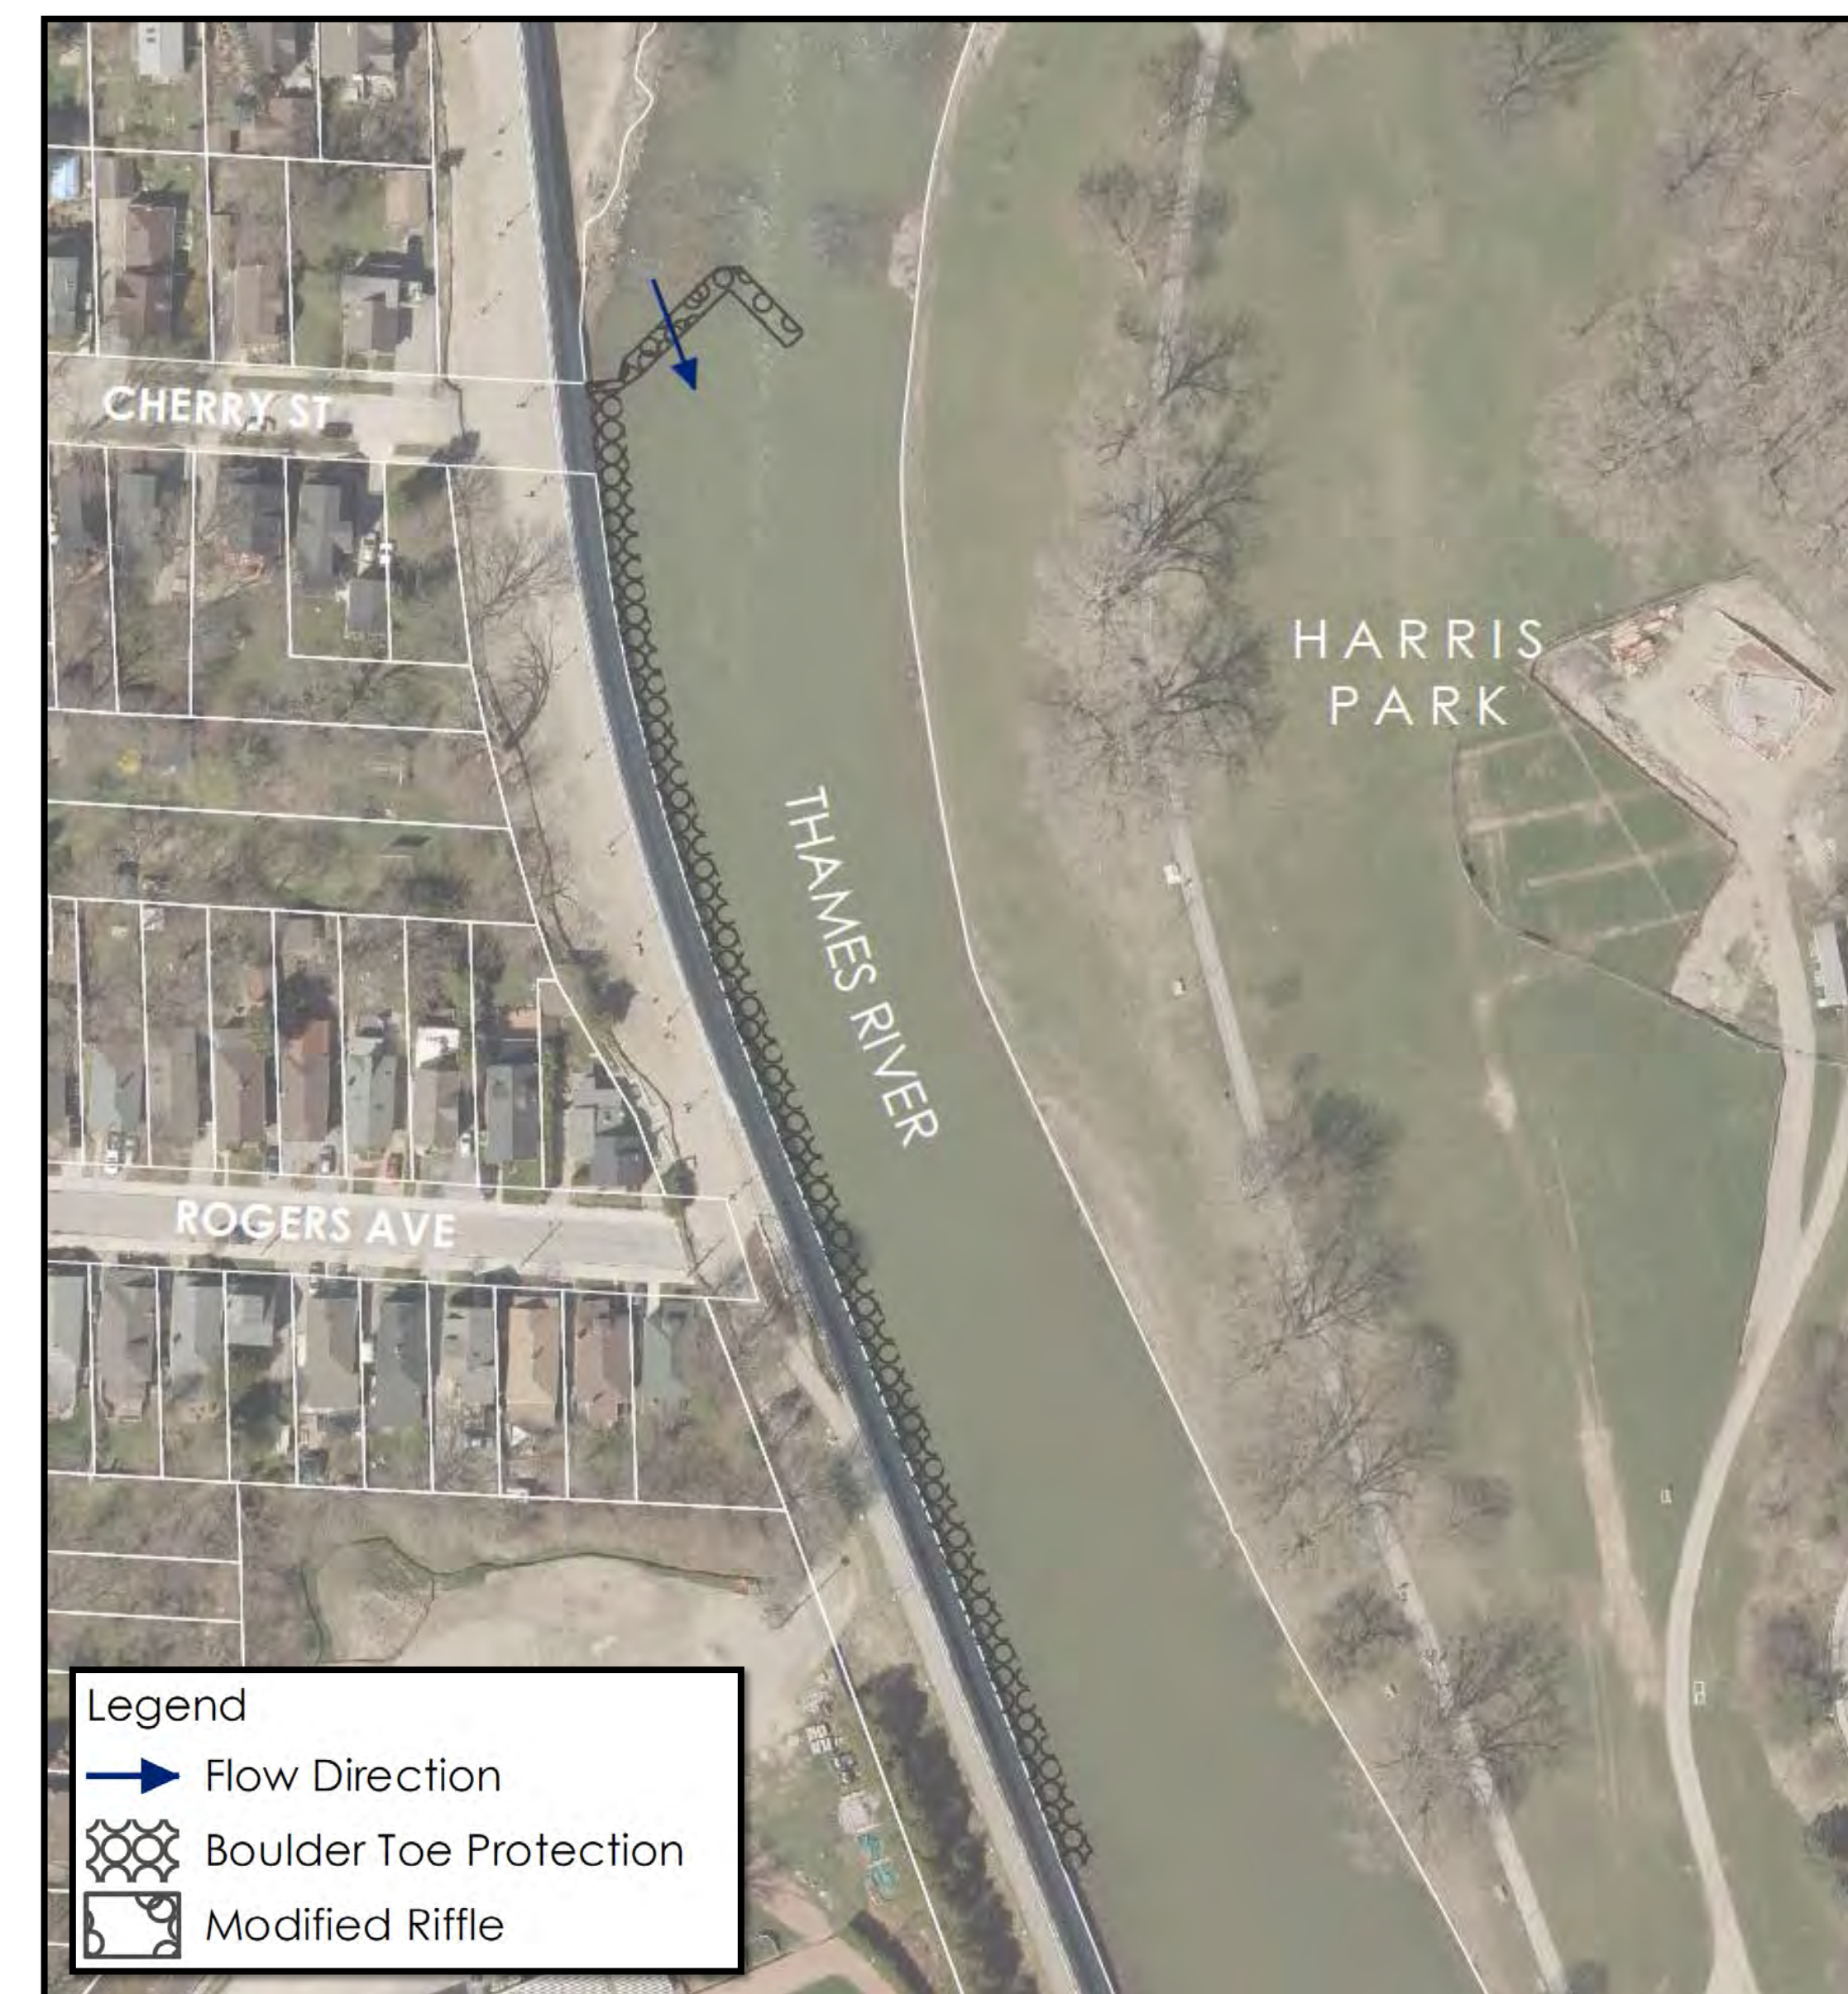
The preliminary recommendations at each site include a combination of toe protection to address the existing areas of erosion and flow modification to address the source and mitigate further erosion.

Harris Park Site
Modification to MNRF Fish Weirs and Boulder Toe Protection
