**West London Dyke Erosion Control
Municipal Class Environmental Assessment
Stakeholder Contact List**

**West London Dyke Erosion Control
Municipal Class Environmental Assessment
Notice of Study Commencement**

Ann Street Site – Conceptual Cross Section

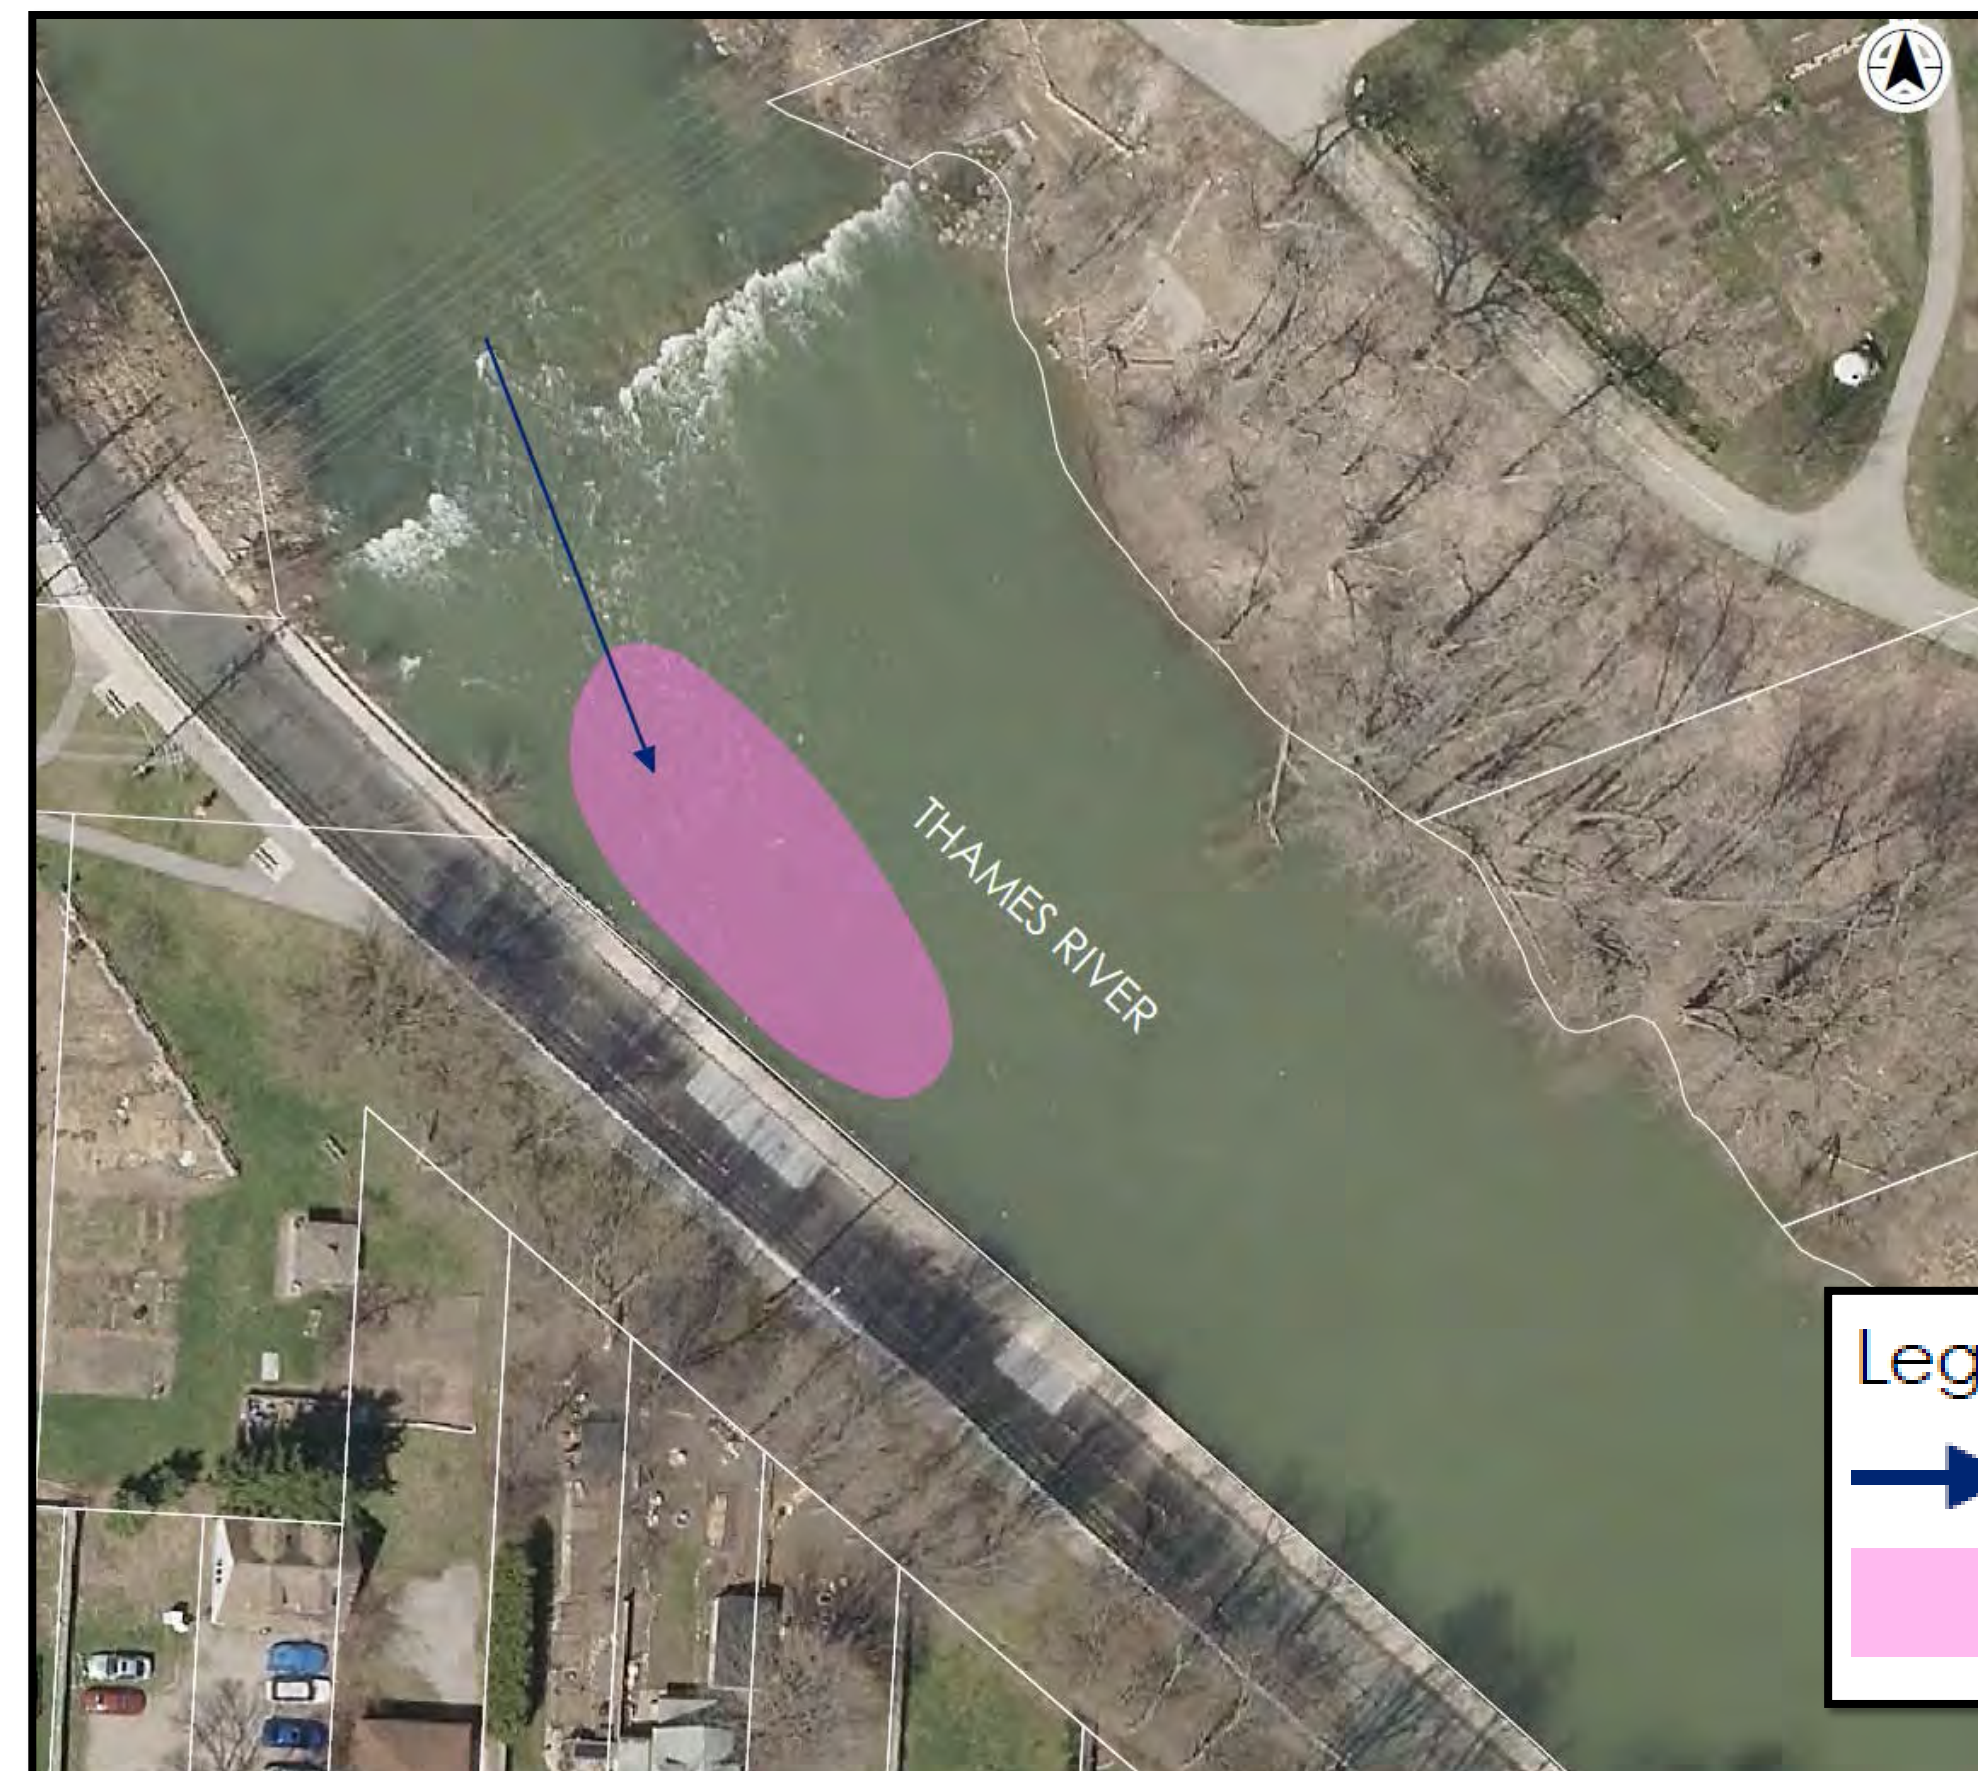
Ann Street Site

While undertaking the West London Dyke (WLD) Master Repair Plan, two locations of erosion (or scour) were identified. Existing structures within the river in each location are directing flows towards the west bank, causing erosion at the toe of the WLD:

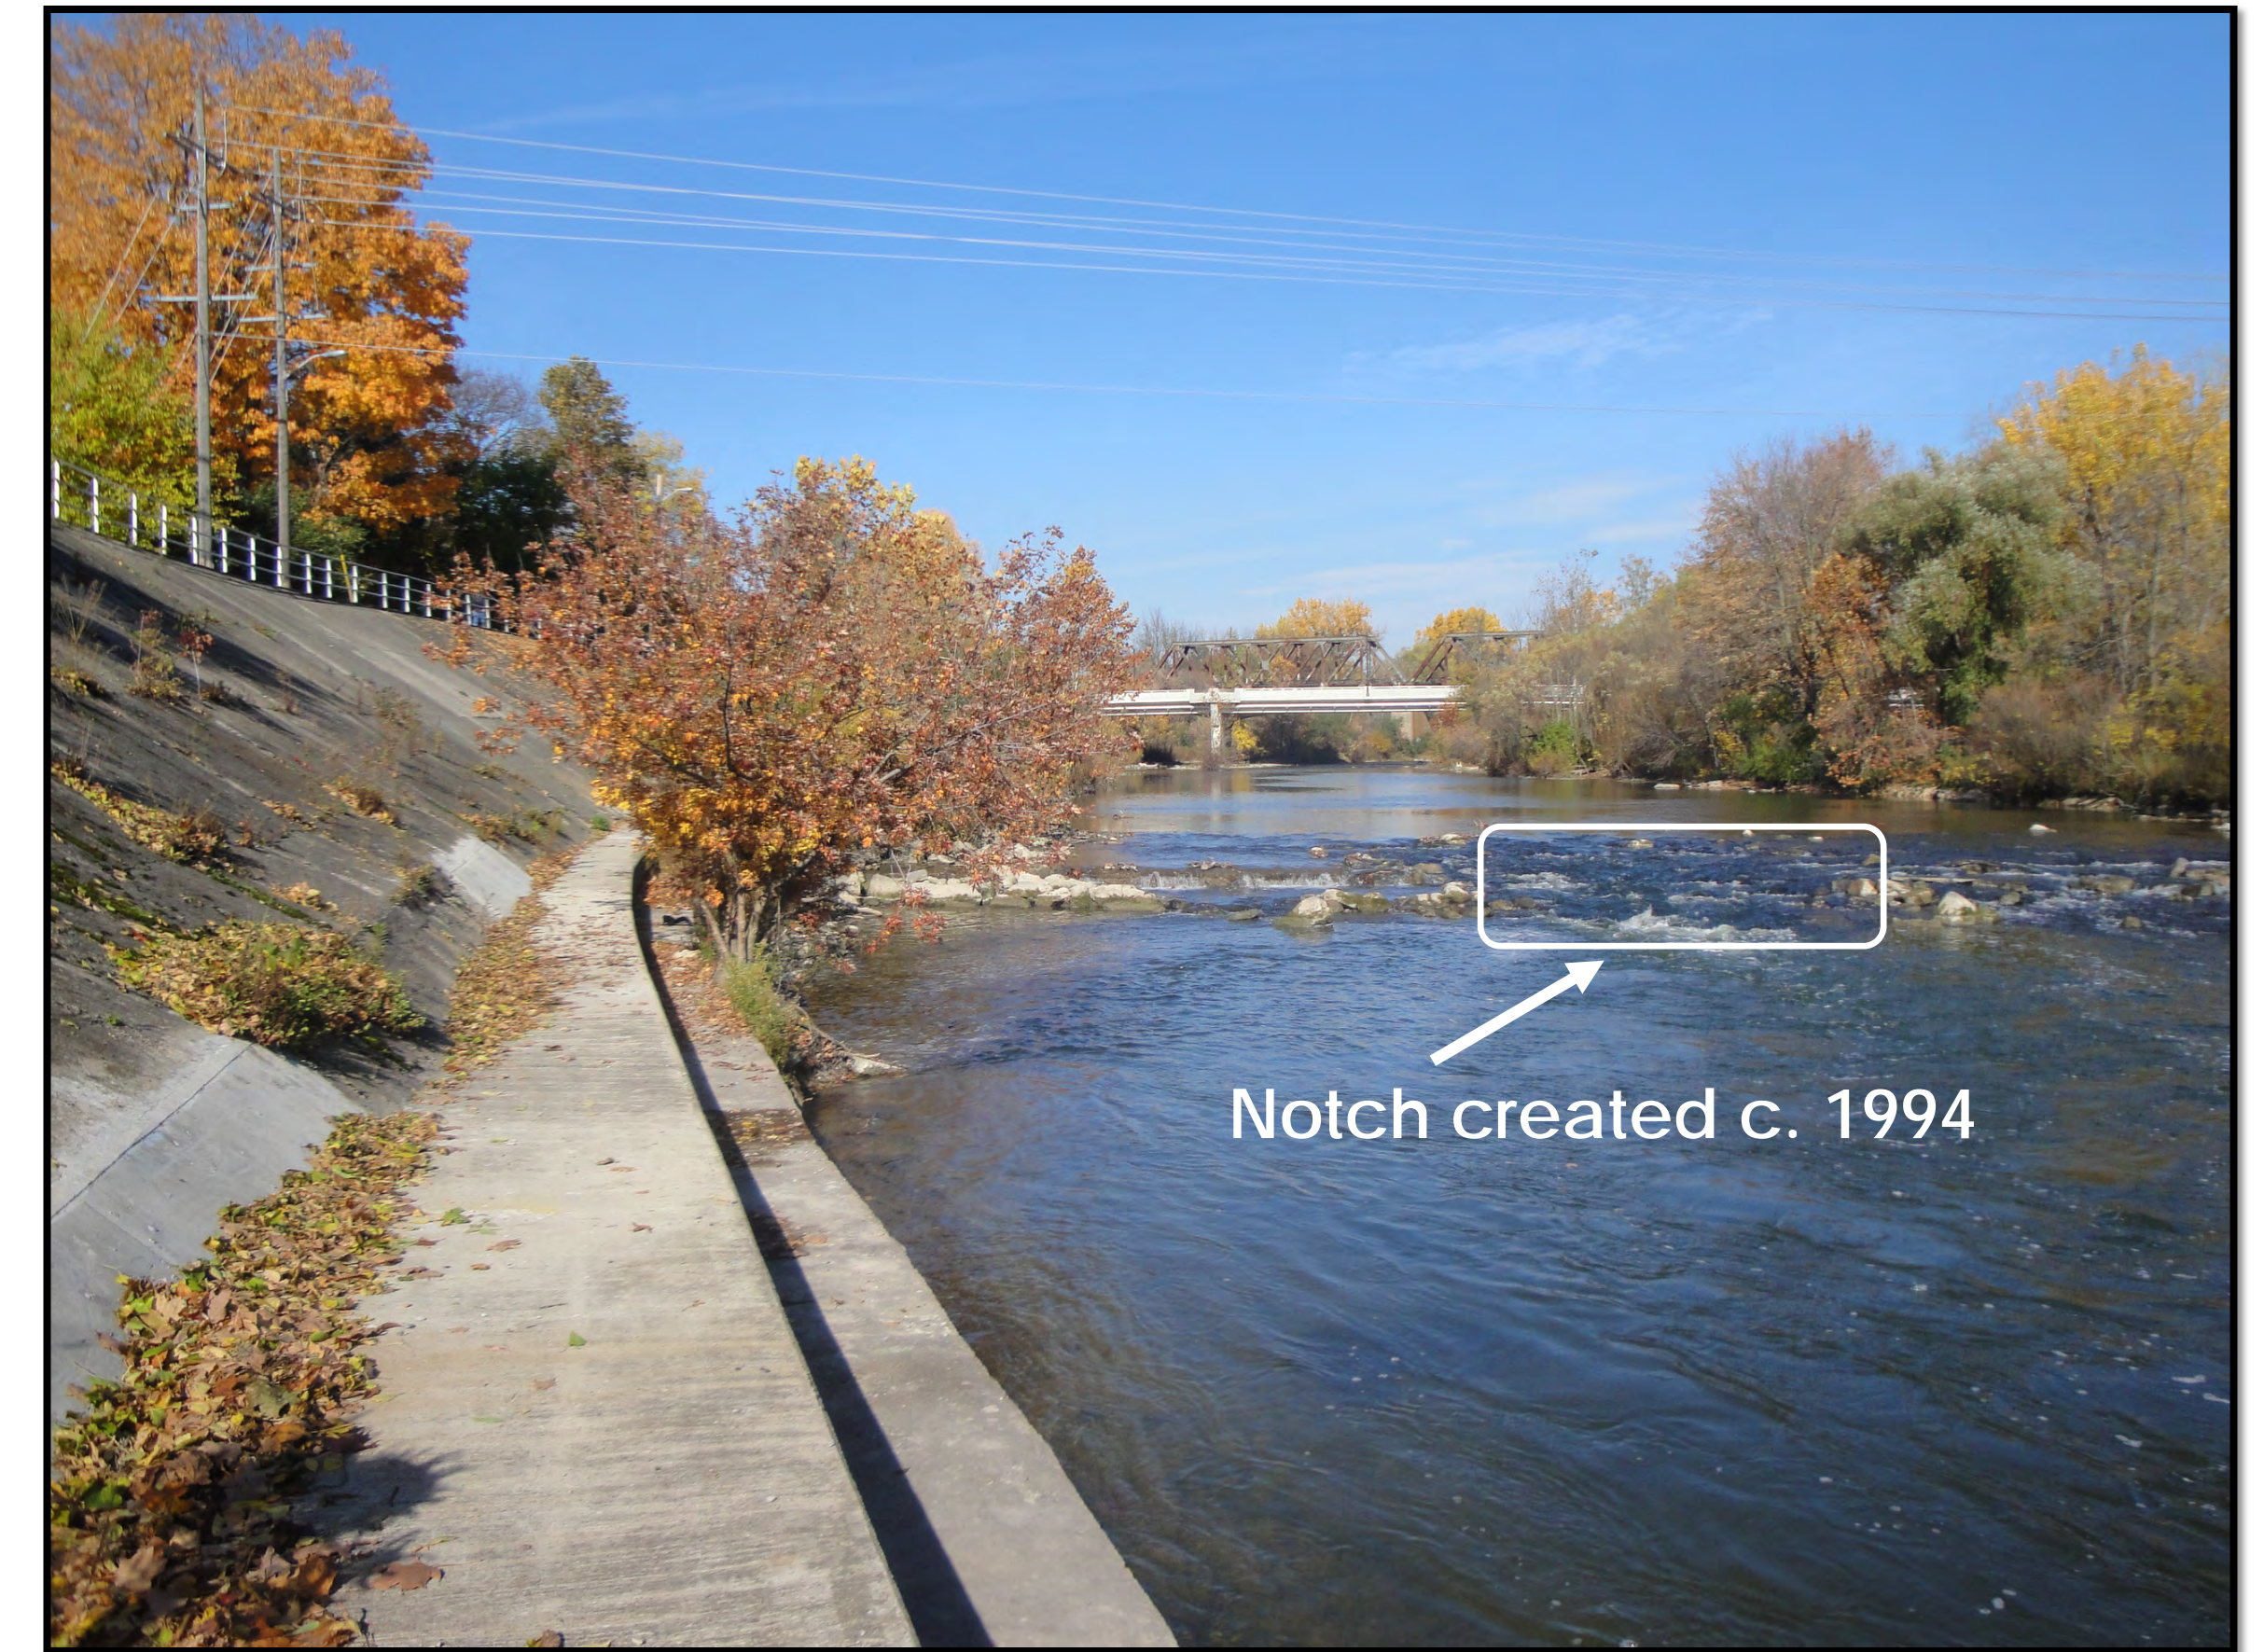
As-Built drawing of sewer crossing - 1994

- An abandoned concrete-encased sanitary sewer crosses the Thames River between Ann Street and St. Patrick Street, forming a weir (a portion of pipe was removed, and the rest filled with concrete c. 1994).
- This sewer was replaced in 1994 with a deeper, twinned sewer. The new sewer crossing is located just upstream of the abandoned crossing.
- Riffles exist both upstream and downstream of the weir crossing.
- This is a popular spot for fishing, and the existing notch provides boaters a place to practice traversing a mini-rapid.

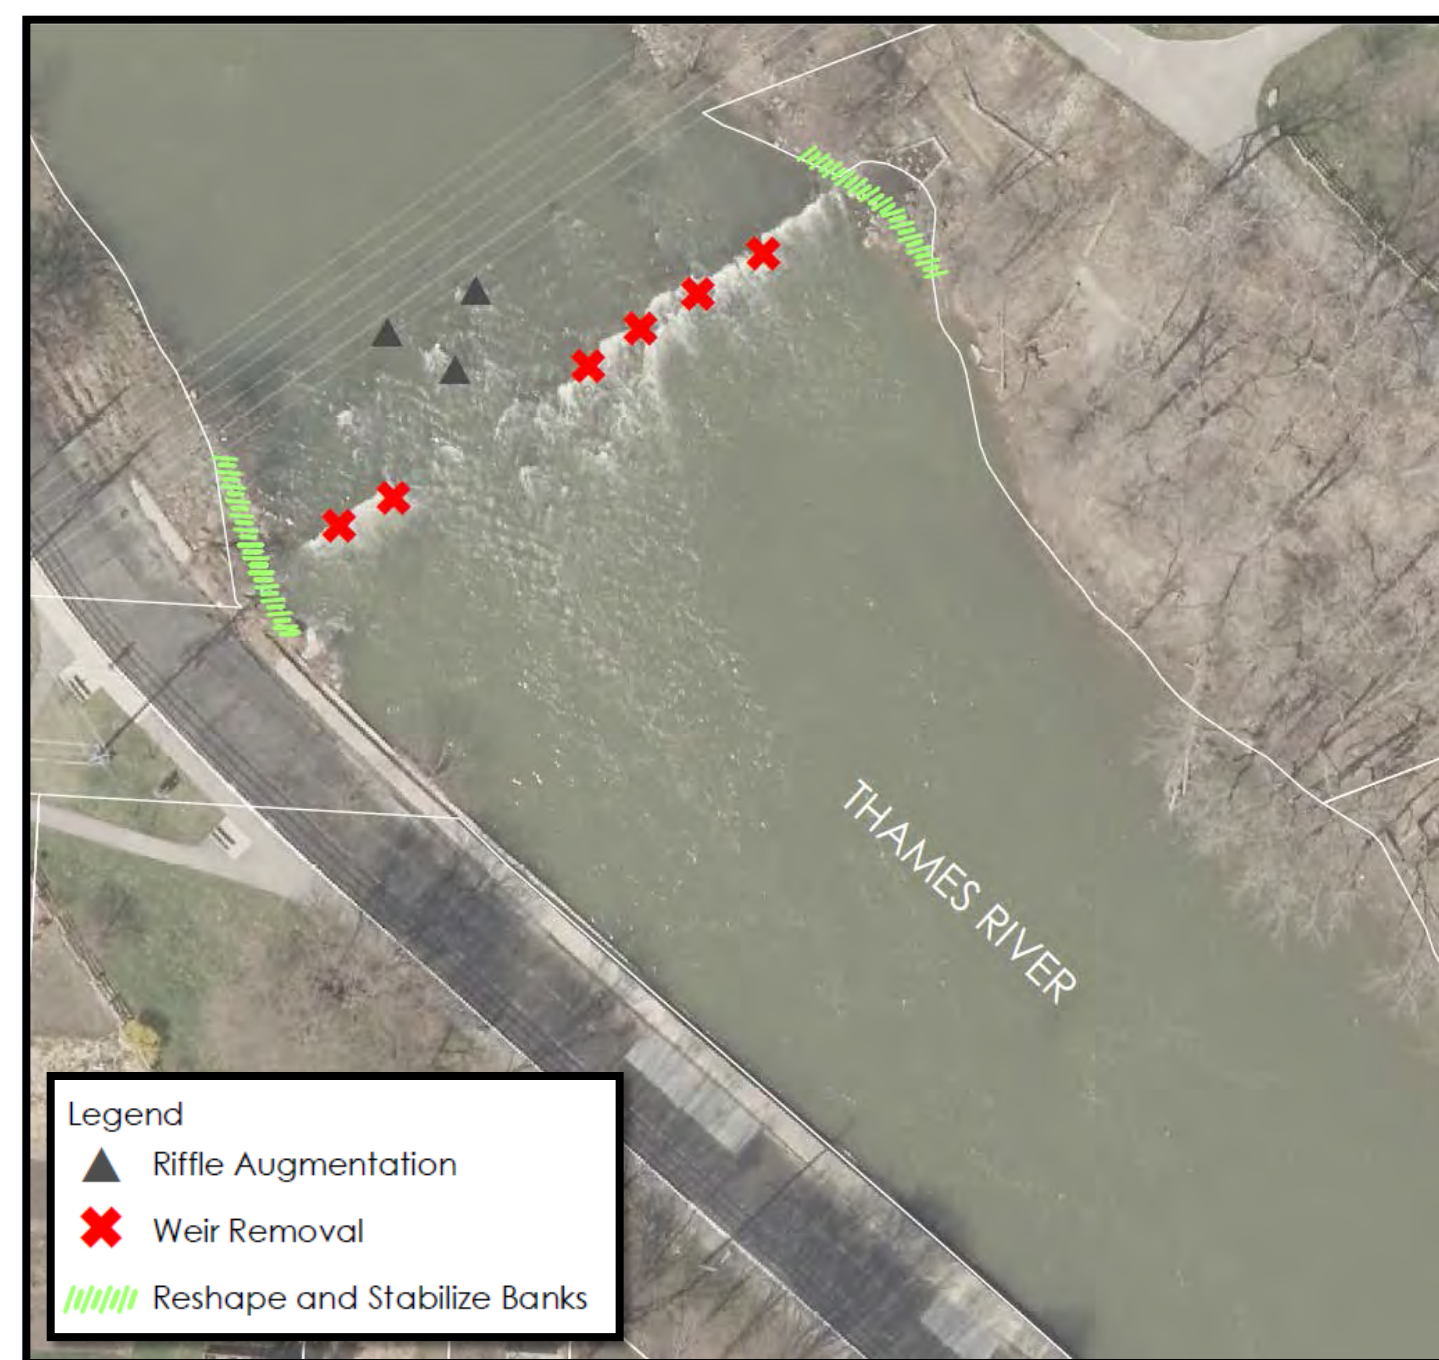
Alternative 1 – Remove Weir

The existing concrete weir would be removed, eliminating the effect of the weir notch that is directing flow toward the west bank. Shaping or regrading of the banks may be required where the weir may have exacerbated erosion.

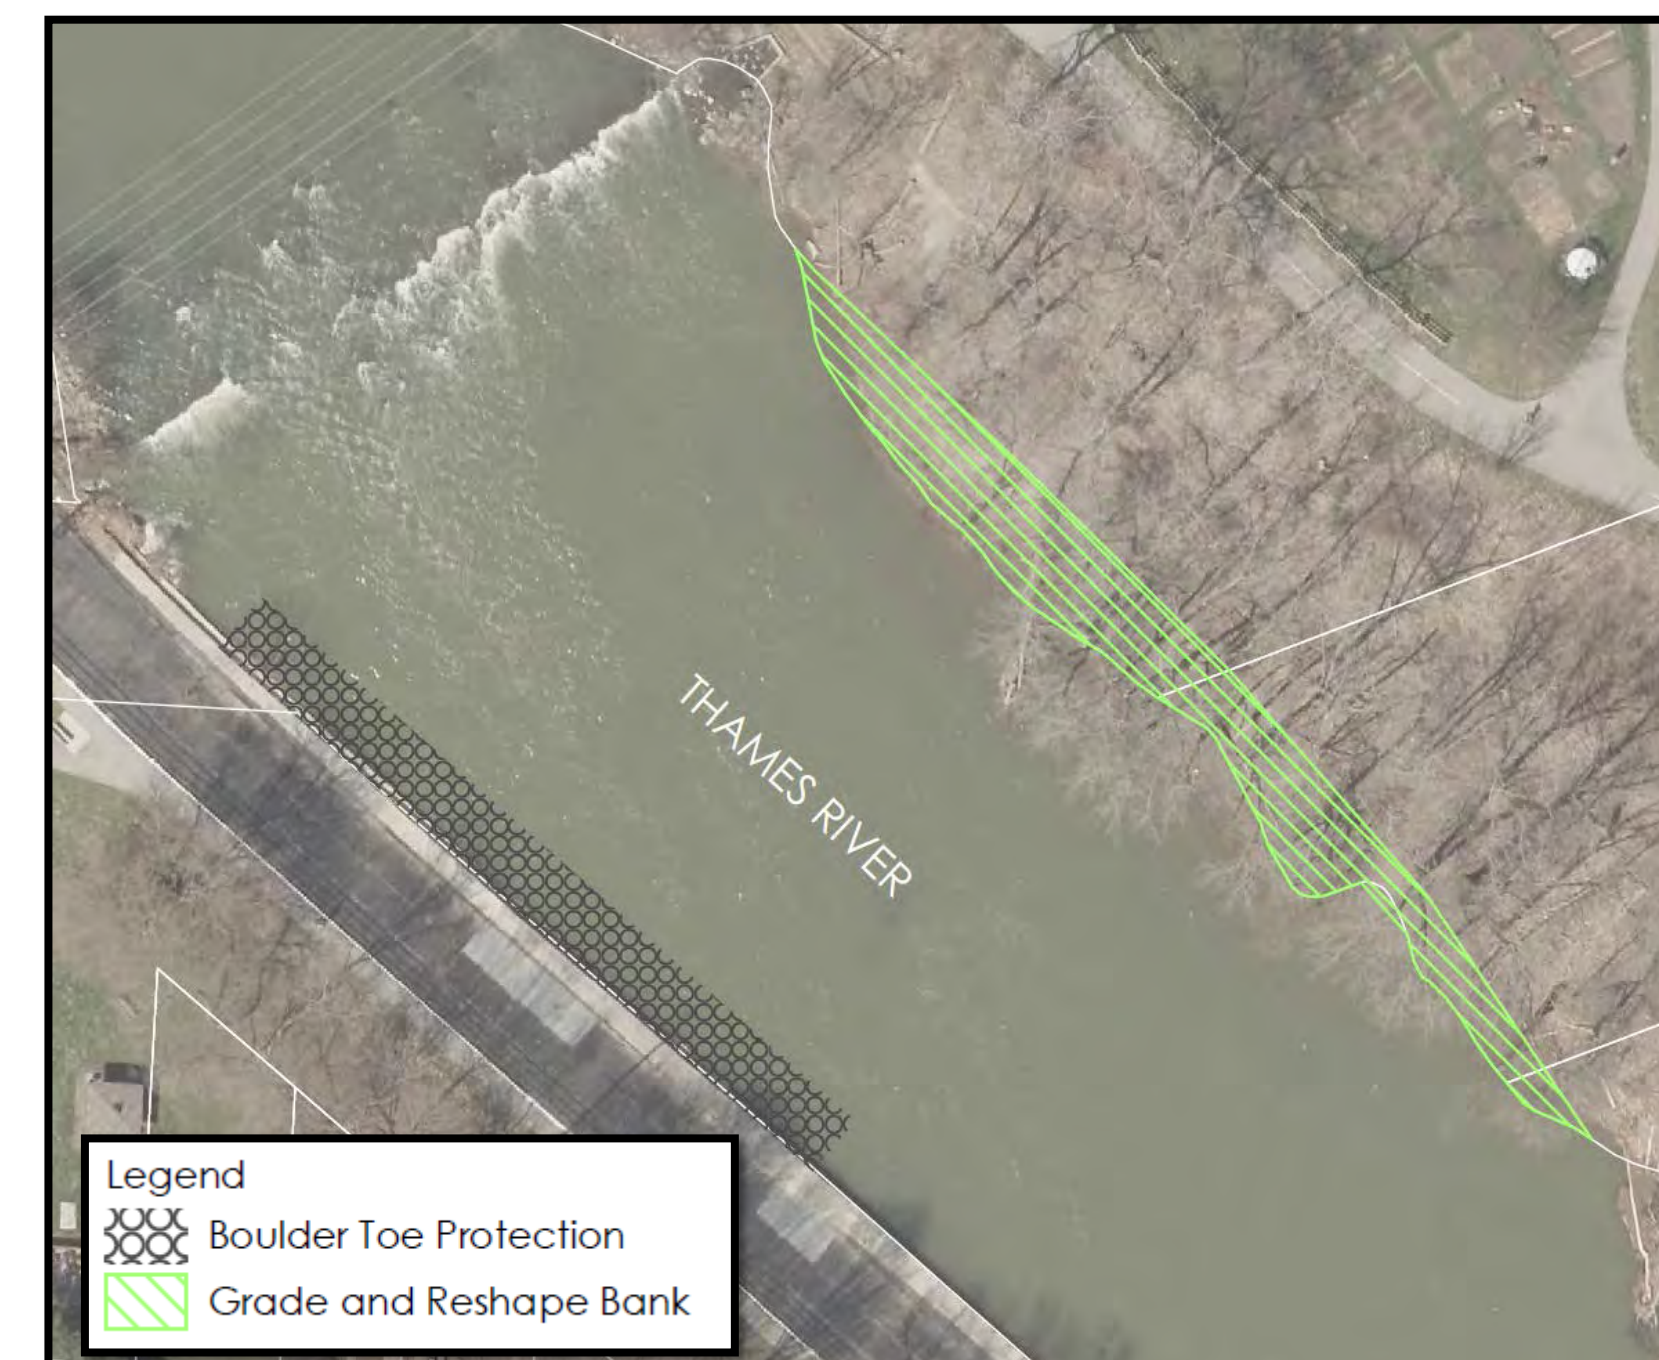
Alternative 3 – Boulder Toe Protection

Boulders would be installed along the toe of the dyke, for a stretch of approximately 60 m. Treatment would be approximately 5 m wide. Under this alternative, grading and reshaping the east bank is recommended to compensate for the reduction in river cross section from the installation of boulders.

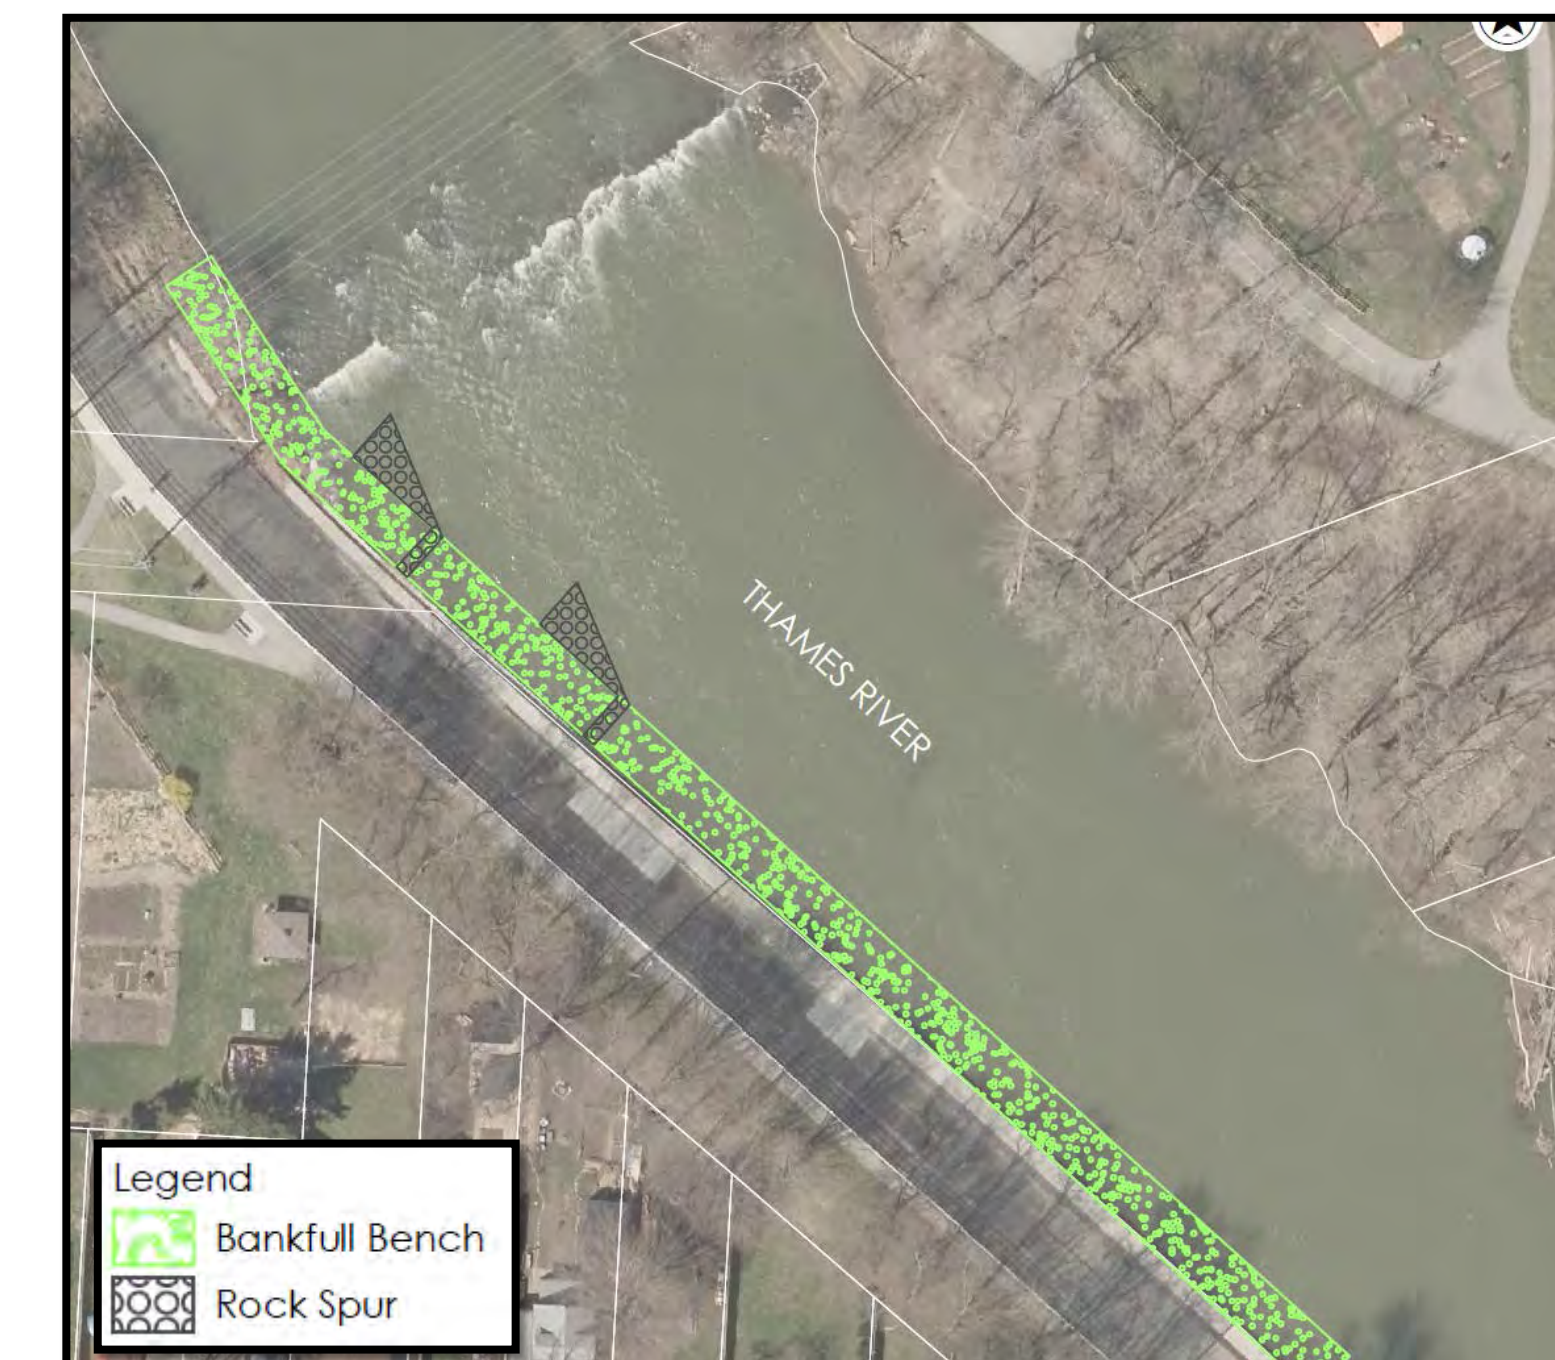
Alternative 4 – Bench and Vanes

A bankfull bench composed of engineered fill (boulders, concrete, granular material) would be installed and planted with deeply rooting vegetation. Vanes consist of boulders or armourstone anchored into the stream bank pointing upstream to slow flow and turn it towards the centre of the river channel.

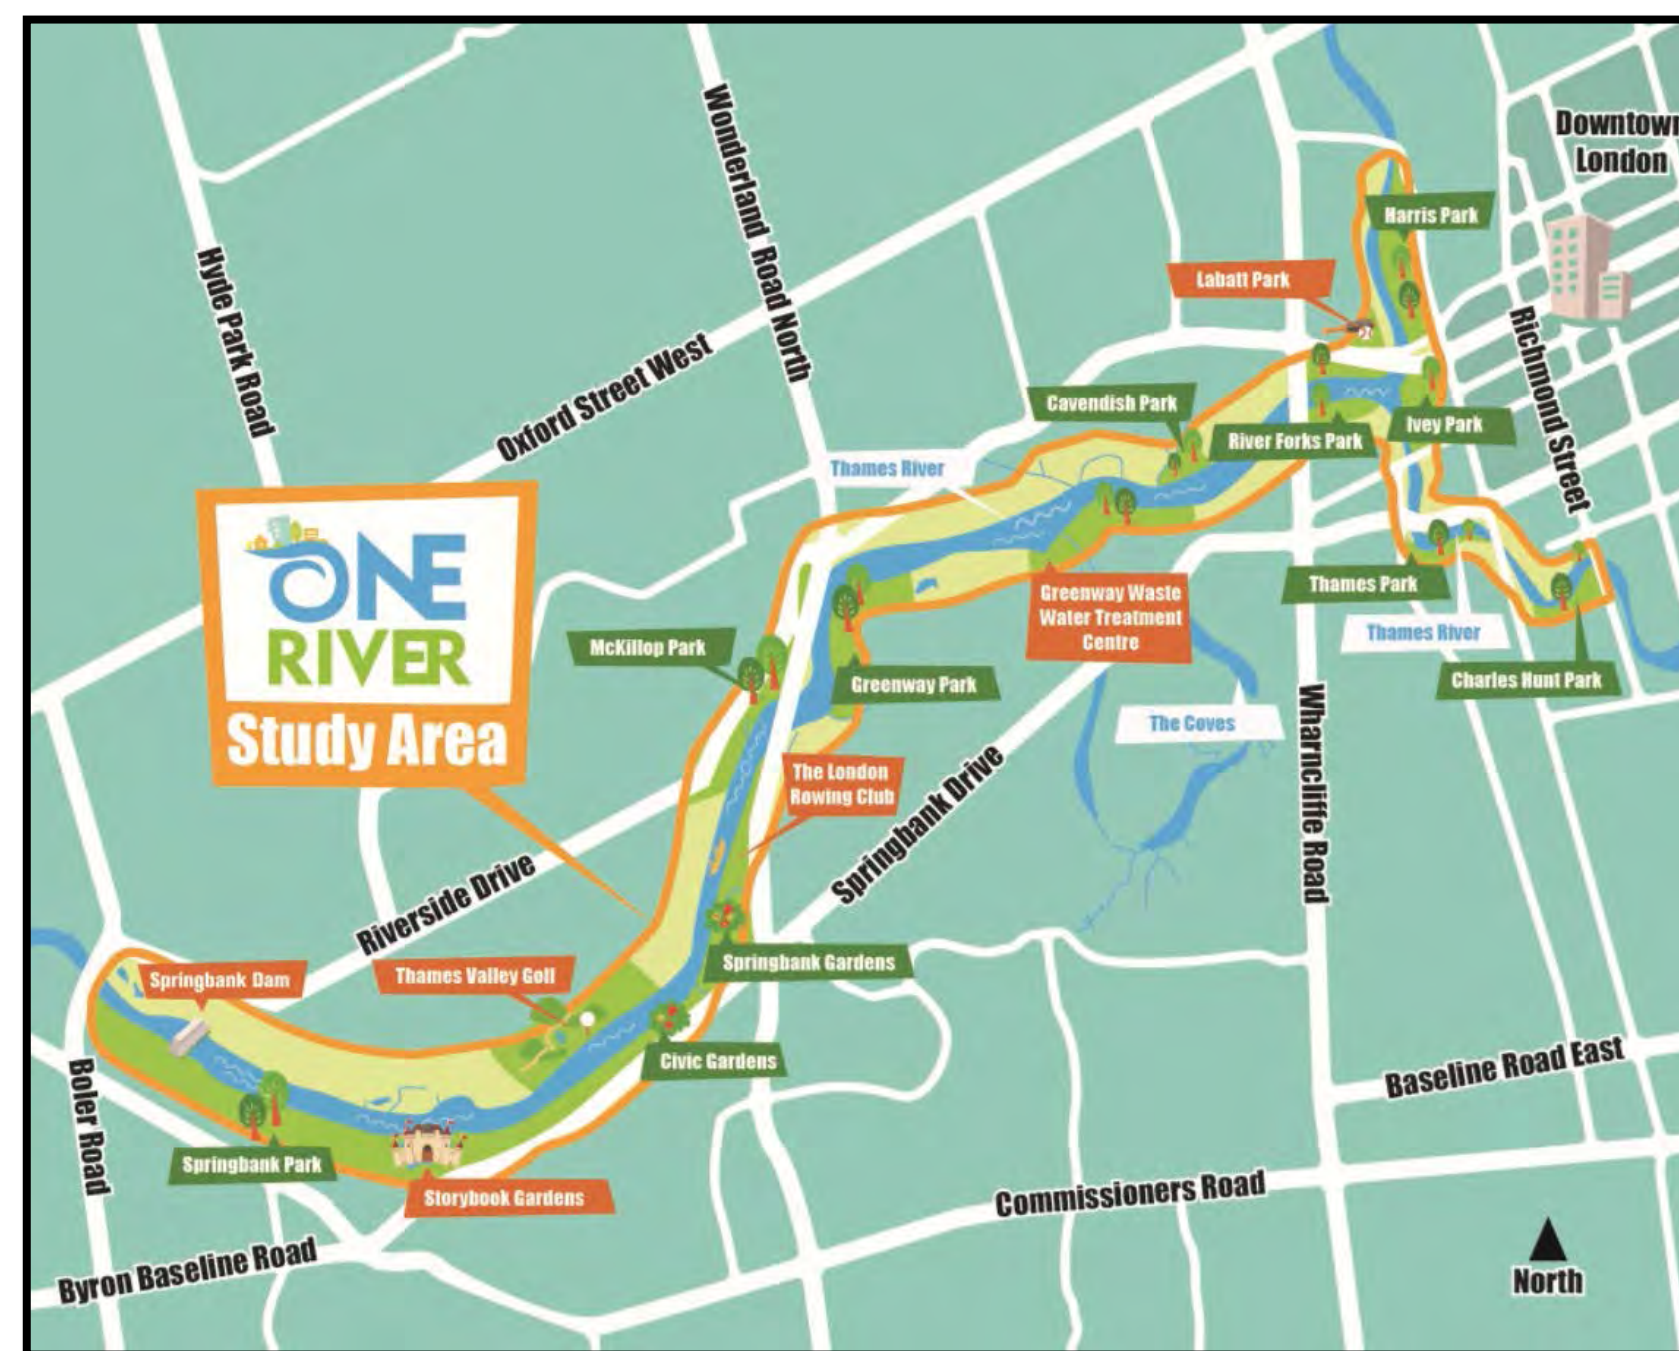
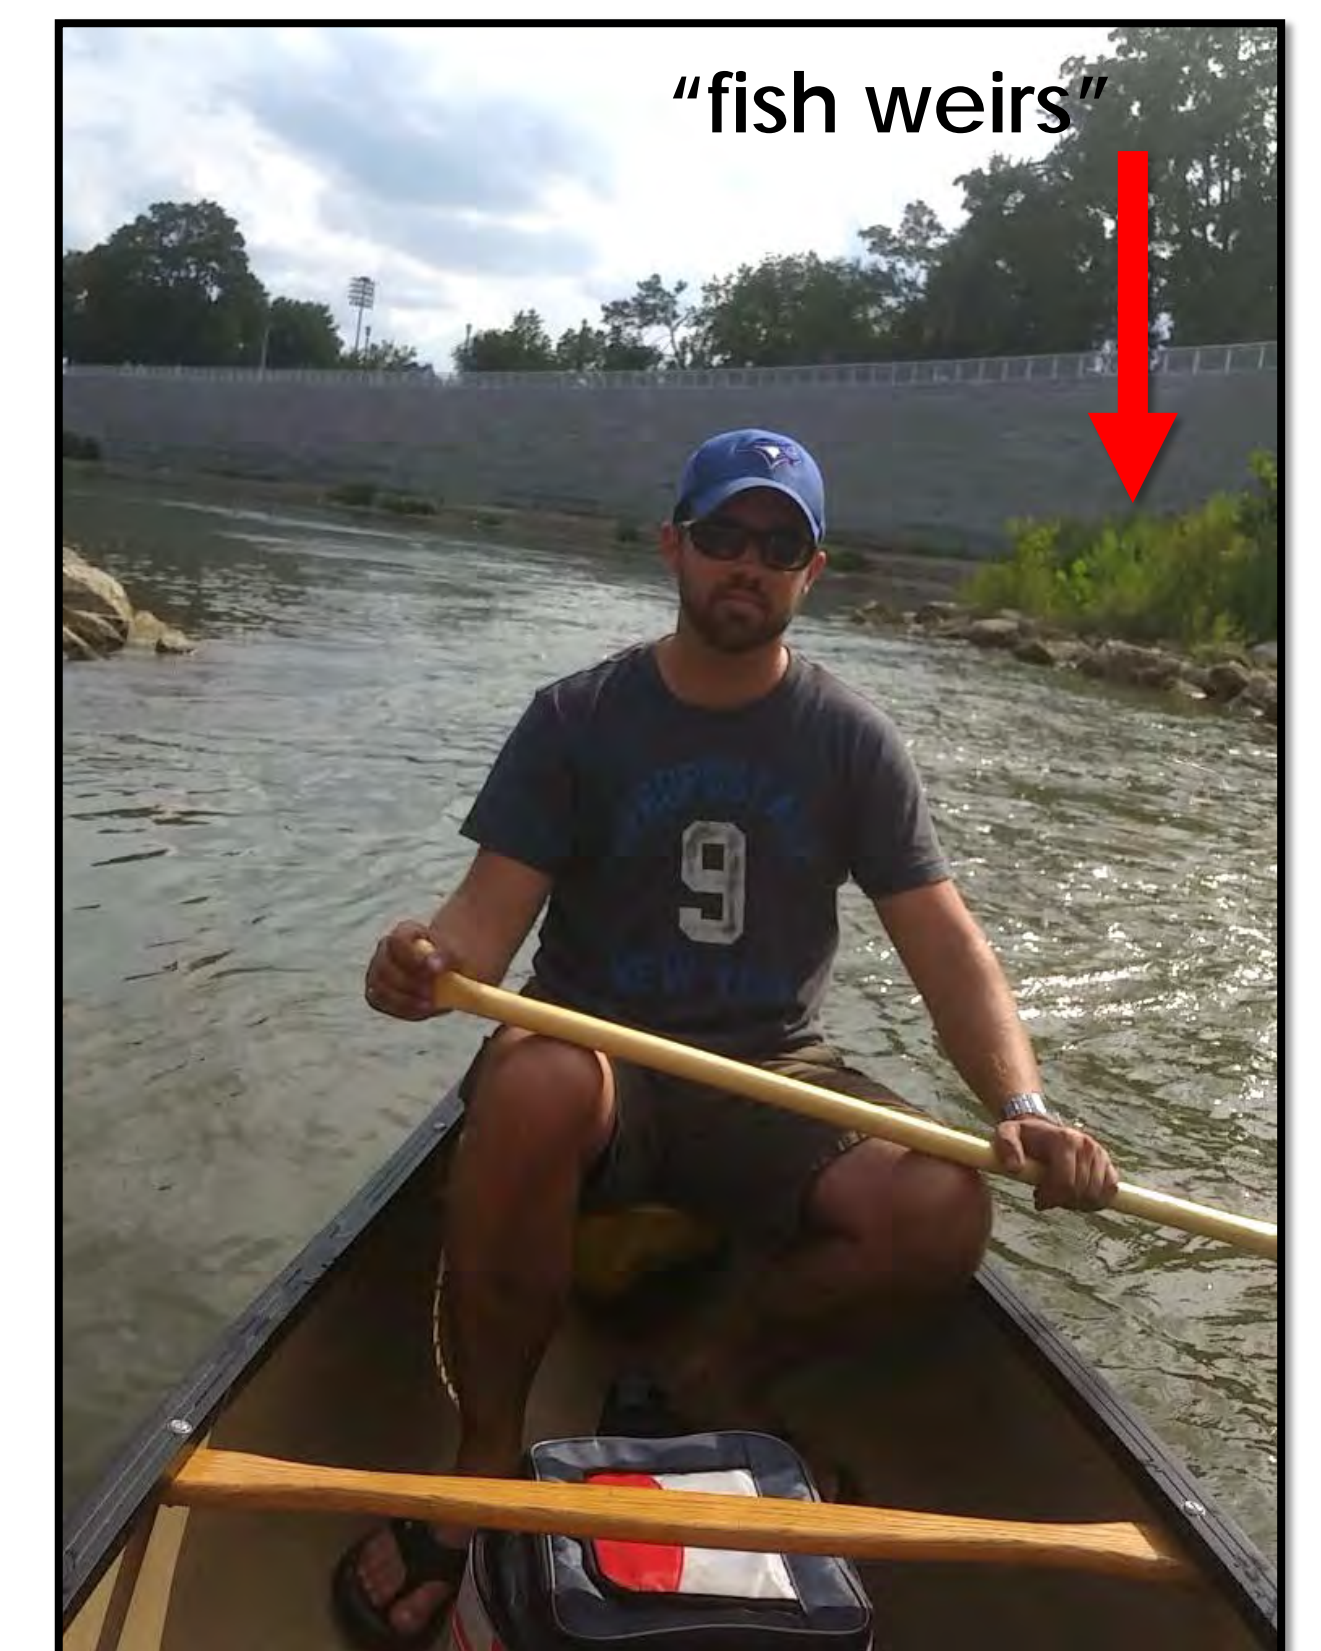
Existing Conditions Harris Park

- The Ministry of Natural Resources and Forestry (MNRF) installed rocks features (referred to as fish weirs) c. 1980's to improve fish habitat and passage in the area.
- This is a popular spot for fishing (and boating).
- The potential exists for species at risk, and species of special concern turtles in this area of the river.
- This area is just upstream of the Forks of the Thames – an area of focus for the One River Master Plan Environmental Assessment and Back to the River. Any recommendations for shoreline improvements will need to be coordinated with those projects.

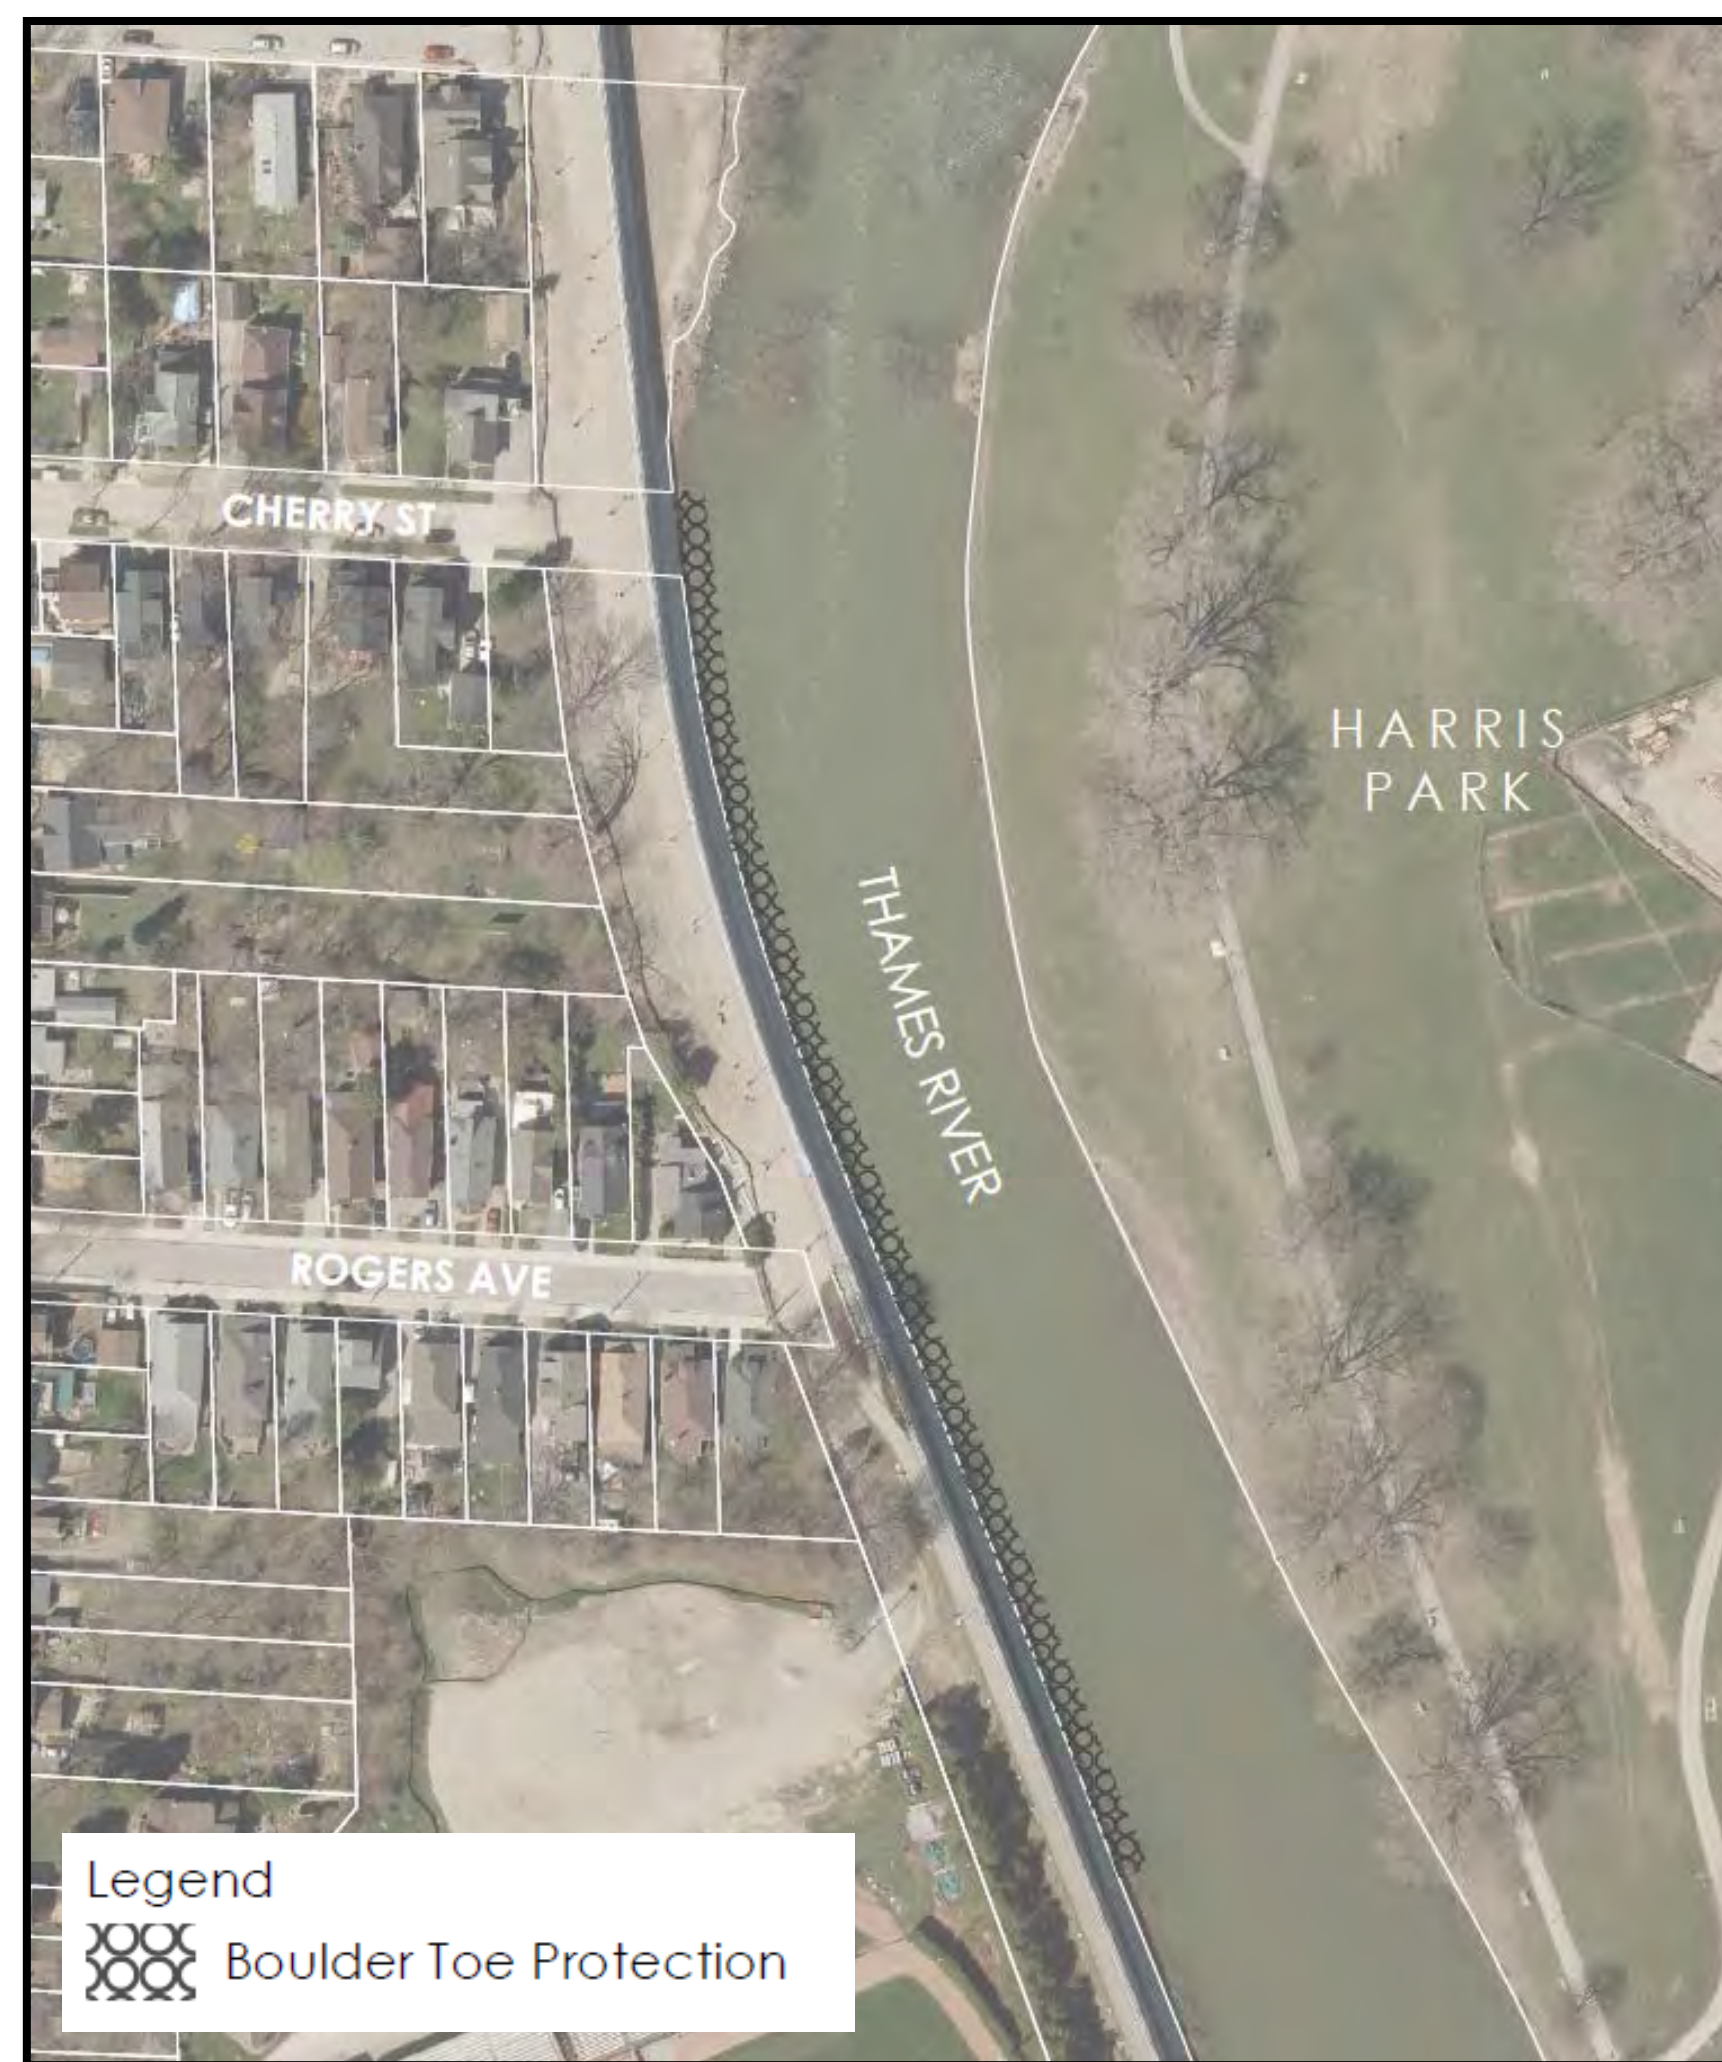
Alternative 1 – Boulder Toe Protection

Boulders would be installed along the toe of the dyke for a stretch of approximately 240 m. The treatment would be approximately 5 m wide.
