**West London Dyke Erosion Control
Municipal Class Environmental Assessment
Stakeholder Contact List**

**West London Dyke Erosion Control
Municipal Class Environmental Assessment
Notice of Study Commencement**

Ann Street Site – Conceptual Cross Section

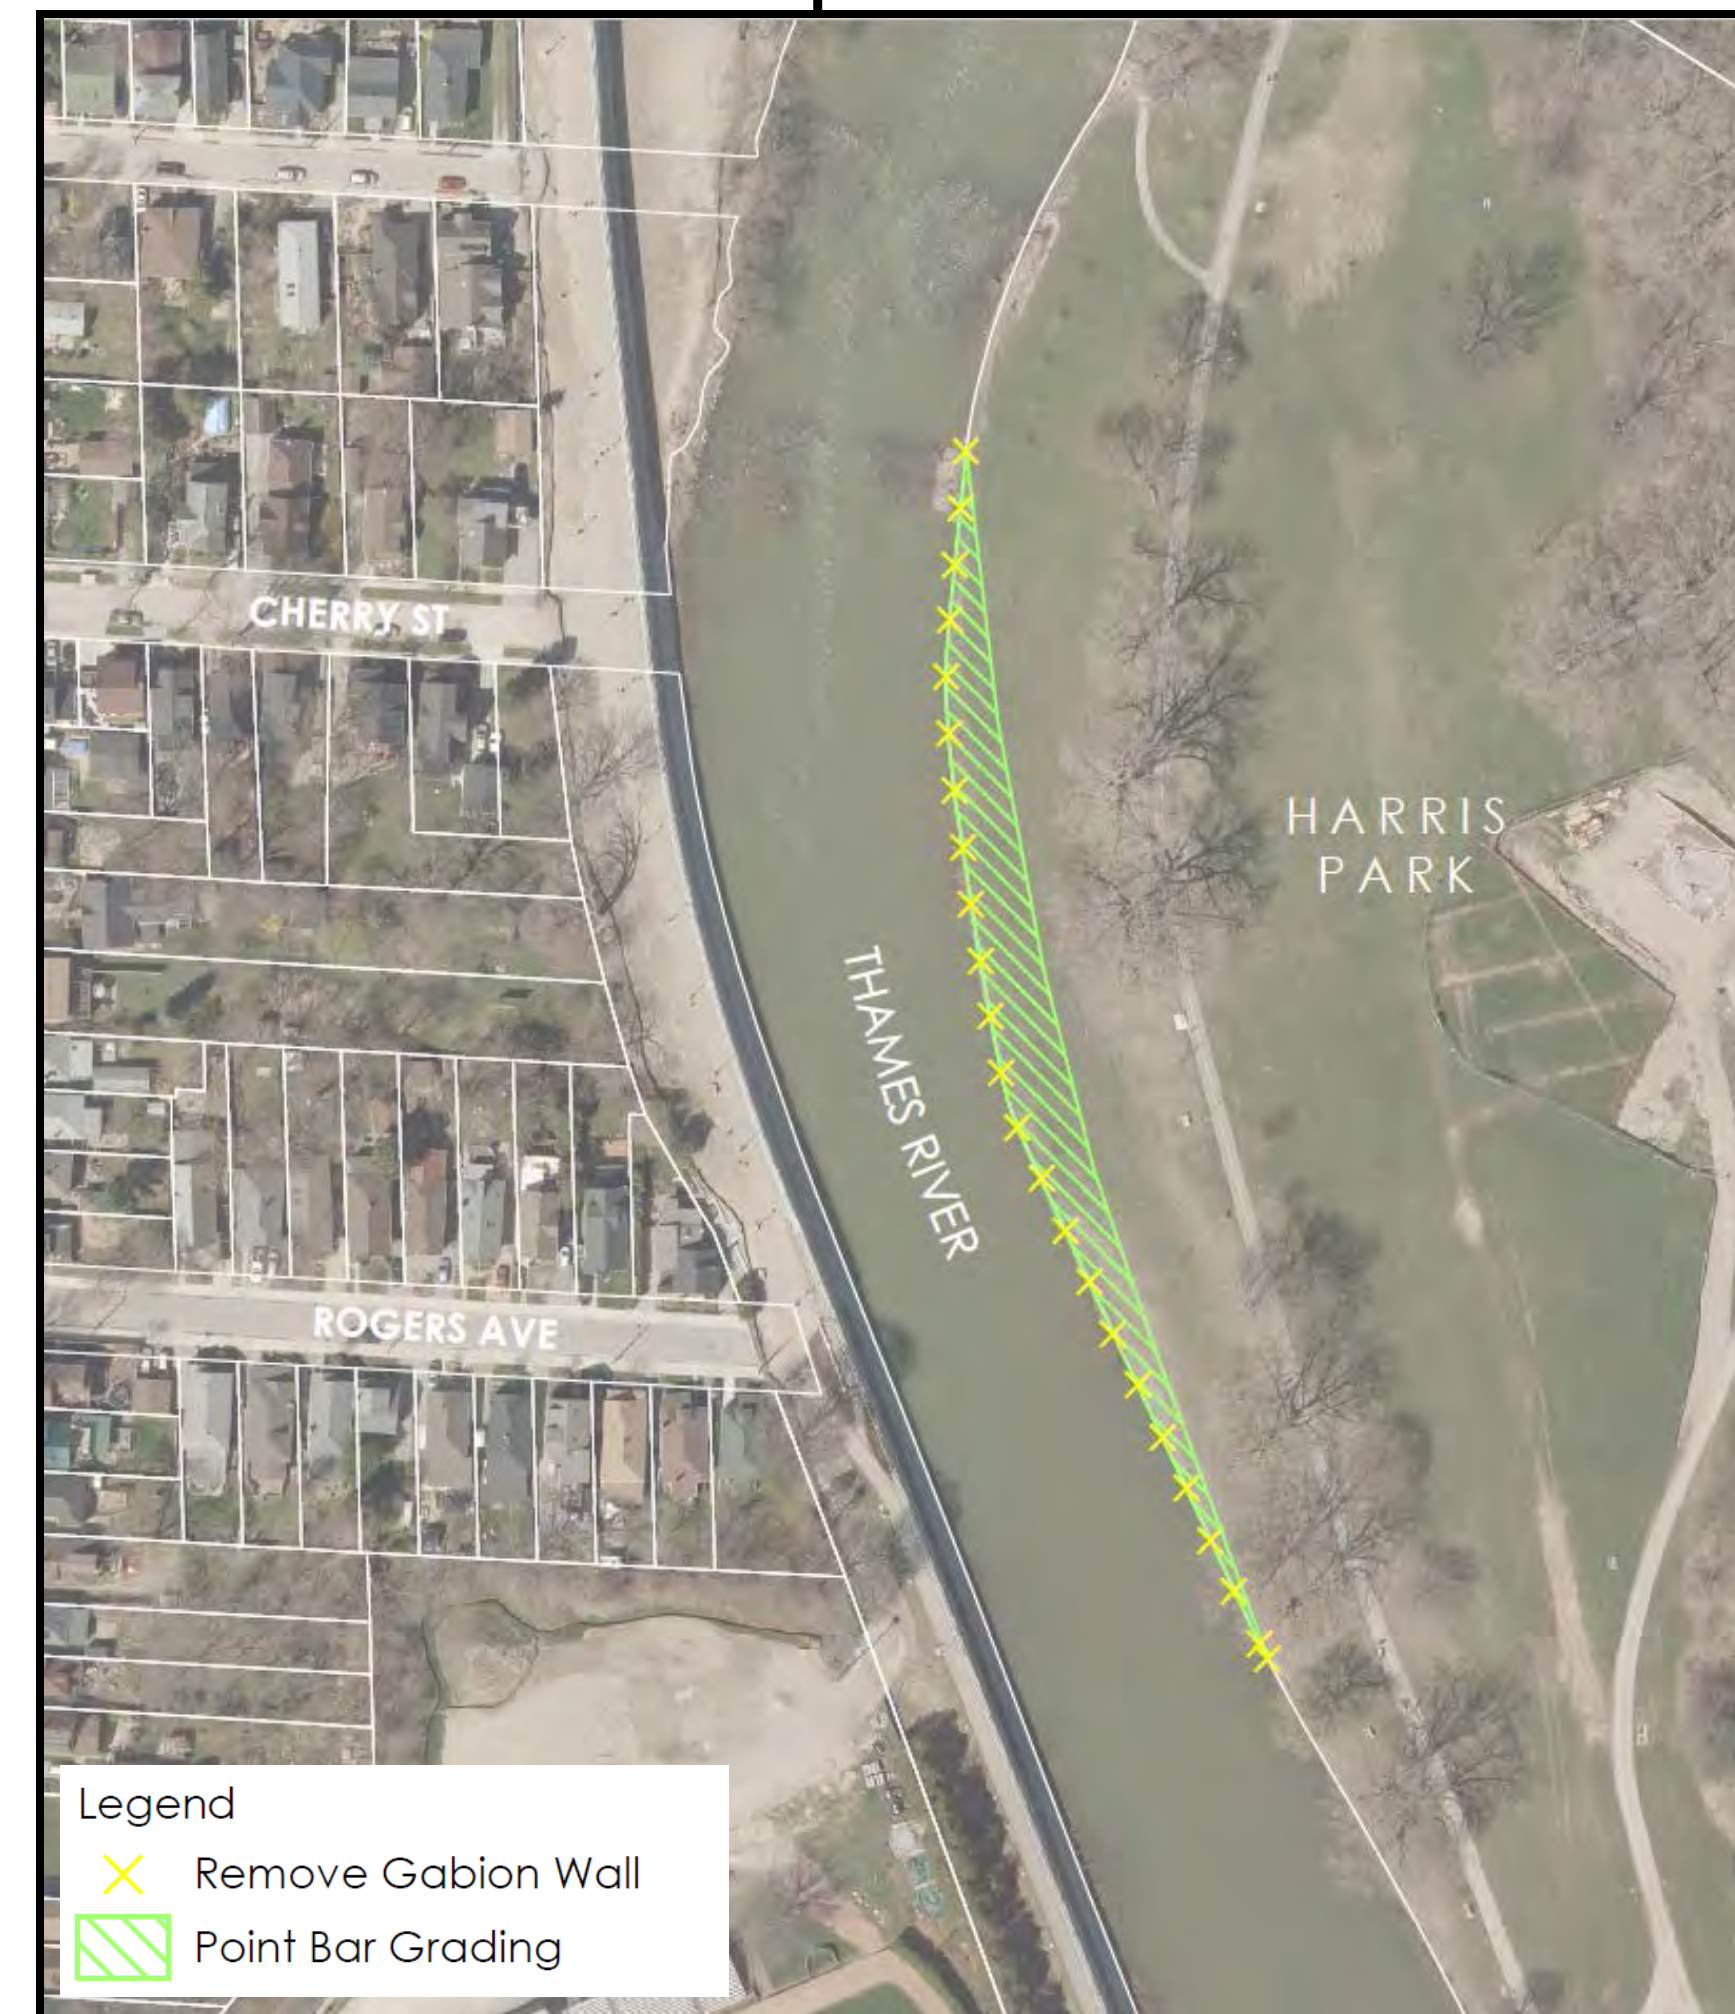
Alternative 2 – Remove Gabions and Reshape Point Bar

The existing gabion baskets would be removed, and the point bar would be reshaped and graded to create a depositional environment typical of a point bar on the inside of a meander belt. This alternative increases the River's cross section and reduces flow velocities which lowers scour and erosion potential.

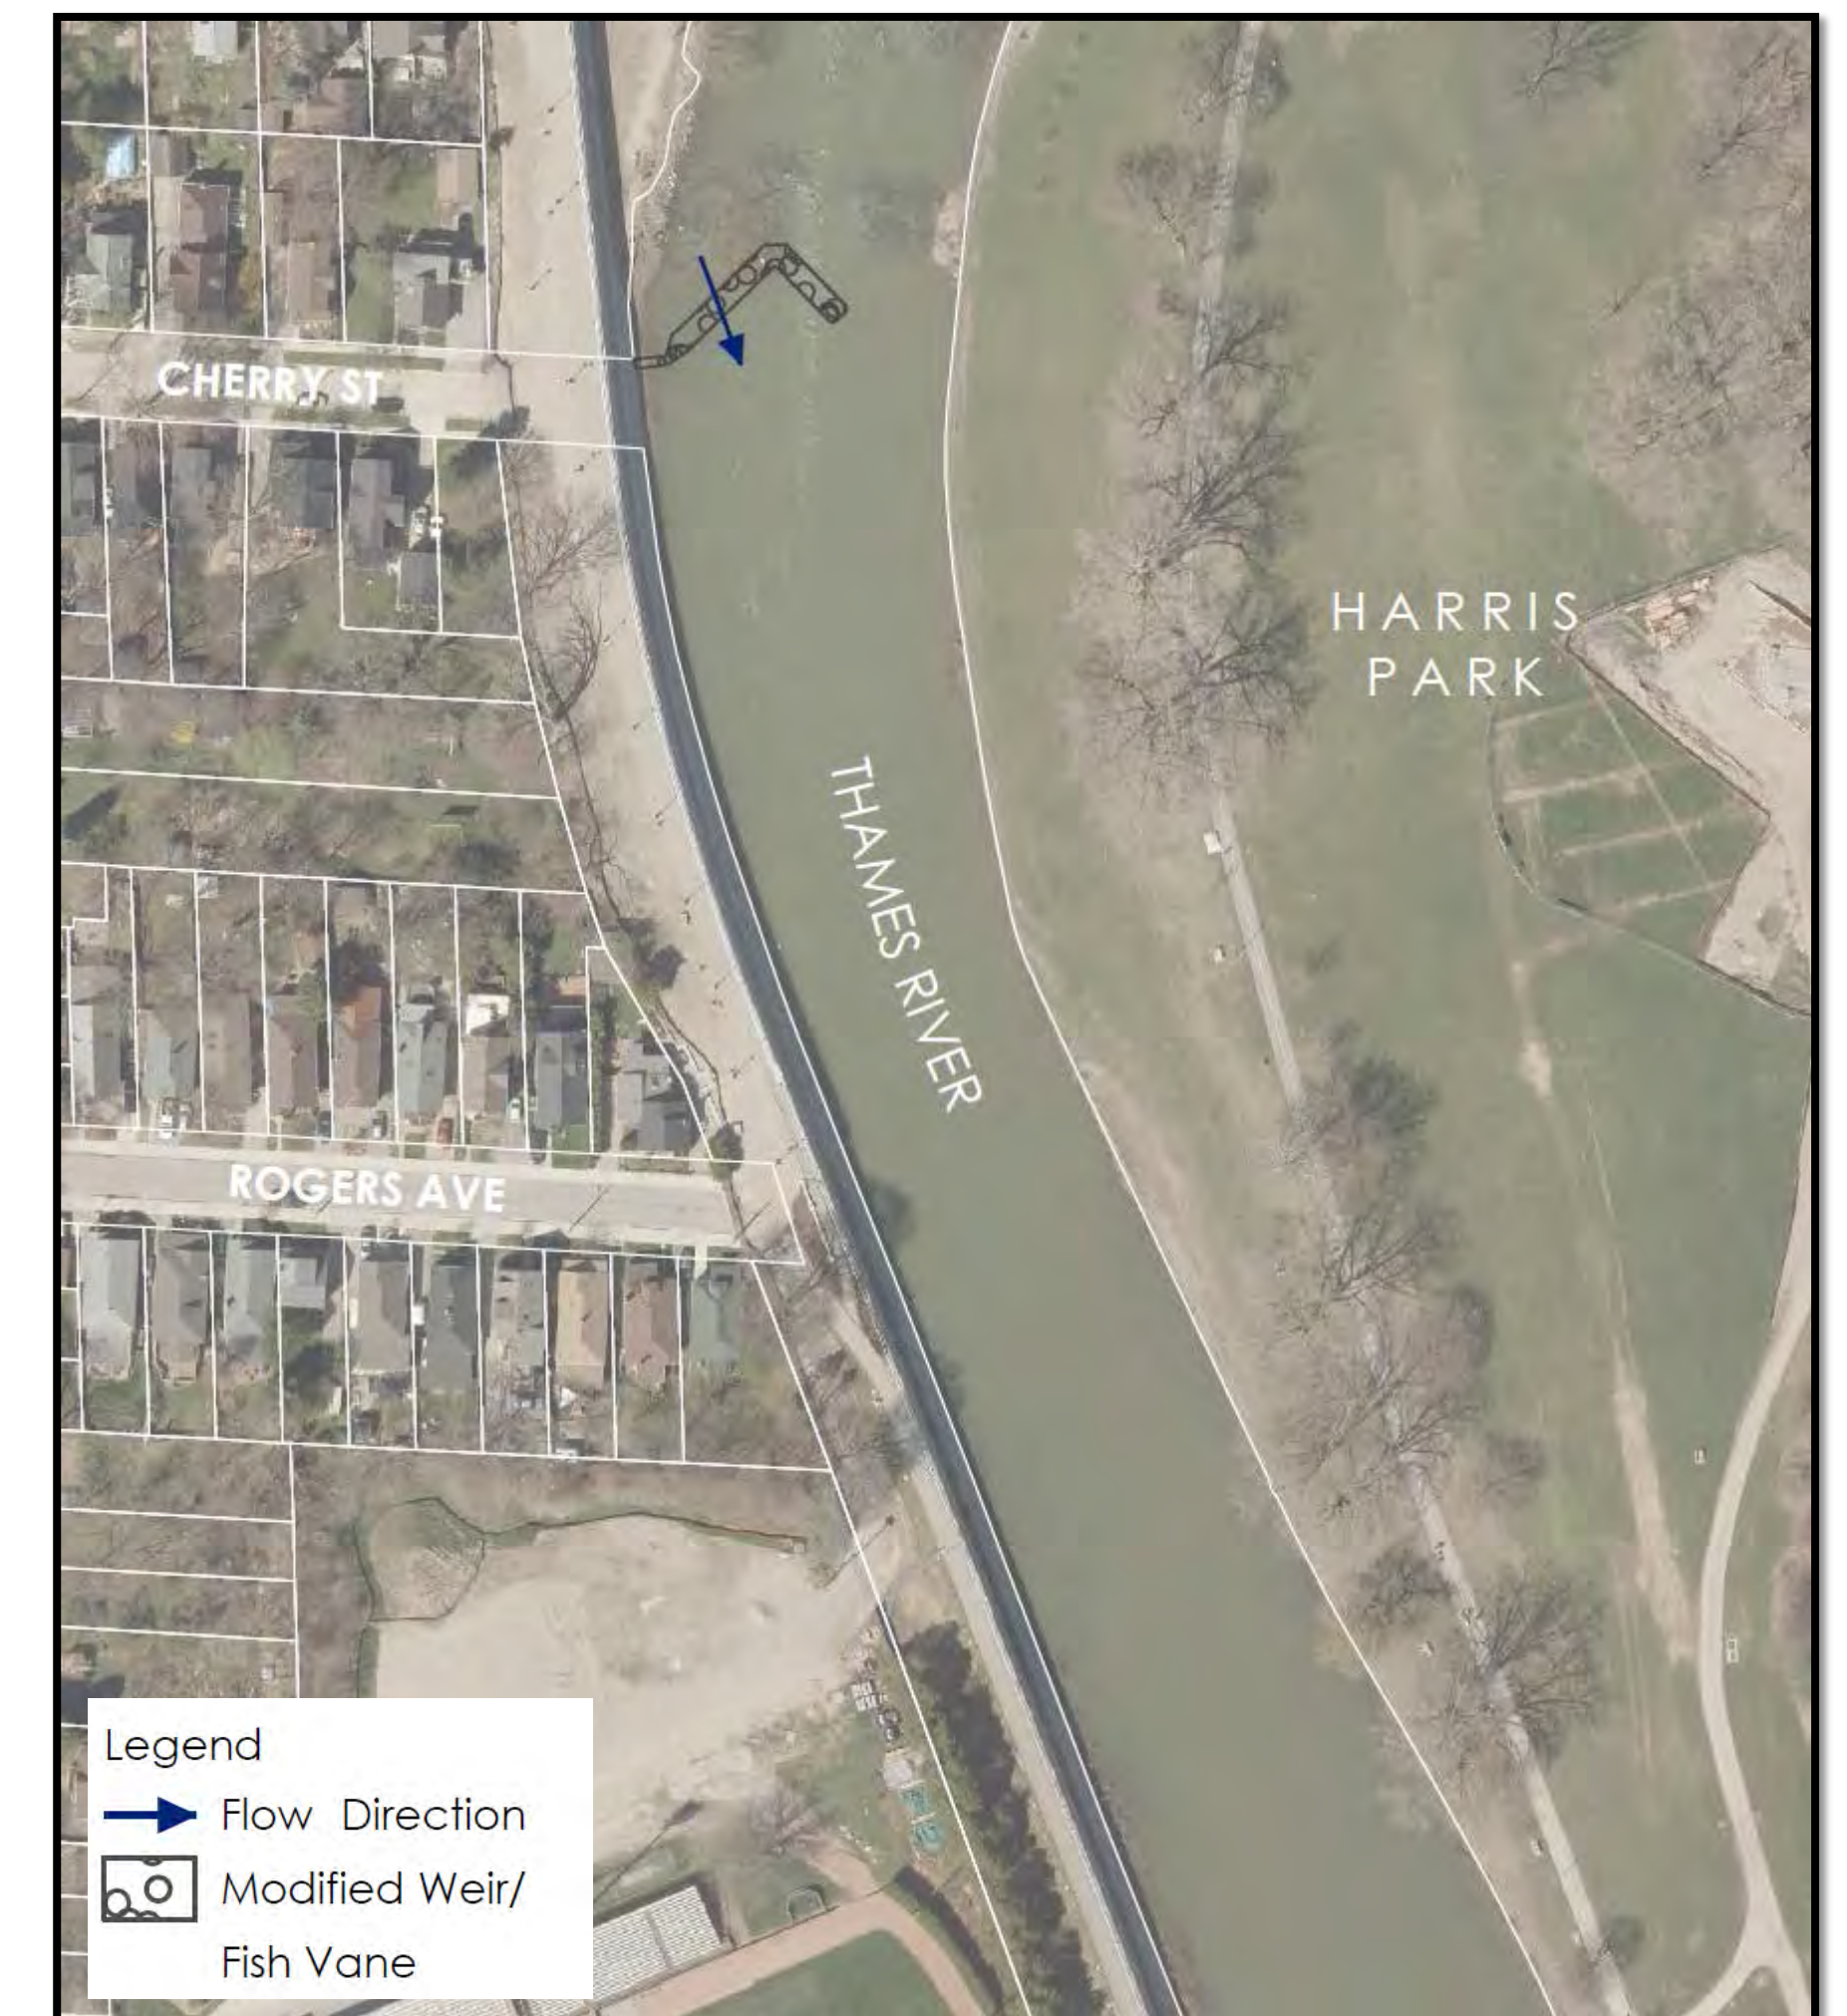
Alternative 3 – Modify MNRF 'Fish Weirs'

This alternative involves modification to the most downstream MNRF fish weir structure to divert flows towards the centre of the river bed, away from the toe of the dyke.

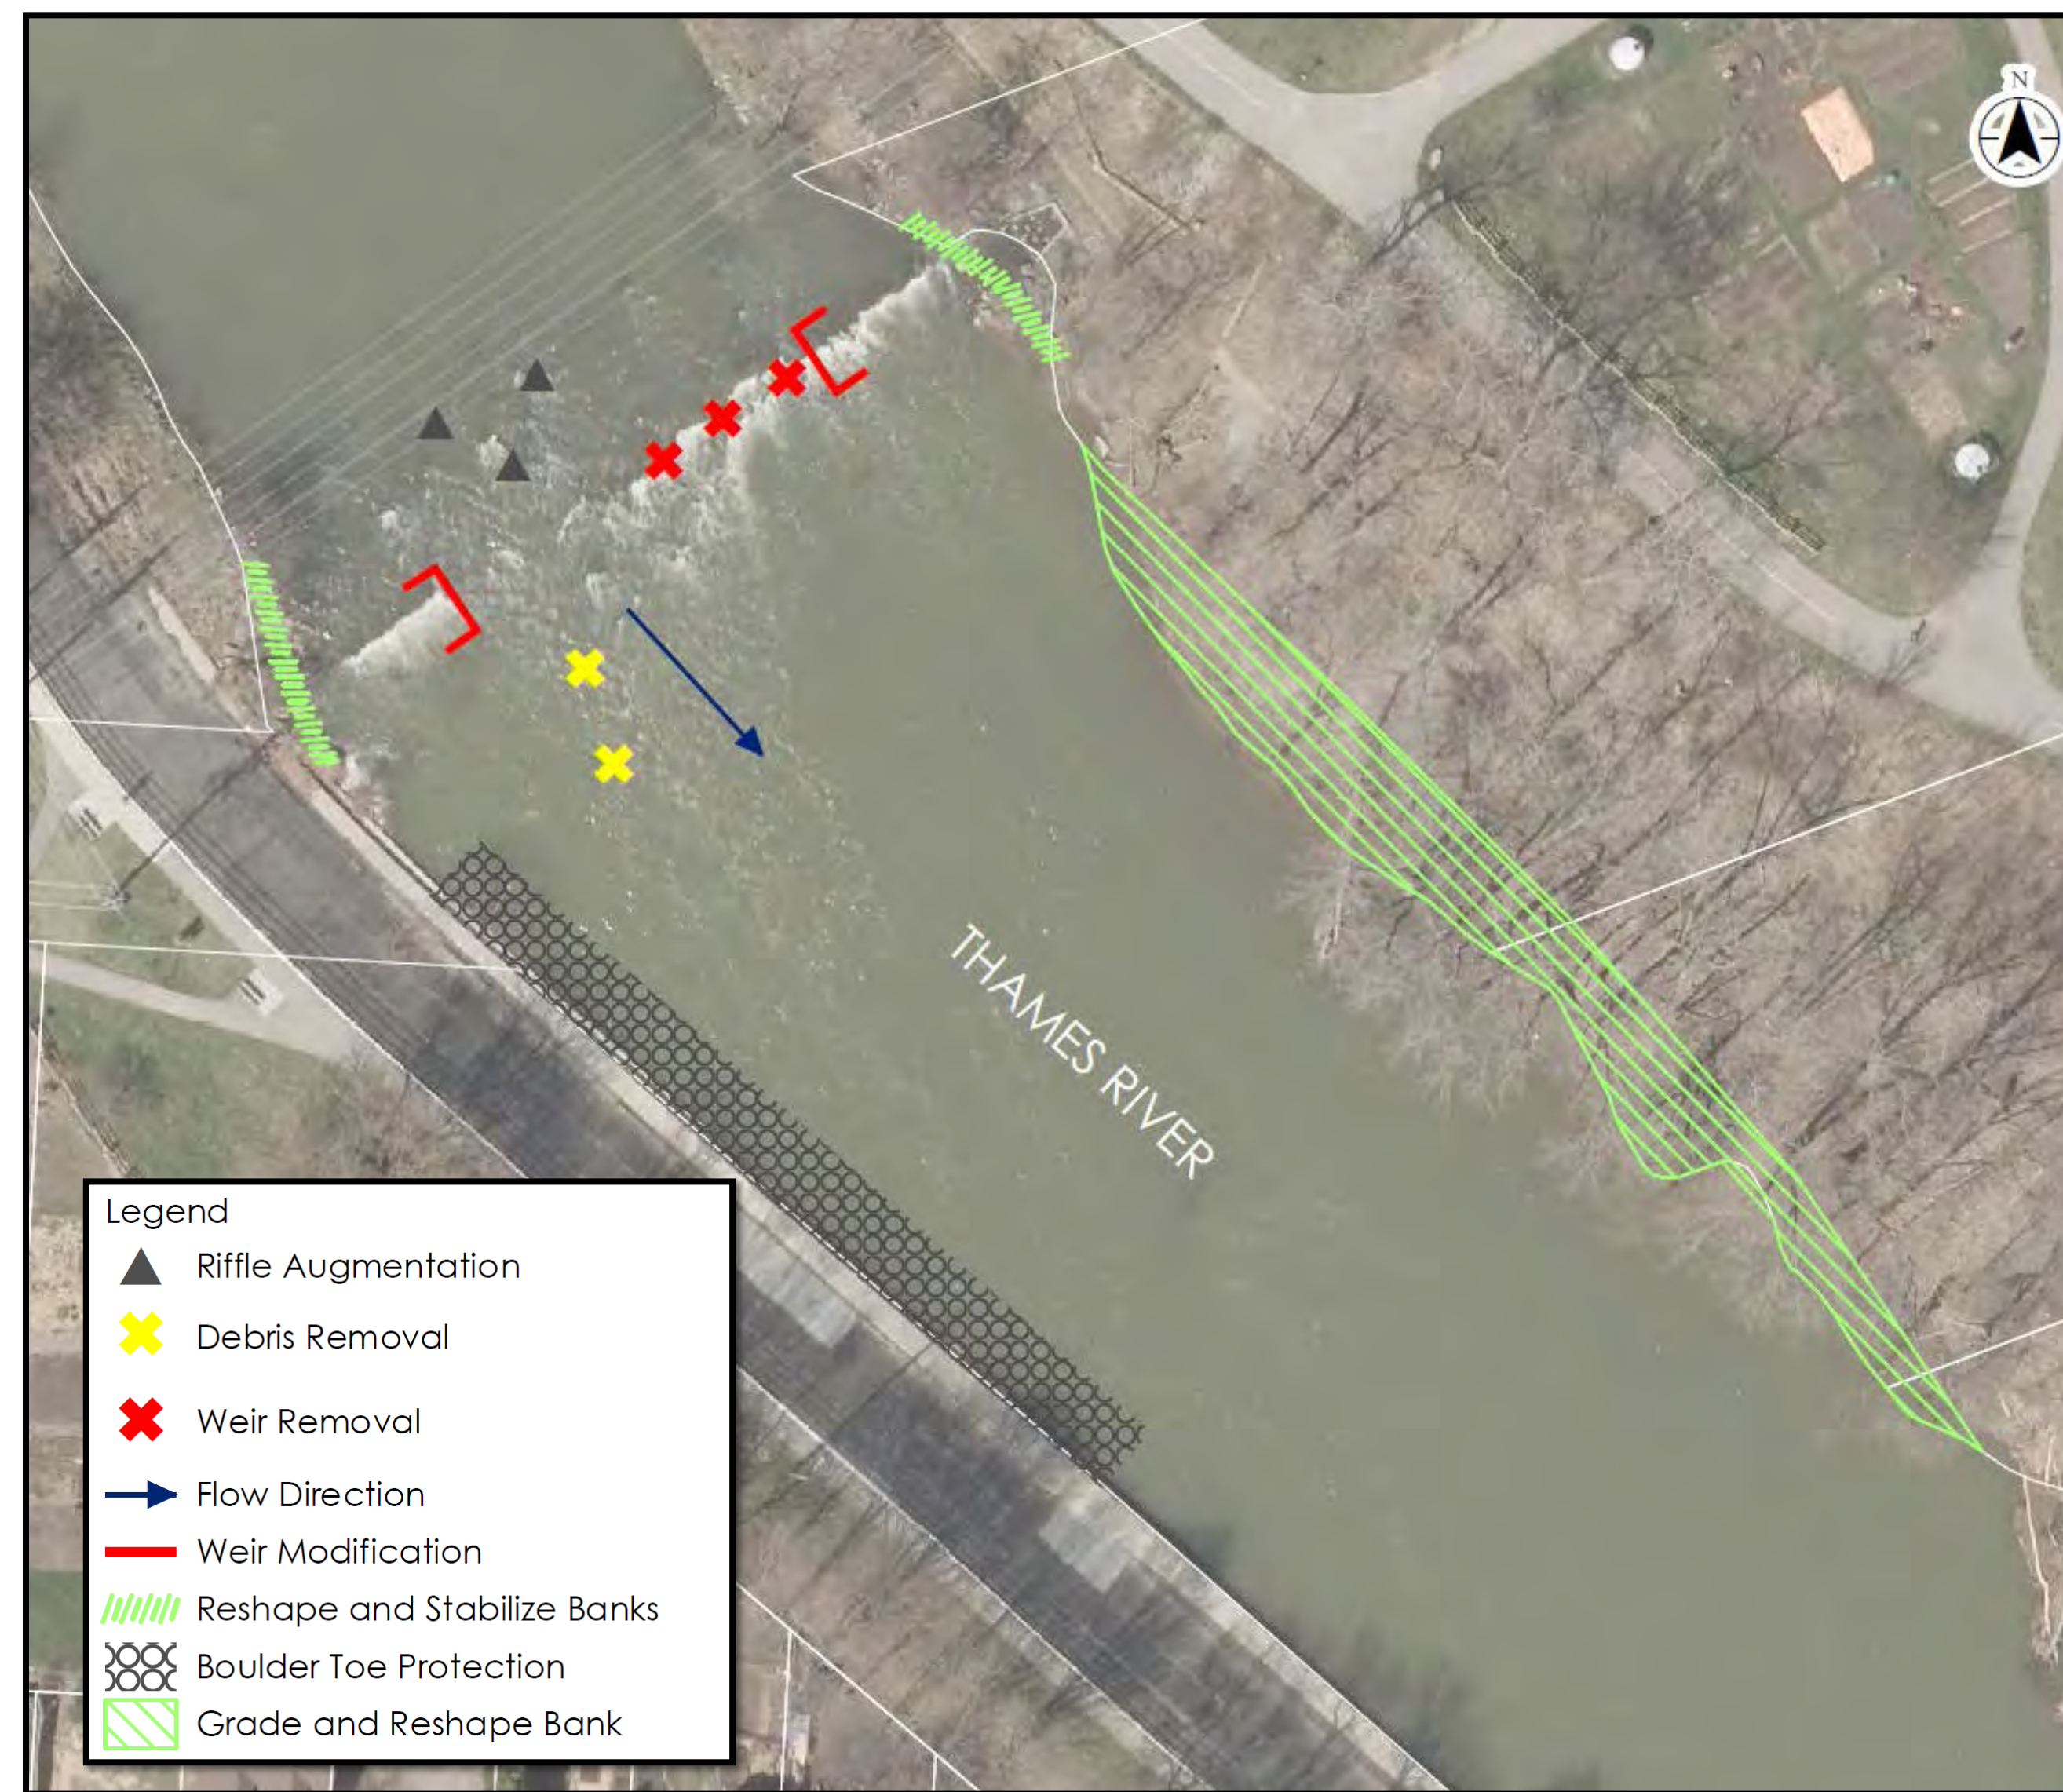
Ann Street Site
Modification to Weir Structure and Boulder Toe Protection

The preliminary recommendations at each site include a combination of toe protection to address the existing areas of erosion and flow modification to address the source and mitigate further erosion.

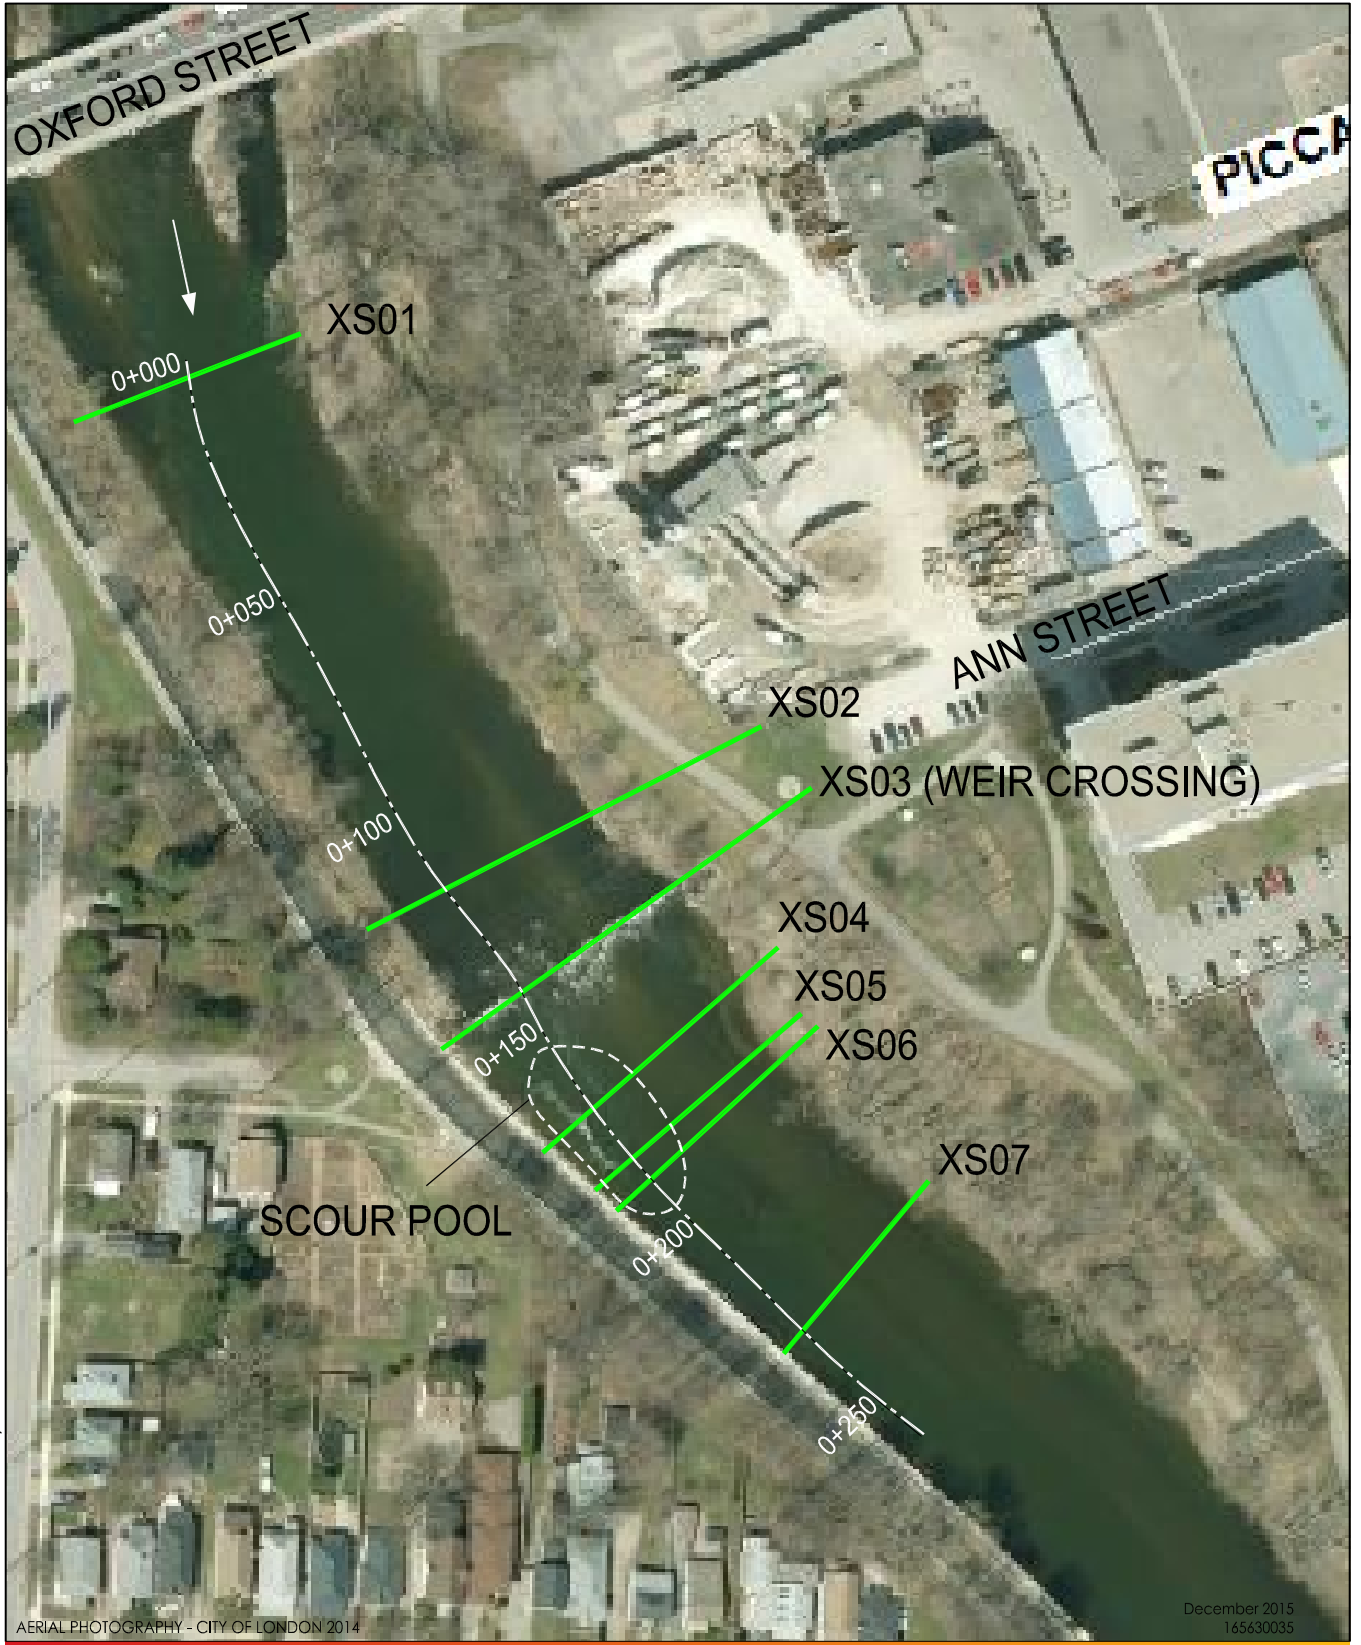
ANN STREET
 CROSS-SECTION LOCATIONS

During the June survey, the geographical extent of the river survey was expanded considerably to increase the length of river surveyed from 30 m to more than 100 m upstream and downstream of the scour locations. This was done to fully include the large scour pools and the distance that separated scour locations from the river features that were suspected of contributing to scour. The locations of the surveyed longitudinal profiles and cross-sections are shown in Figures 2 and 3, and details of the survey results are provided below.

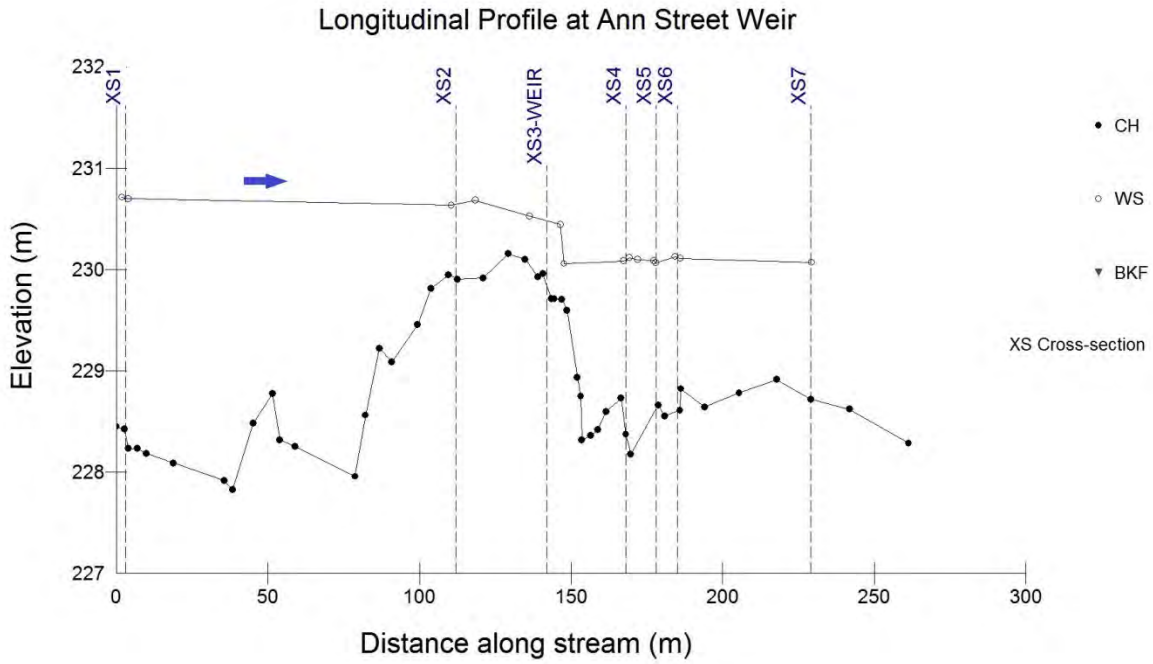
ANN STREET SITE; CROSS-SECTION LOCATIONS. CROSS-SECTIONS VIEWED FACING DOWNSTREAM

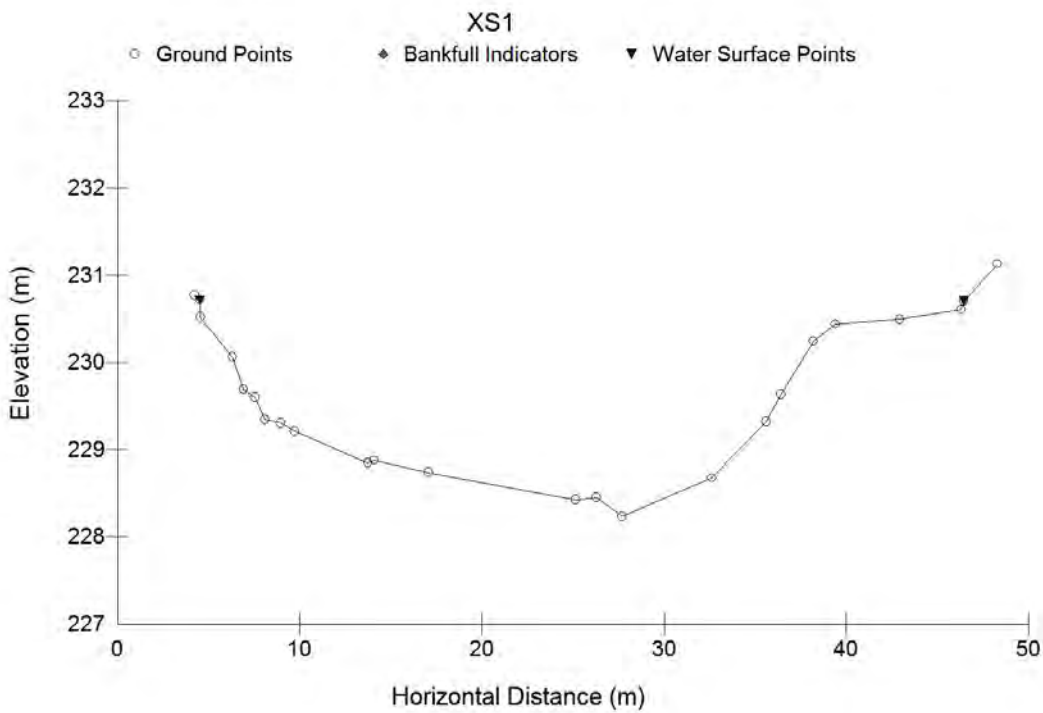
CROSS-SECTION 1 (POOL), LOCATED 50 M DOWNSTREAM OF OXFORD STREET

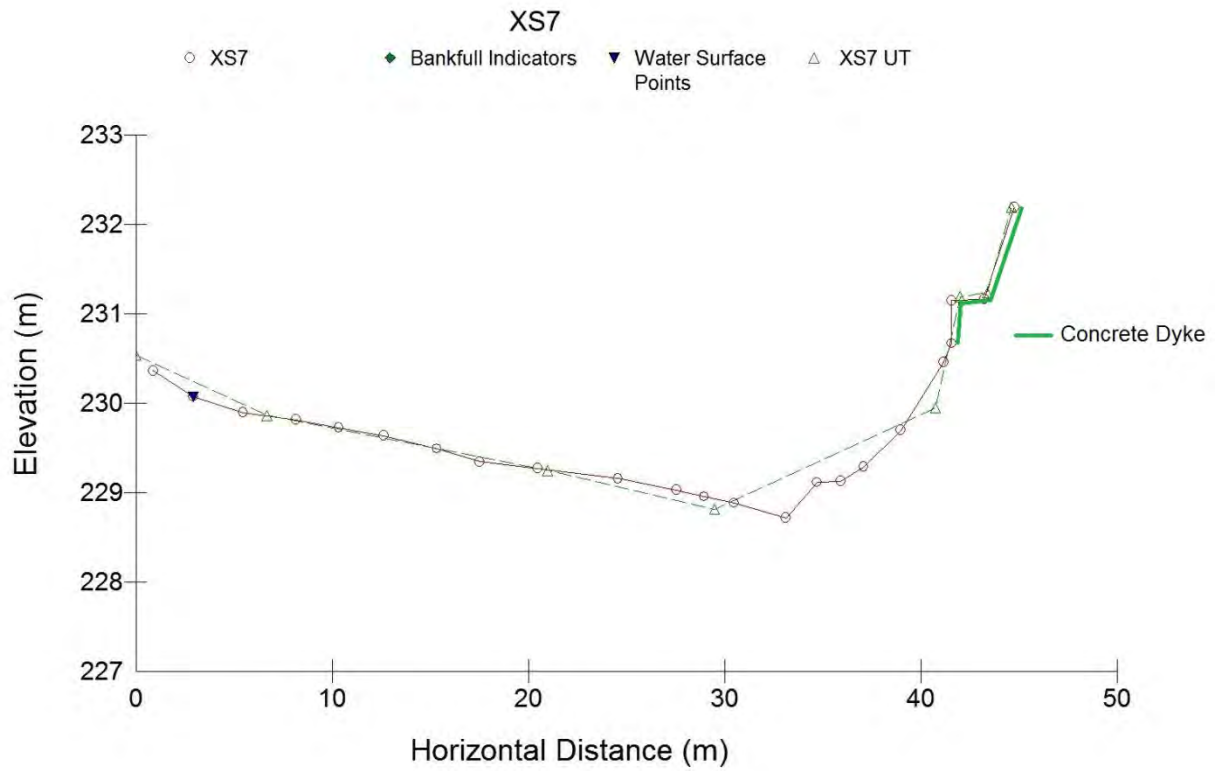
CROSS-SECTION 7 (RIFFLE); DASHED LINE IS UTRCA 2014 SECTION

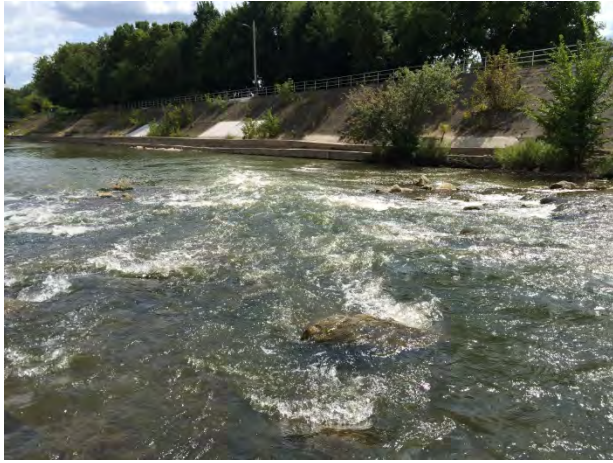
Photo 1-1 – Ann Street Site, view from weir looking downstream in the direction of flow toward bank at dyke toe.

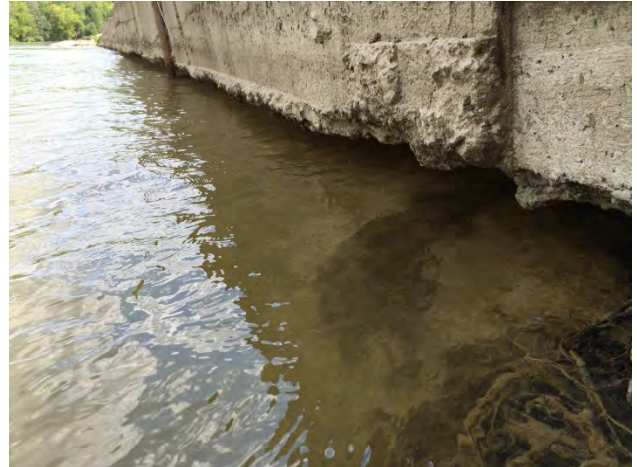
Photo 1-2 – Ann Street Site. Dyke toe 25 m downstream of weir showing 0.4 m undercut. The substrate (submerged) is silt till. View downstream.

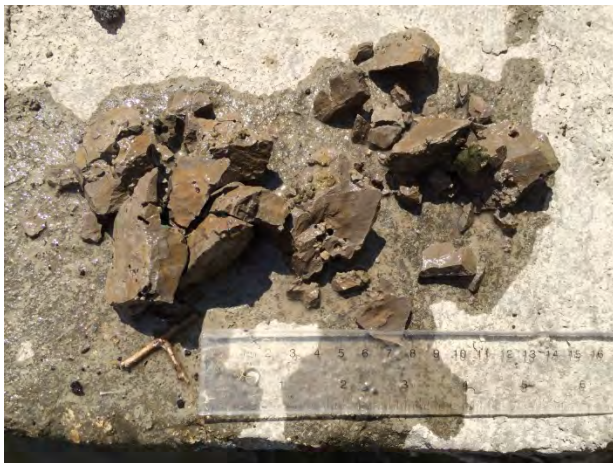
Photo 1-3 – Ann Street Site. Sample of weathered silt till collected from site. The material is friable and easily eroded. Freshly exposed till is resistant to fluvial erosion.

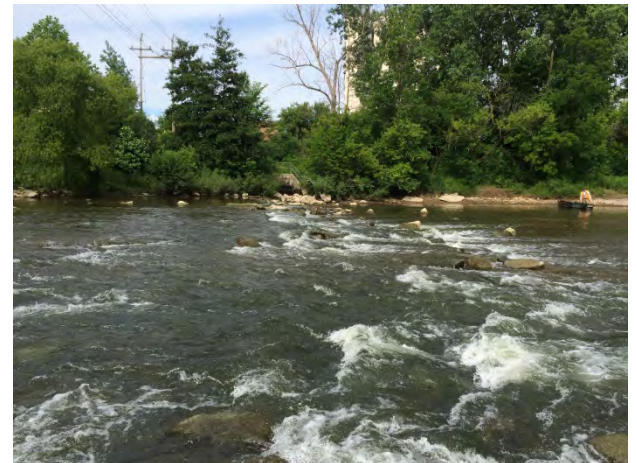
Photo 1-4 – On top of Ann Street Weir looking eastward from right bank to left bank. Flow to right.

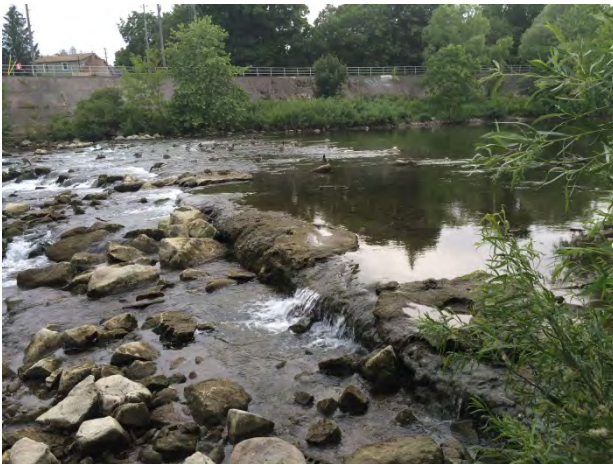
Photo 1-5 – On top of Ann Street Weir looking concrete structure and riprap. View toward right bank, flow to left.

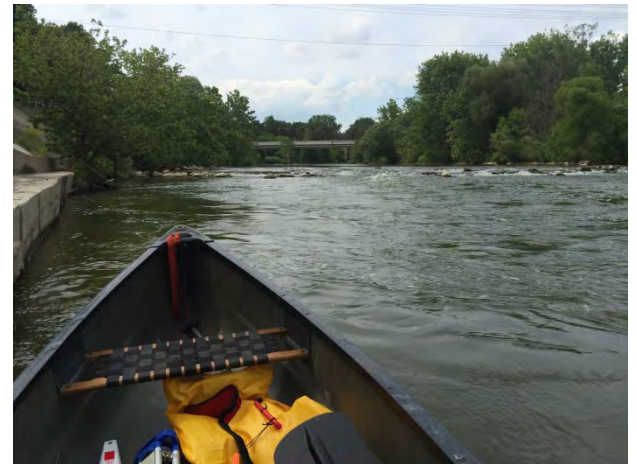
Photo 1-6 – Downstream of Ann Street Weir looking upstream at right bank scour pool. Note eddying effect at location of scour pool.

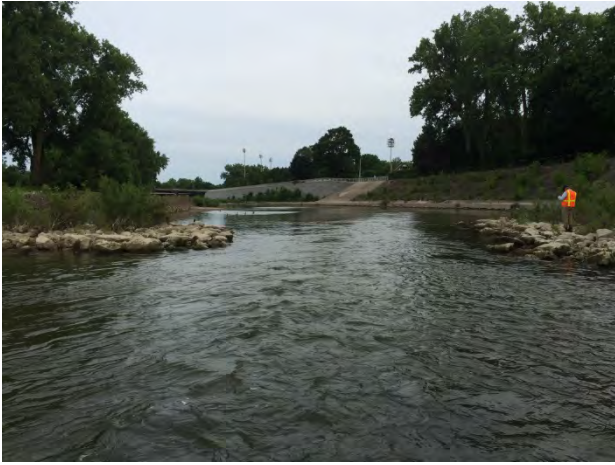
Photo 2-1 – Upstream end of the Leslie Street Site looking downstream. The narrowing of the channel in the foreground is the downstream vane of the MNR weir.

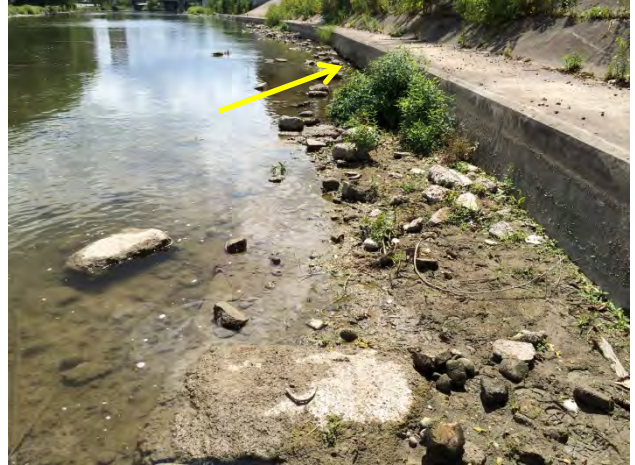
Photo 2-2 – Leslie Street. Base of dyke and armourstone toe along the upstream section of the compound pool. Sections of the concrete toe of the dyke have been undermined (arrow). View downstream.

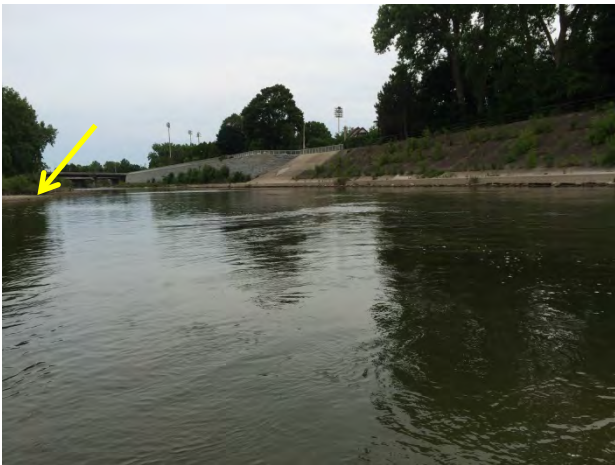
Photo 2-3 – Upstream of the Leslie Street Site looking downstream. Upstream limit of the scour pool. Note sandy point bar forming on left bank (arrow).

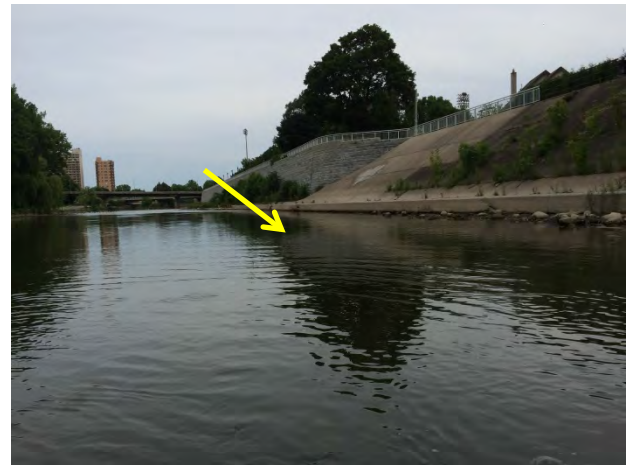
Photo 2-4 – Leslie Street Site looking downstream. The deepest part of the scour pool is located at the transition from sloped to vertical dyke wall at the foot of Rogers Avenue (arrow).

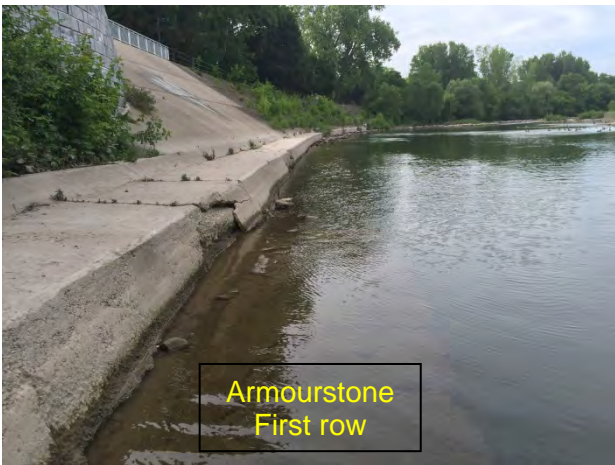
Photo 2-5 – Leslie Street Site looking upstream at right bank and deepest area of scour pool. The first row of armourstone (submerged) is in good condition. Some of the blocks from the second row (at right, not visible) have fallen into the pool. View upstream.

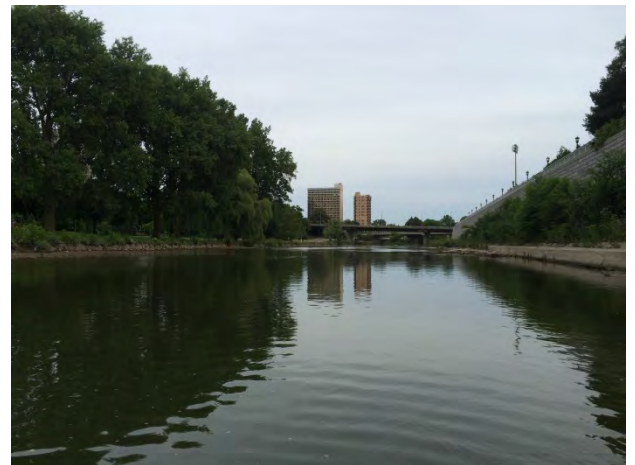
Photo 2-6 – Leslie Street Site looking at downstream riffle. Gabion baskets along left bank were failing.

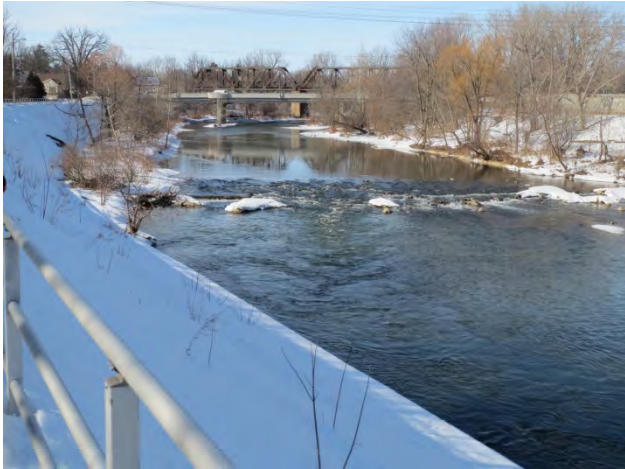
Photo 1-1 – Ann Street Weir showing flows coming off weir toward the dyke (foreground). March 12, 2015. River discharge: 3.9 m³/s.

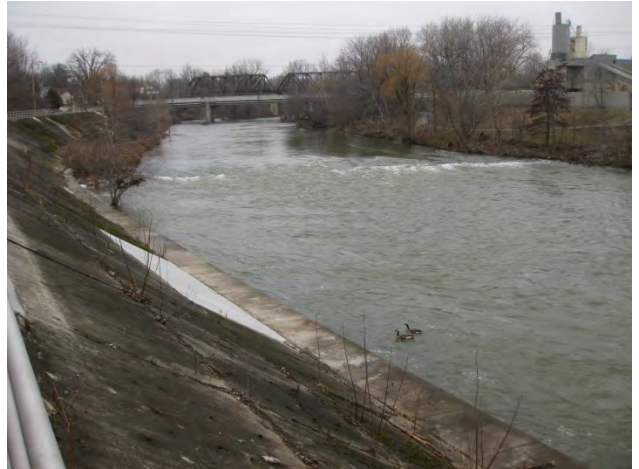
Photo 1-2 – Ann Street Weir, April 8, 2015. River discharge 38.0 m³/s.

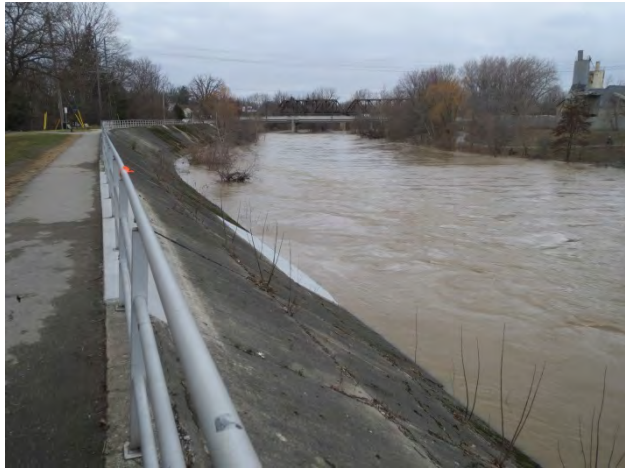
Photo 1-3 – Ann Street Weir, April 10, 2015. River Discharge 157.7 m³/s. Frequent boils visible on the water surface at the toe of the dyke indicate turbulence (kolks) and high shear.

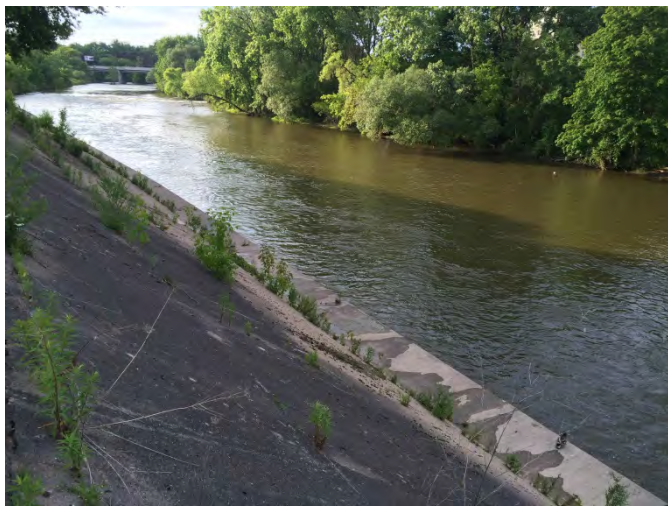
Photo 1-4 – Ann Street Weir, May 20, 2015. River discharge 3.1 m³/s. Turbulence evident along dyke toe despite low flows.

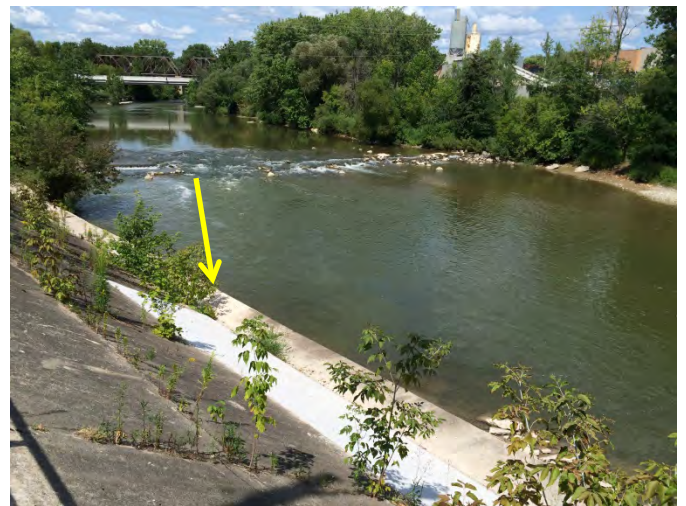
Photo 1-5 – Ann Street Weir, June 13, 2015. River discharge 26.8 m³/s. Vantage is approximately 100 m downstream of vantage of photos 1-1 to 1-4.

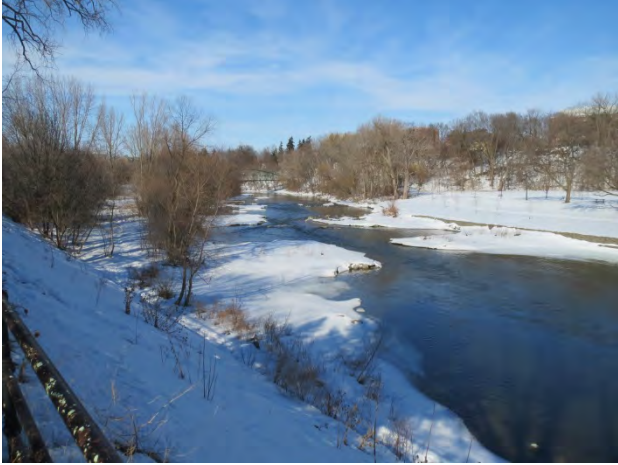
Photo 1-6 – Ann Street Weir, August 22, 2015. River discharge 5.4 m³/s. Flow vector intercepts bank approximately 40 m downstream of weir (arrow).

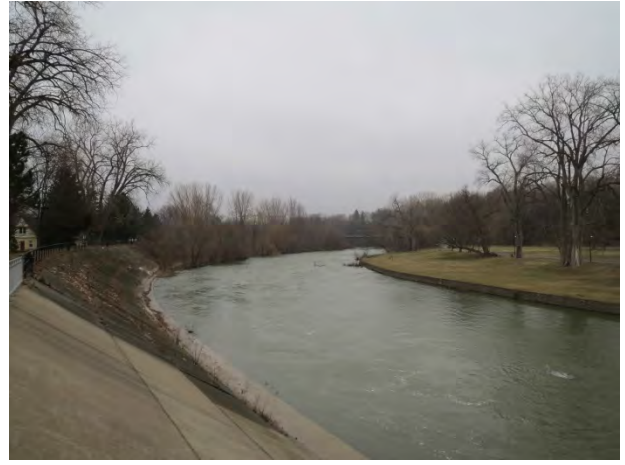
Photo 2-1 – Leslie Street Site (Vantage 1 - upstream): Flow coming off MNR Weir located upstream of the scour area, March 12, 2015. River discharge 3.9 m³/s. Flows calm.

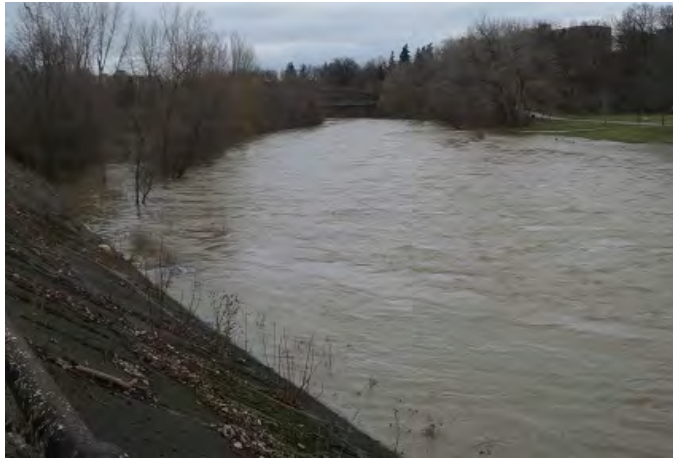
Photo 2-2 – Leslie Street Site (Vantage 1), April 8, 2015. River discharge 38.0 m³/s. Some turbulence evident along dyke toe.

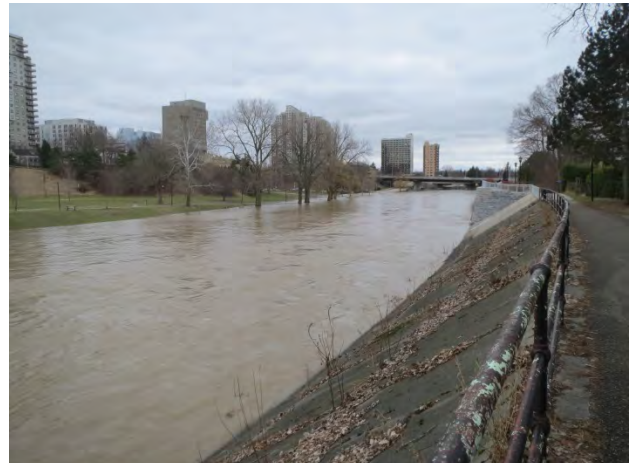
Photo 2-3 – Leslie Street Site (Vantage 1), April 10, 2015. River discharge 157.7 m³/s. Flows near to toe of the dyke are relatively calm, with no indication of excessive turbulence or scour.
