**West London Dyke Erosion Control
Municipal Class Environmental Assessment
Stakeholder Contact List**

**West London Dyke Erosion Control
Municipal Class Environmental Assessment
Notice of Study Commencement**

Ann Street Site – Conceptual Cross Section

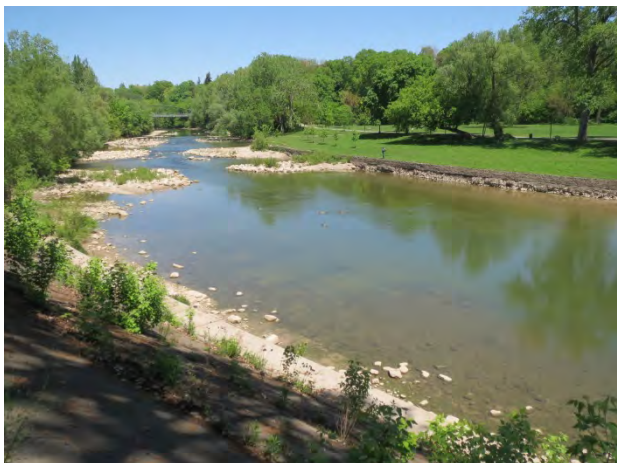
Photo 2-4 – Leslie Street Site (Vantage 2 - downstream), April 10, 2015. View of downstream section of compound pool. Boils on water surface near the dyke toe indicate turbulence (kolks) and high shear.

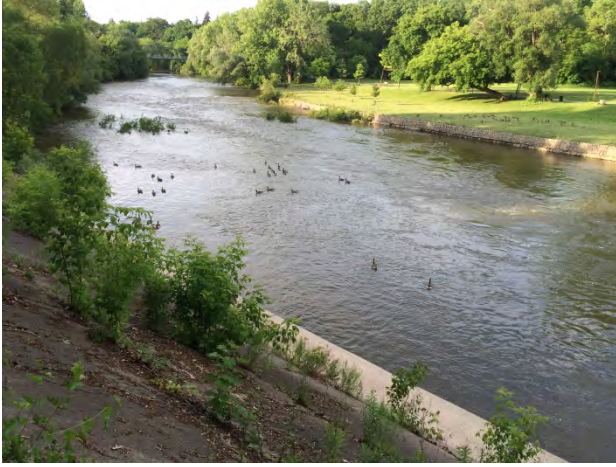
Photo 2-7 – Leslie Street Site (Vantage 1), June 13, 2015. River discharge 26.8 m³/s. Note calm conditions at toe of dyke (foreground).

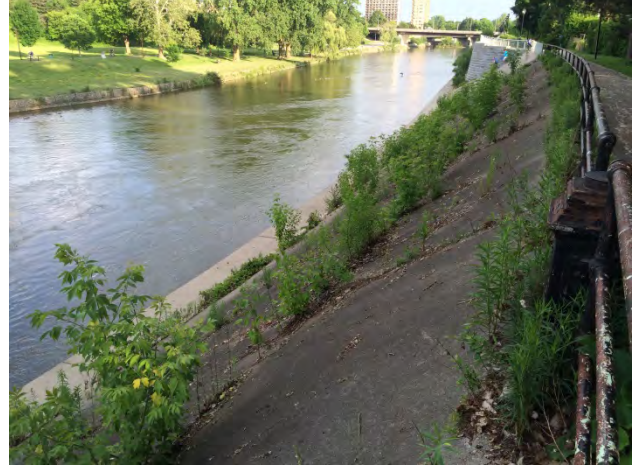
Photo 2-8 – Leslie Street Site (Vantage 2), June 13, 2015. Some turbulence evident through the thalweg but flows along dyke toe are relatively calm.

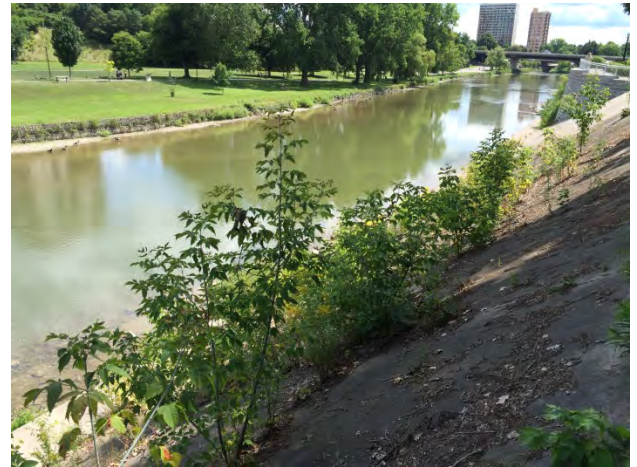
Photo 2-9 – Leslie Street Site (Vantage 1), August 22, 2015. River discharge 5.3 m³/s. Flows calm/no turbulence.
