Manure Spills in Ontario

**ACTUAL
CASE FILES**

Inside: Actual Cases (the events are real)

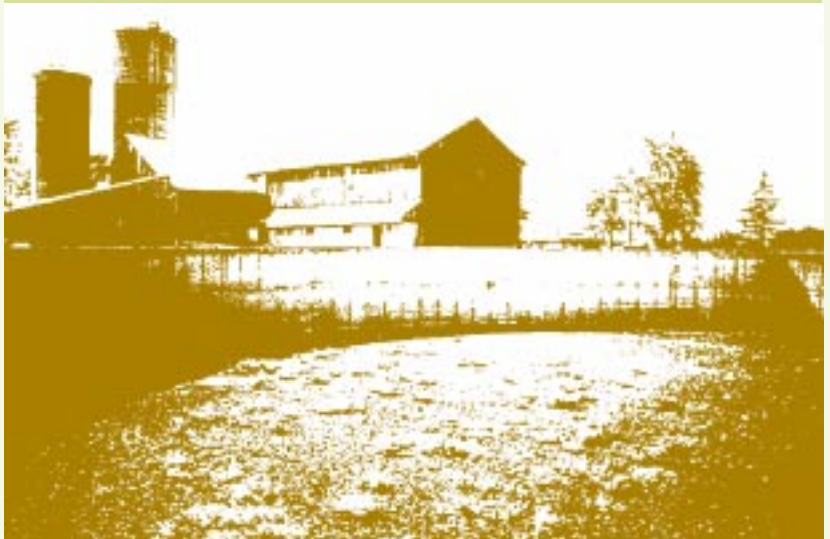
- The farm's liquid manure storage lagoon was overflowing into a field.
- An irrigation gun was used to apply liquid manure on a level field of wheat stubble.
- The application was carried out at night in November, following several days of rain and snow.
- The application rate was reported to be 7200 gal/acre but was likely higher.

- Manure from the overflowing storage lagoon entered a nearby field tile system which drained into a closed municipal drain that crossed the property, and then into an open channel on a neighbour's farm.
- Liquid manure entered the closed municipal drain *via* a tile blowout and open catch basins, eventually contaminating two in-stream ponds in the open channel on the neighbour's farm.

- Ensure adequate manure storage to allow flexibility in application due to weather.
- Do not apply liquid manure when the soil is already saturated from rain and snow.
- Inspect fields prior to manure application to ensure tile blowouts are repaired.
- Take time to monitor tiles for contamination.
- Have a plan in place to deal with any problem that may occur as a result of application.
- If problems occur inform the Ministry of the Environment at the...

Ensure adequate storage.

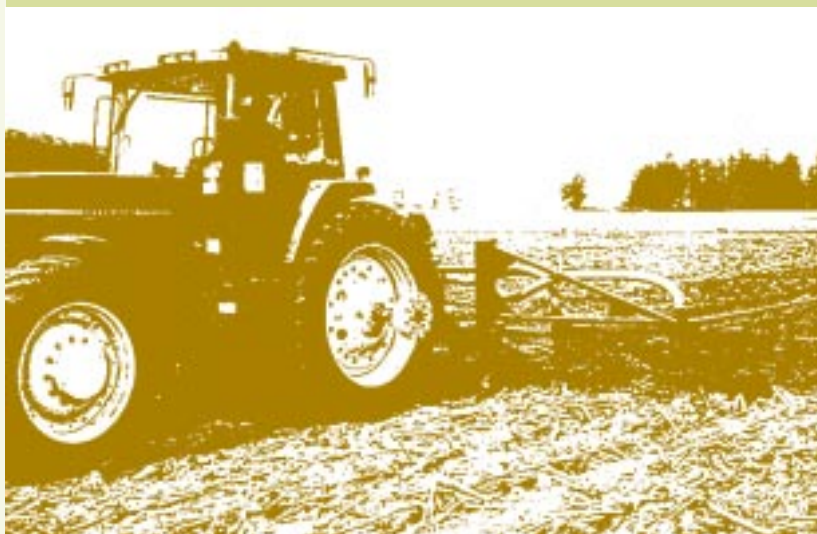
- Excessive amounts of liquid manure were applied with an irrigation gun on a level untilled field.

- Manure leached down into the systematic tile system and drained to the open municipal drainage ditch.
- The water quality was impaired downstream in the municipal drain and watercourse.
- The farmer observed discoloured water and foam being discharged from the field tile into the open drain.

- Delay manure application until field tiles stop flowing.
- Consider a split application.
- Till the soil prior to application to break-up the macropore pathways that can carry the manure to field tiles.
- Develop a **Nutrient Management Plan** to help outline the timing of manure applications to maximize nutrient utilization and minimize nutrient loss.
- Observe tile outlets during application.
- If problems develop, STOP APPLICATION, plug the tile outlet and contact the...

Strive for uniform application.

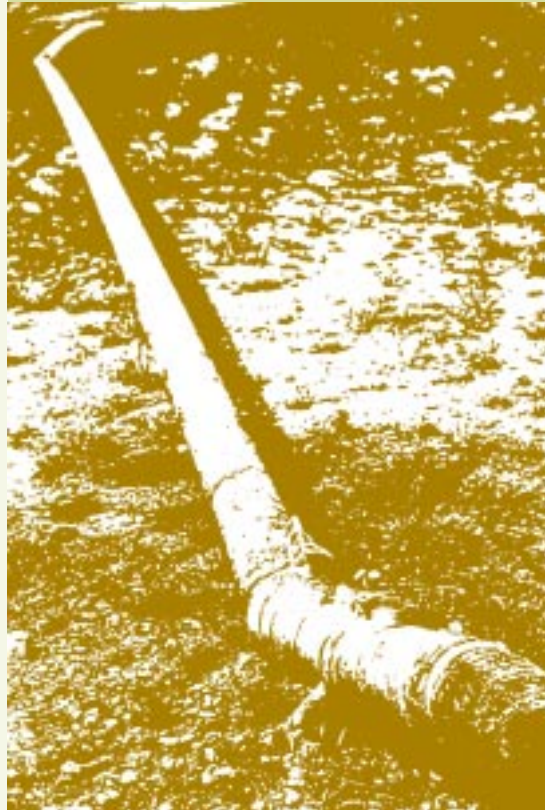
- An irrigation pipeline was laid out over a bridge to reach a field for the application of liquid manure.
- When the pump was turned on, a section of pipe over the bridge disconnected.
- The farmer wired the pipes back together then continued the manure application.
- Some attempt was made to scoop up the manure pooled near the breakage.
- The farmer notified the Ministry of the Environment two days after the event occurred.

- Manure leaked from the separated pipes and flowed down the stream bank into the creek.
- Fish were killed in the creek downstream of the spill.

- Use a section of flexible pipe to carry manure over bridges.
- Monitor the pipeline during application.
- Be prepared to shut down immediately if a problem develops by having manpower and radios on hand.
- Notify the...

Ensure proper connections for pipes.
