**EMBRO DAM
CLASS ENVIRONMENTAL ASSESSMENT
FLUVIAL GEOMORPHOLOGY REPORT**

Prepared for:
UPPER THAMES RIVER CONSERVATION AUTHORITY

Prepared by:
MATRIX SOLUTIONS INC.

Version 0.1
November 2022
Kitchener, Ontario

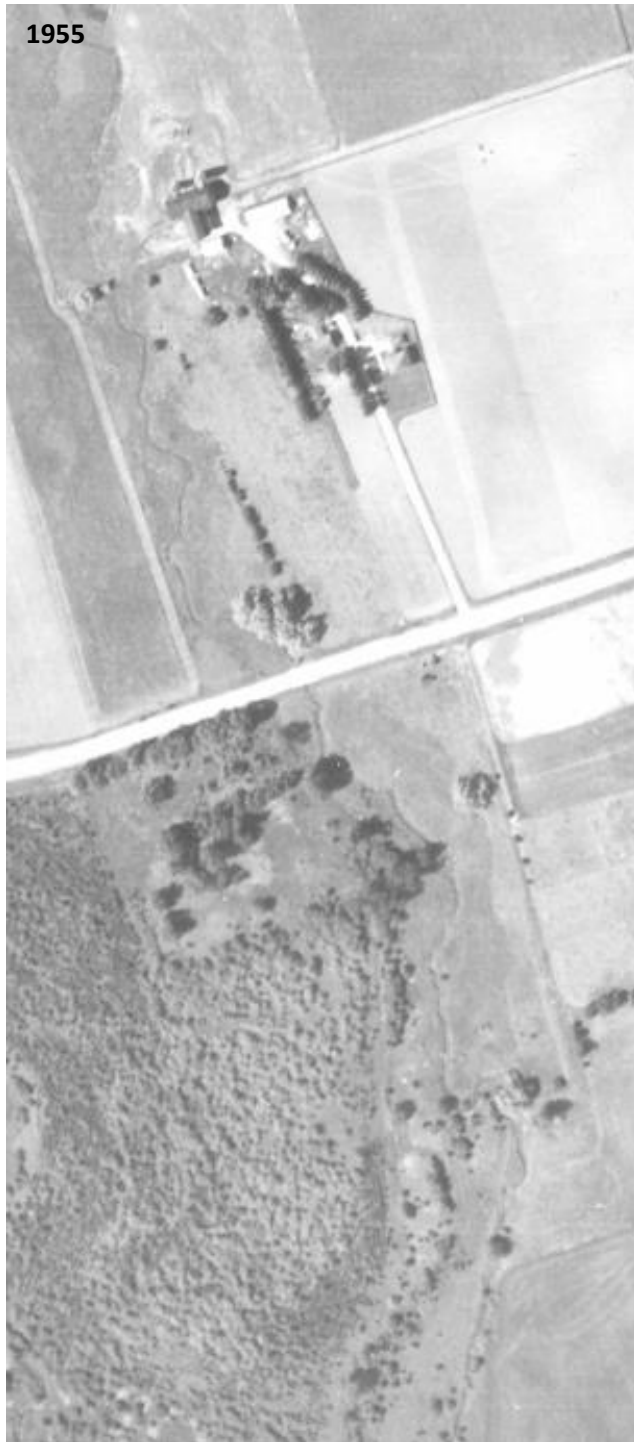
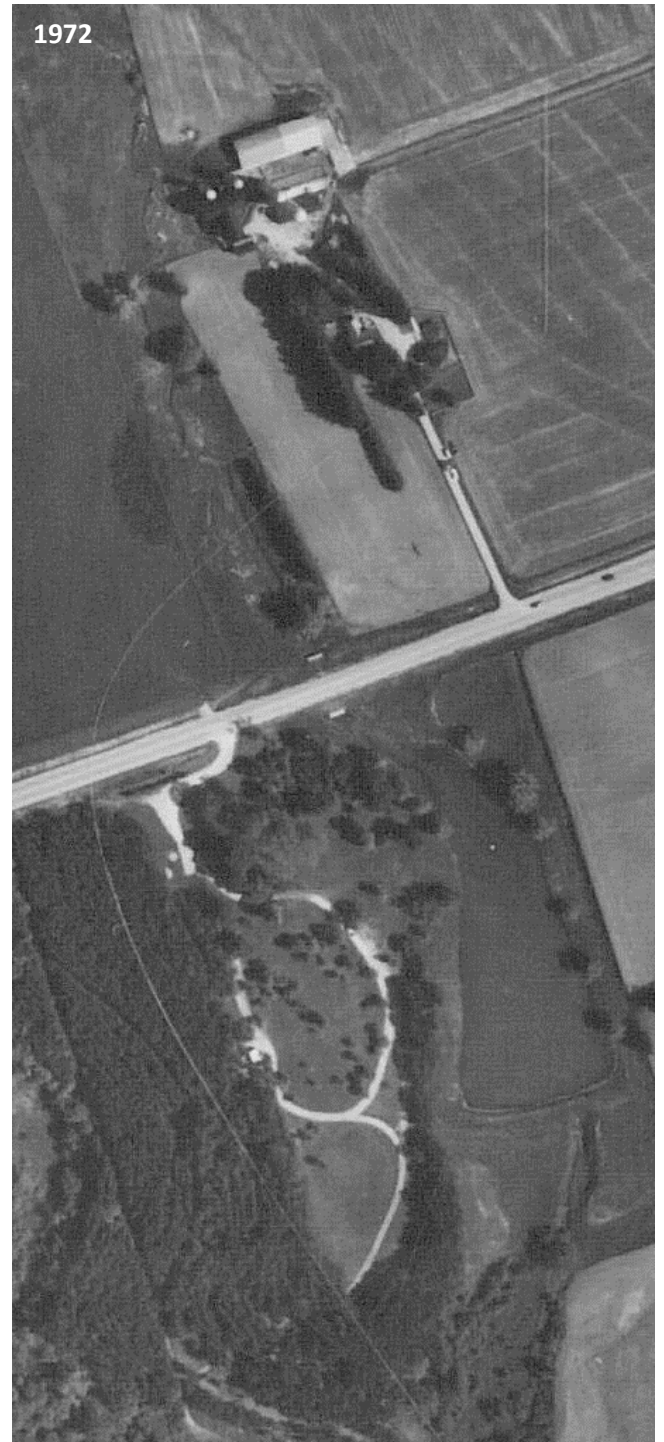
FIGURE 1a Overview of Historical Channel Change along Youngville Drain in Proximity to Embro Pond

Year	Observation
1955	Embro pond was not yet constructed south of Road 84 and Youngsville Drain meandered within its floodplain. Upstream of Road 84, Youngsville Drain was sinuous and appears to be situated in a field (grasses, herbaceous plants) with few trees. A hedgerow occurs east of the creek and separates the creek from active landuse.
1972	Construction of Embro pond was complete (note: pond was completed in 1959) Channel realignment/straightening occurred, beginning at ~ 95 m north of Road 84. Channel modifications appear to have occurred at the outlet of the dam (widening, deepening, and straightening).
1989	Floodplain vegetation west of Youngsville Drain, and north of Road 84, appears to be naturalizing and increasing in diversity Some channel planform development appears to be occurring at the upstream limit of the channel straightening
2000	A row of trees appears to have been planted to the west of Youngsville Drain, north of Road 84. The row of trees to the east of the watercourse appears to have been extended further north. No change in planform configuration is evident in comparison to the 1989 image.

2010	Vegetation/tree growth north of Road 84 is notable. Portions of Youngsville Drain are obscured from view on the photo. Overall, no change in planform configuration is evident in comparison to the 2000 image.
