Emburo Dam and Conservation Area

Existing Geomorphic Conditions

December 2015, Draft

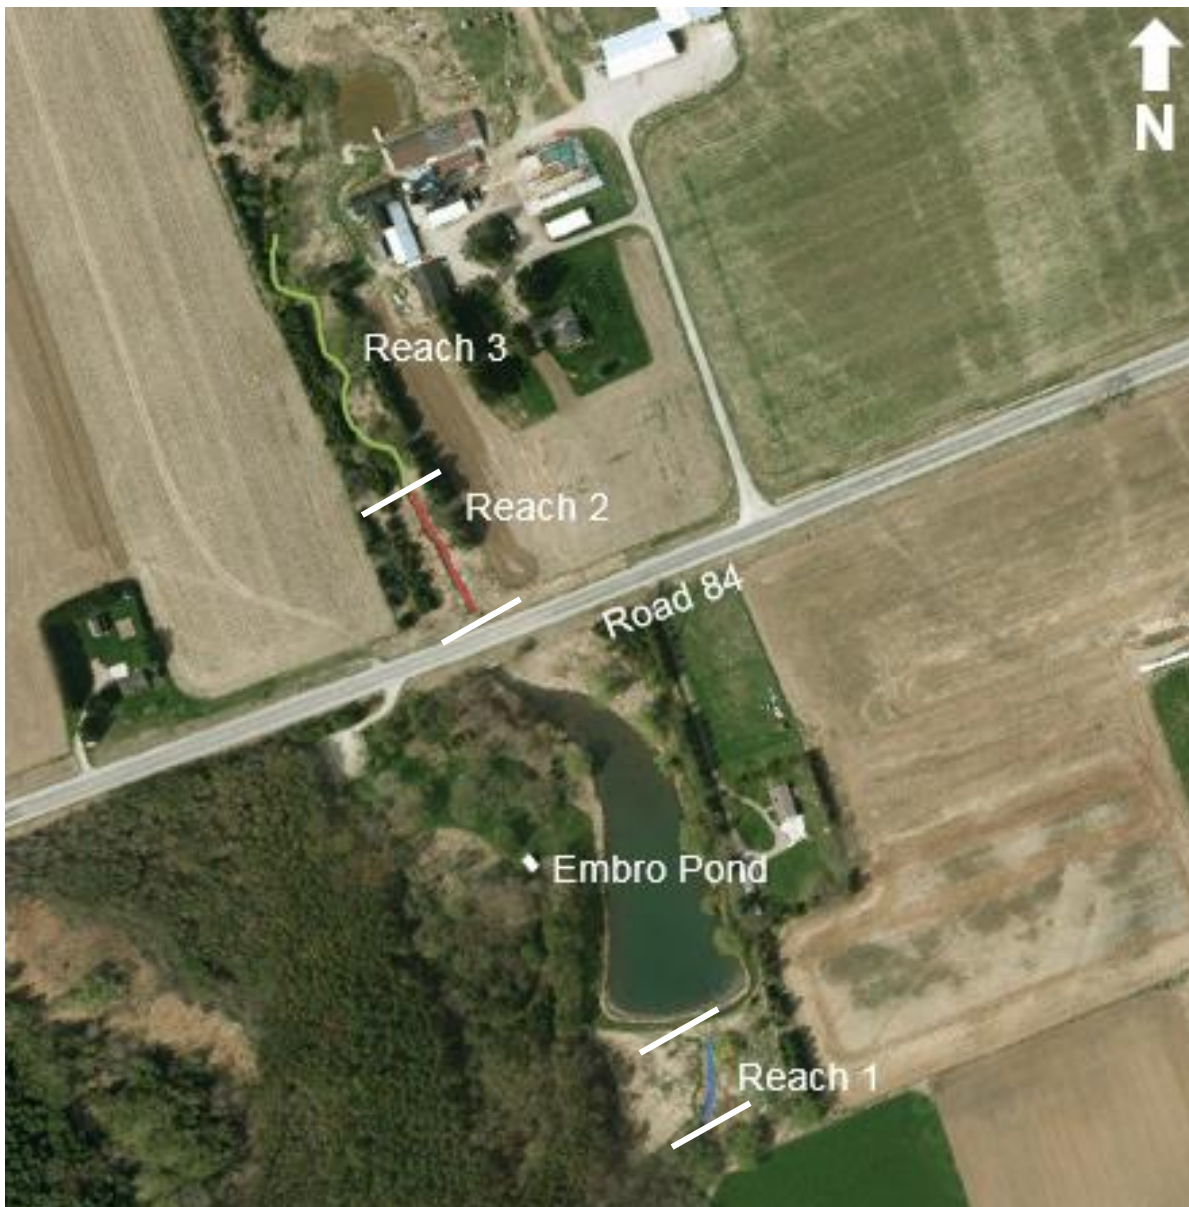
Figure 1-2. Reach delineation along Youngsville Drain.

During the field assessment, three reaches were identified. Reaches are defined as lengths of channel along which there is relative homogeneity of controlling and modifying influences and thus channel form and processes are similar. A description of dominant channel characteristics is provided by reach below. Although intended for urban watercourses, the Rapid Geomorphic Assessment (RGA) was applied to gain insight into overall channel stability and to identify dominant channel processes. The focus of field data collection/measurements was predominantly upstream of the dam's backwater influence.

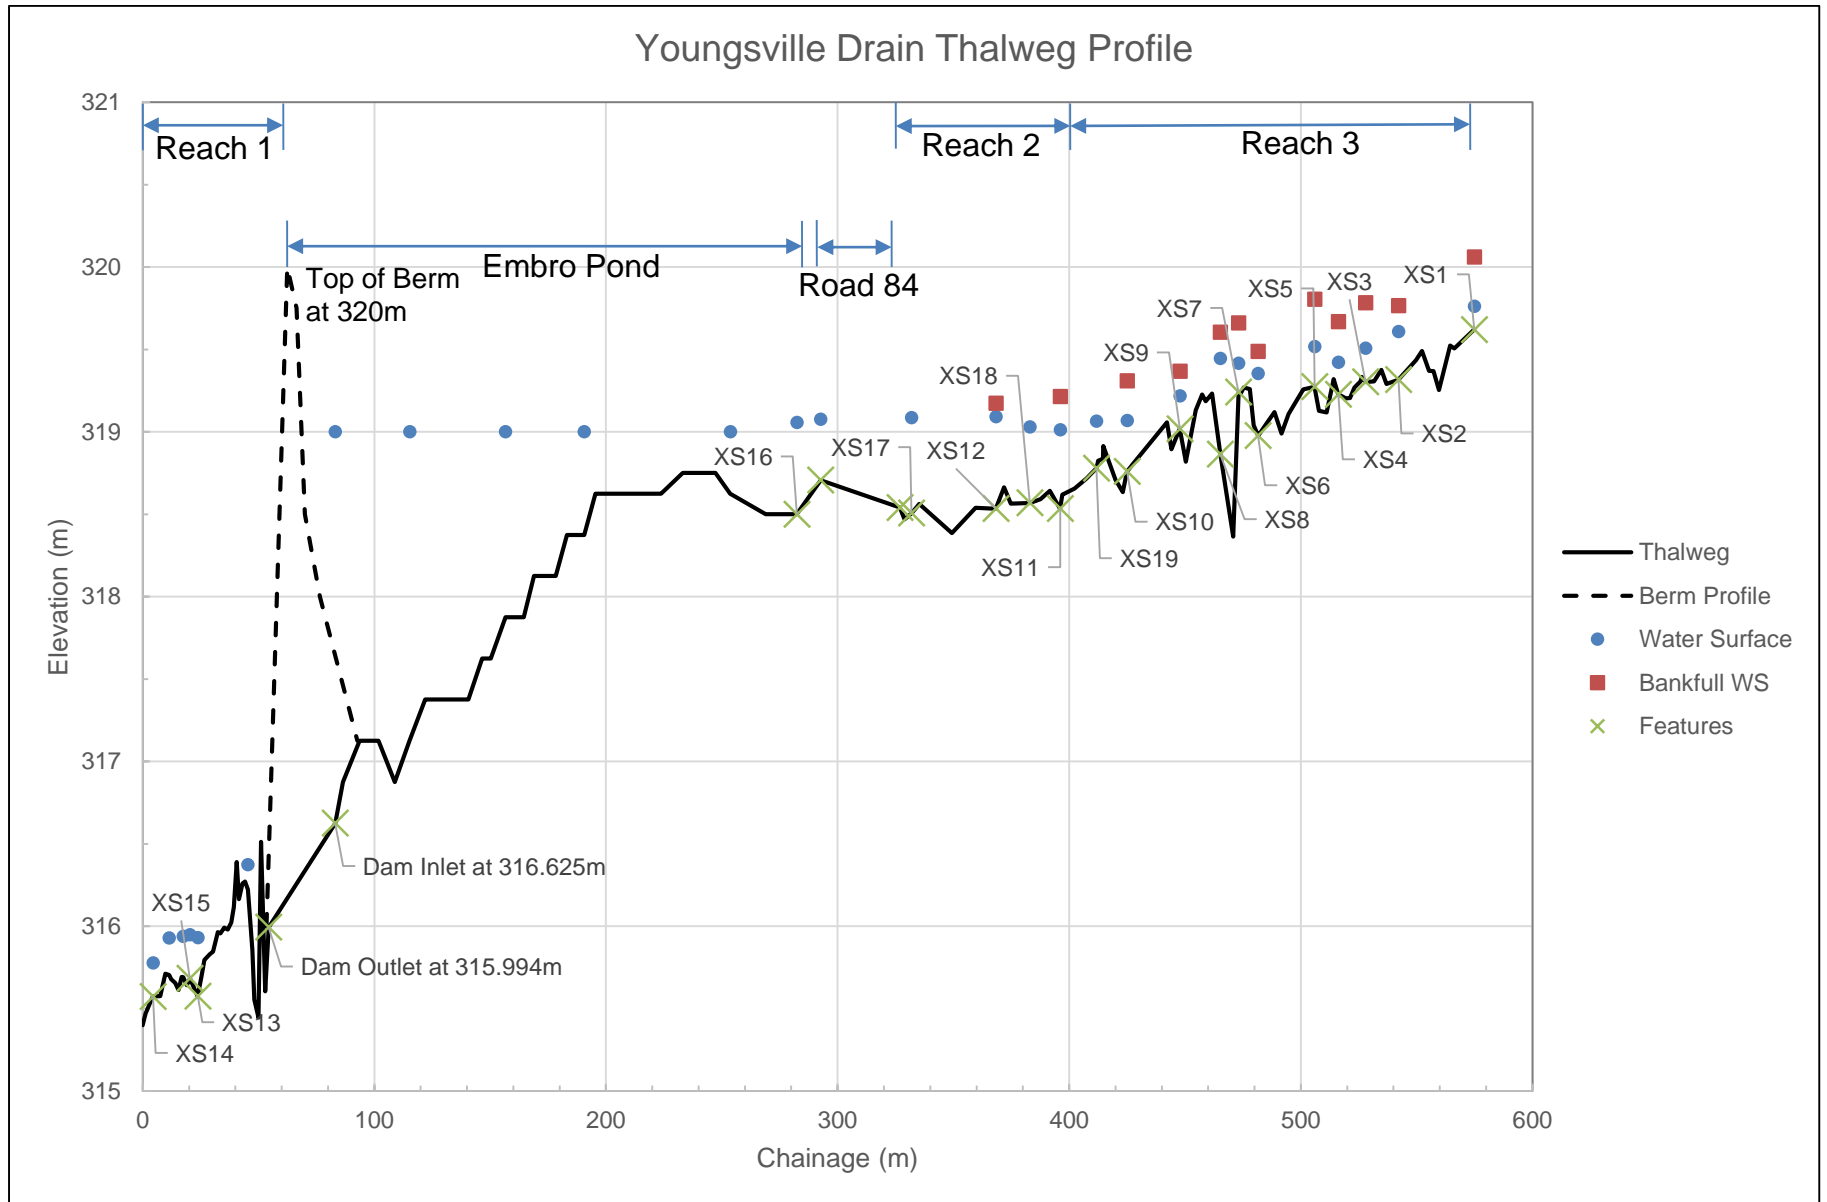
Figure 1-3. Channel bed profile along Youngsville Drain.

The focus of field data collection/measurements was predominantly upstream of the dam's backwater influence and included cross-section profiles and substrate characterization. A topographic survey of the channel bed morphology was undertaken by UTRCA and provided to the ERI team for analysis and integration into the fluvial geomorphic assessment. The reach delineation is demonstrated on **Figure 1-2** the surveyed channel bed profile is illustrated in **Figure 1-3** which includes a profile through Embro Pond based on 2015 water depth mapping provided by the UTRCA.
