DAM SAFETY ASSESSMENT REPORT FOR
Emburo Dam
Final
July, 2007

DAM SAFETY ASSESSMENT REPORT FOR
Emburo Dam

Final
July, 2007

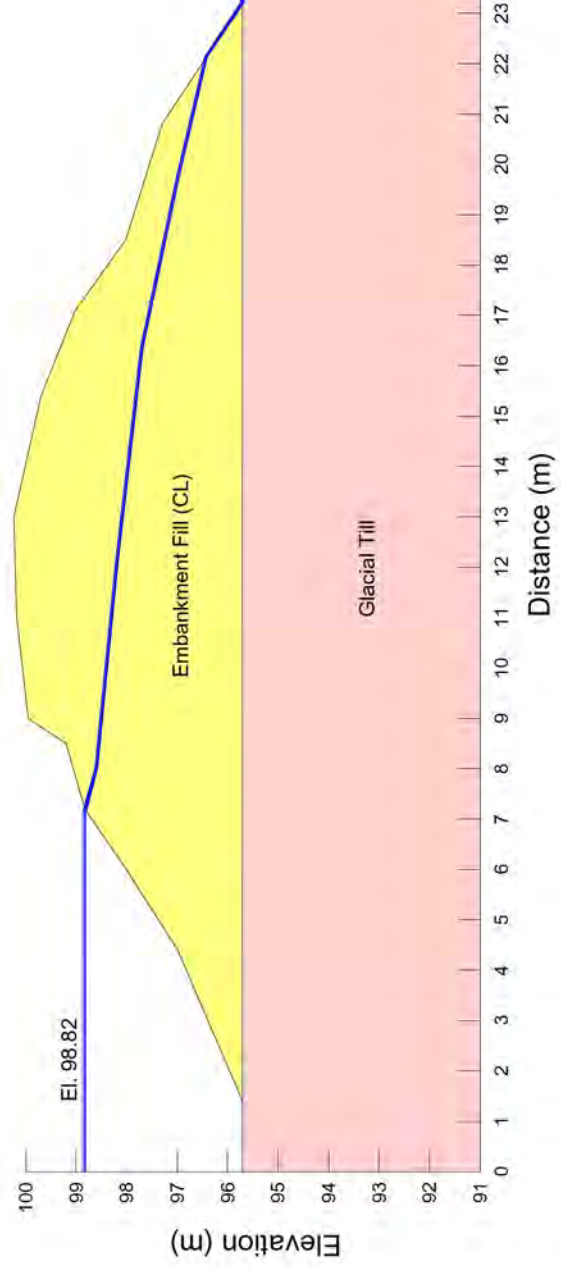
Figure 8.1
 Upper Thames River Conservation Authority
 Dam Safety Assessment Report - Embro Dam
Stability Section

The stability of the earth embankment was examined. The section location taken for the stability analyses is through the highest portion of the dam at about its midpoint. At this section, the embankment is about 4.5 m high. Figure 8.1 shows the section used in the stability analysis.

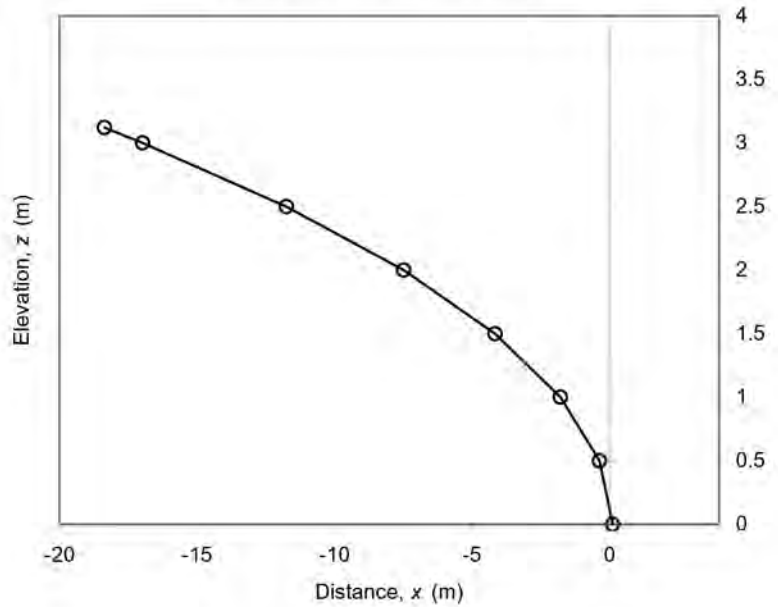
Figure 8.2
 Upper Thames River Conservation Authority
 Dam Safety Assessment Report - Embro Dam
Embro Dam Basic Parabola

A graphical method, as described by Craig (1997), was used to establish the phreatic surface and correspondingly the pore pressures within the embankment dam and foundation material. The graphical solution requires the plotting of a basic parabola. Figure 8.2 shows the details of generating the basic parabola for the dam. The phreatic surface is then obtained by applying the prescribed corrections to the basic parabola. Figure 8.2 shows the produced phreatic surface.

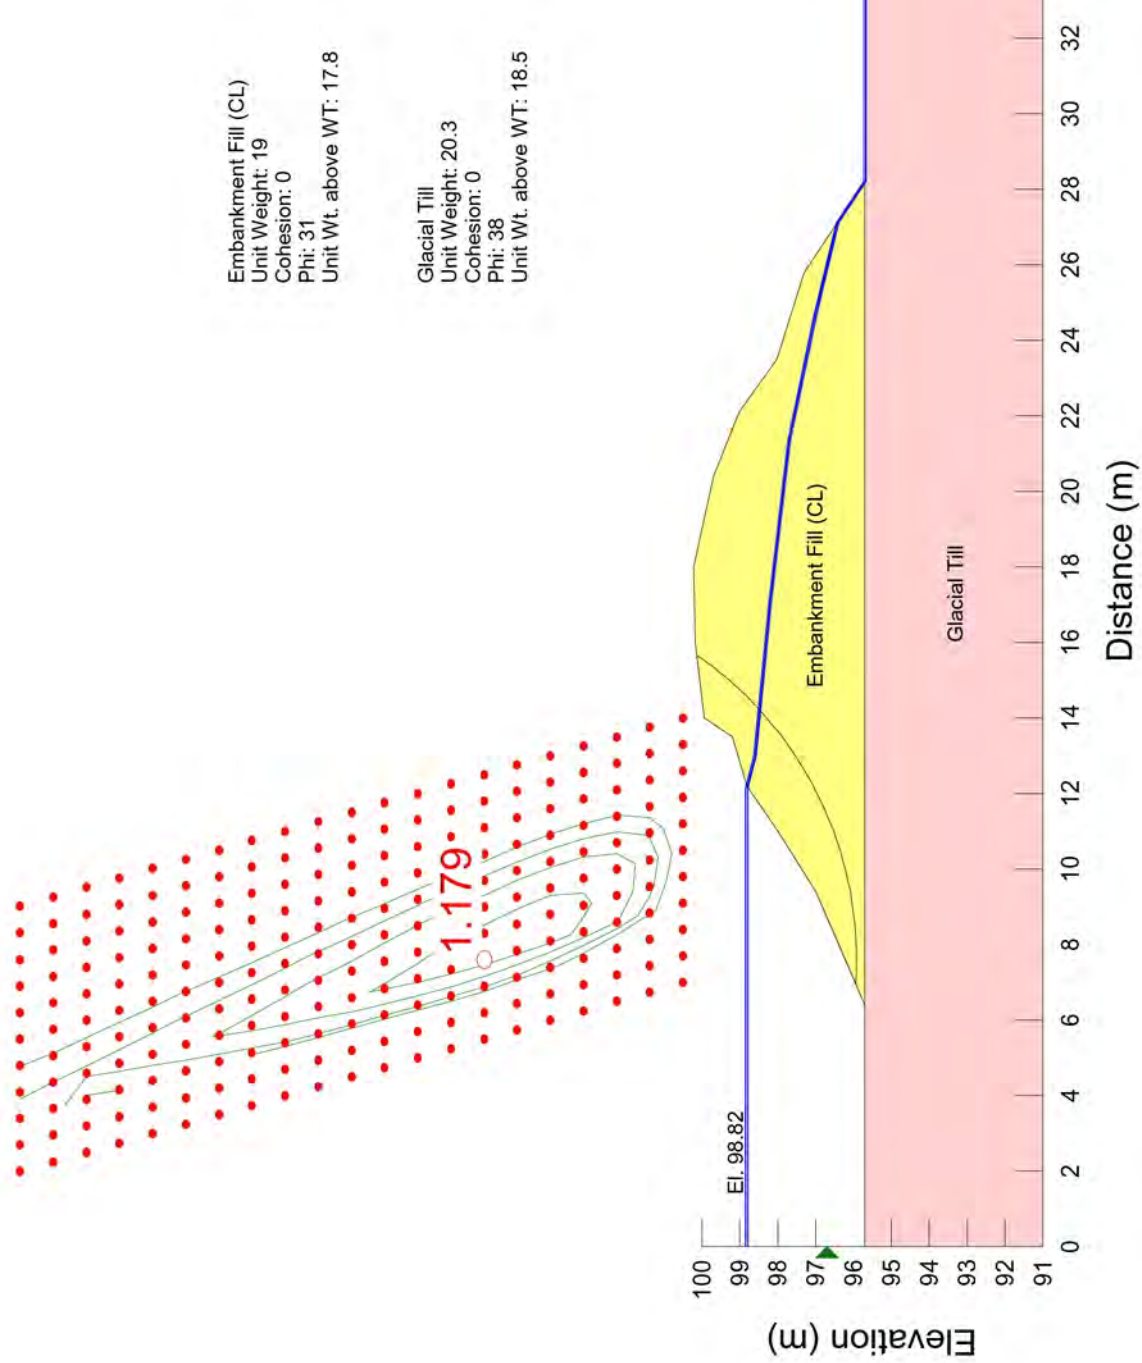
Figure 8.3
 Upper Thames River Conservation Authority
 Dam Safety Assessment Report - Embro Dam
Upstream Stability, Normal Load Condition

The results of the stability analyses are provided in Table 8.1, together with the acceptance criteria and calculated factors of stability. Figures 8.3 to 8.8 graphically depict the cross sections analyzed and the minimum factors of safety established for both the upstream and downstream sections.
