DAM SAFETY ASSESSMENT REPORT FOR
Fullarton Dam
Final
August, 2007

DAM SAFETY ASSESSMENT REPORT FOR
Fullarton Dam

Final
August, 2007

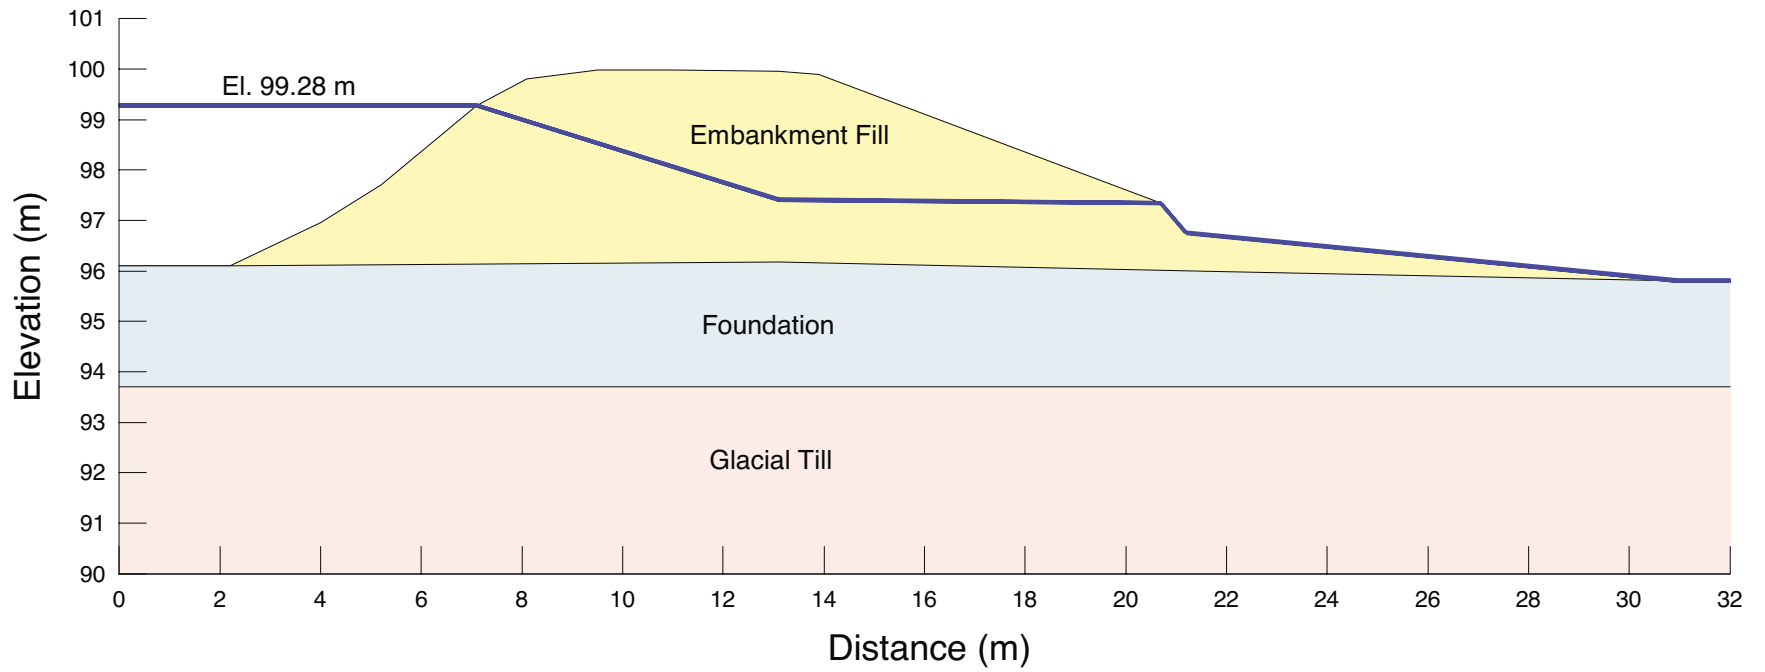
Figure 8.1
 Upper Thames River Conservation Authority
 Dam Safety Assessment Report - Fullarton Dam
Stability Section

The stability of the earth embankment was examined. The section location taken for the stability analyses is through the highest portion of the dam at about its midpoint. At this section, the embankment is about 3.4 m high. Figure 8.1 shows the section used in the stability analysis.

The phreatic surface was established using the piezometer readings and a point just above the toe. Figure 8.1 shows the phreatic surface.

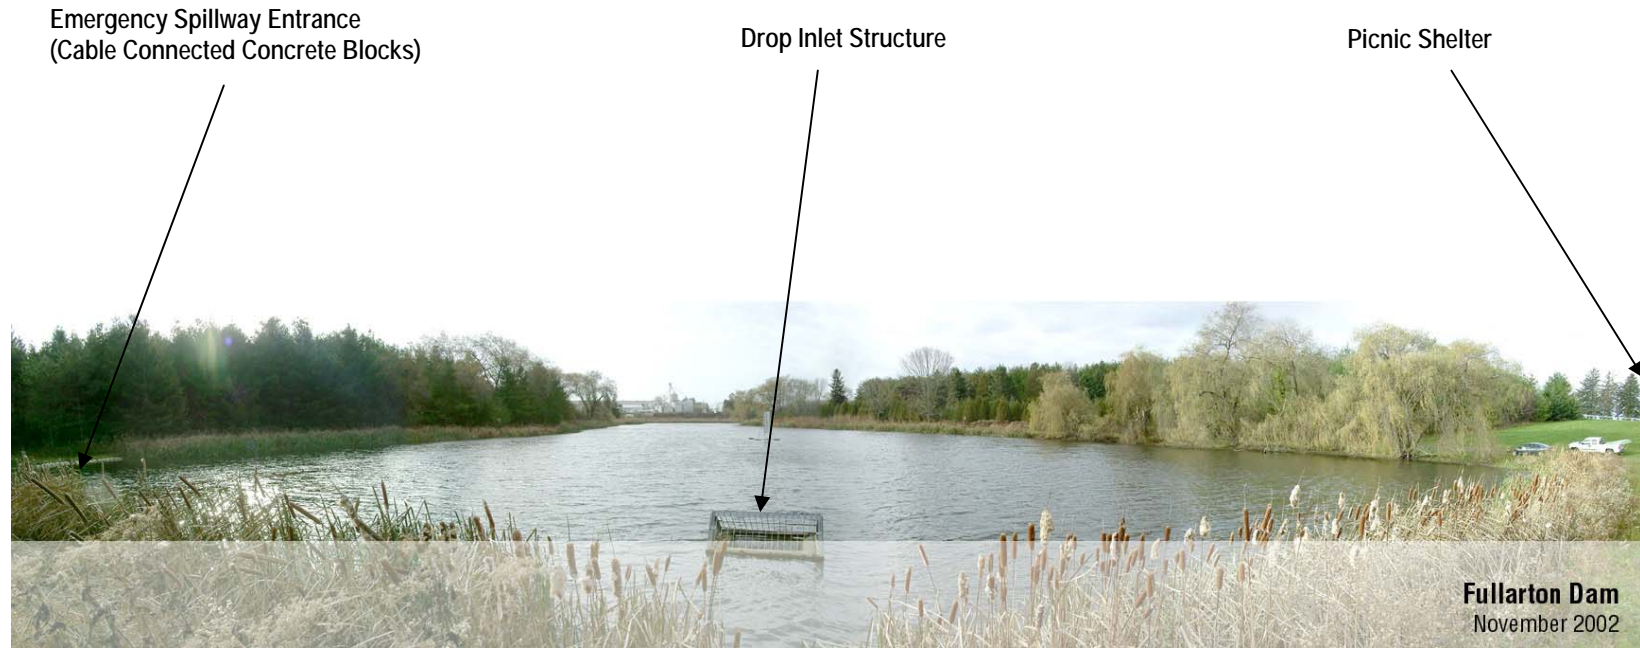
Photo 1 – Upstream View of Reservoir

The Fullarton Dam is located approximately 2 km south of the town of Fullarton on an unnamed tributary of the North Thames River. The conservation dam is close to two baseball diamonds which are located on a hill. An agricultural processing factory is located at the south (upstream) end of the reservoir (Photo 1). The dam and reservoir were built for recreational purposes and are adjacent to Country Road 163.

The discharge facilities at the dam consist of a concrete drop inlet structure with a set of stop logs at the upstream face and an inverted V-shaped trashrack anchored to the top of the inlet (Photo 1). At the time of the site visit, water was flowing over the stop logs. The dam is approximately 3.4 m high from its crest to the invert of the downstream channel/creek (Photo 4). There is an emergency spillway located on the right* or east bank (Photo 5). This is a lower section at the end of the embankment dam which is covered with cable-connected concrete blocks (Photo 6). The concrete blocks are cable-connected across the mouth of the spillway which measured 9.5 m in length and appeared to be in good condition. The emergency spillway has a grassed discharge channel that runs parallel to the creek before joining it. The spillway channel has variable slopes and widths, and is 2.4 m wide at its narrowest section. The upper reaches of the emergency spillway channel were

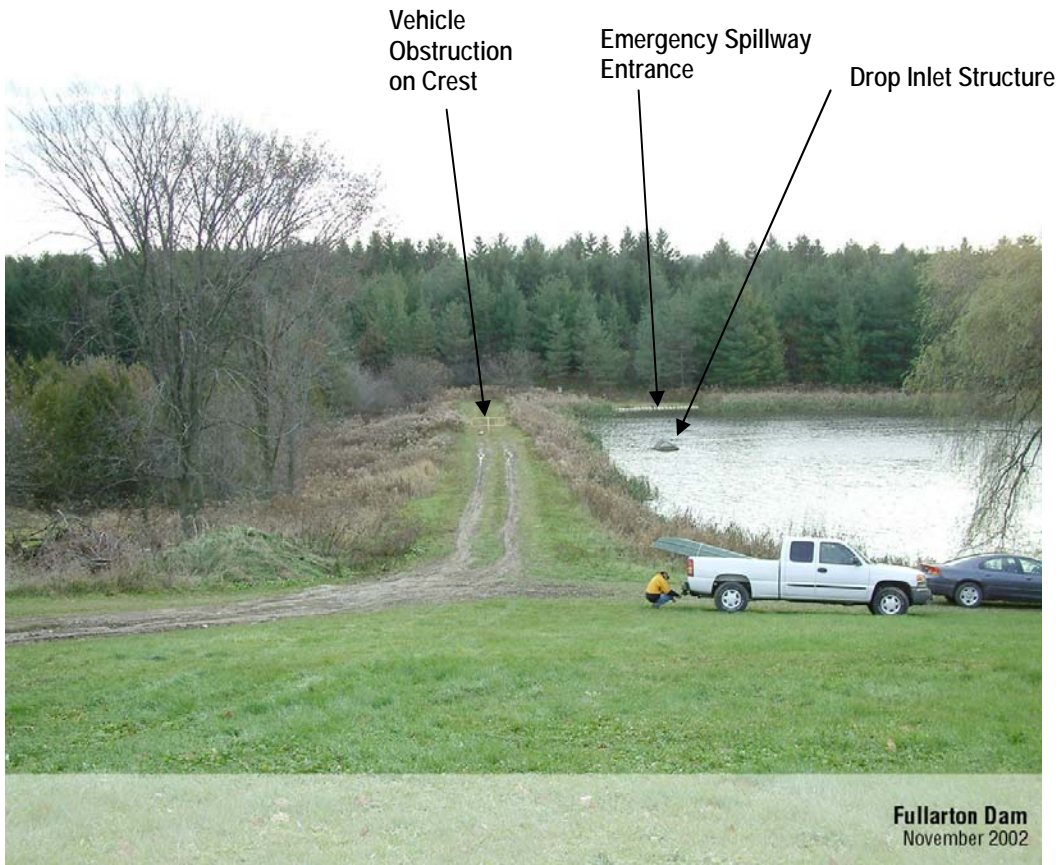
Photo 2 – View of Dam from Left Bank

The Fullarton Dam is a small fill dam approximately 100 m long (Photo 2) which, at the time of the visit, had a head of water of approximately 3 m acting across the dam. Freeboard was approximately 0.7 m. The dam is provided with an emergency spillway. A track leads off the right end of the dam.

The dam controls a very small drainage area of 4 km² comprising mostly agricultural land. The conservation reservoir surface area is small and is impounded by a low earth-fill embankment dam located at the northern end of the reservoir (Photo 2). Flow releases from the dam outlet enter a narrow channel (Photo 3), and flow in a northeasterly direction for approximately 0.45 km before entering the main stem of the North Thames River. The North Thames River continues to flow in a southerly direction some 16.5 km before reaching St. Marys Dam in the town of St. Marys.

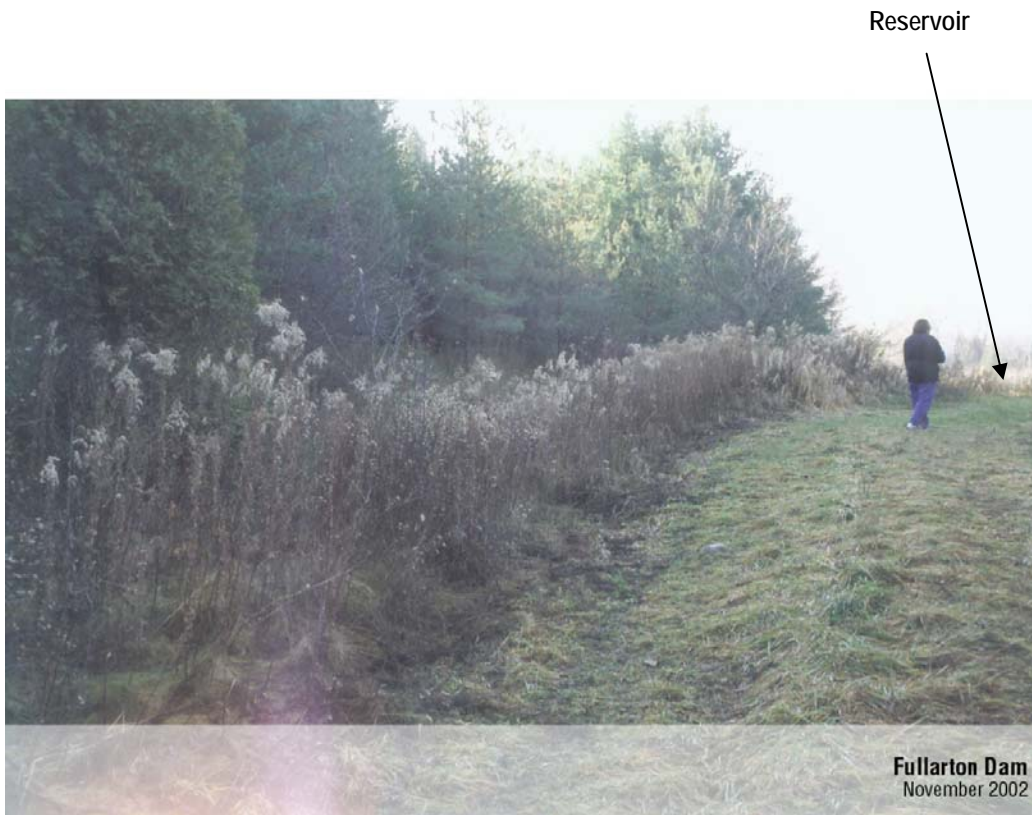
Photo 7 – Upper Reach of Emergency Spillway Channel

clear (Photo 7) and grassed. The lower portion of the spillway was not well-defined and was overgrown with larger brushes.

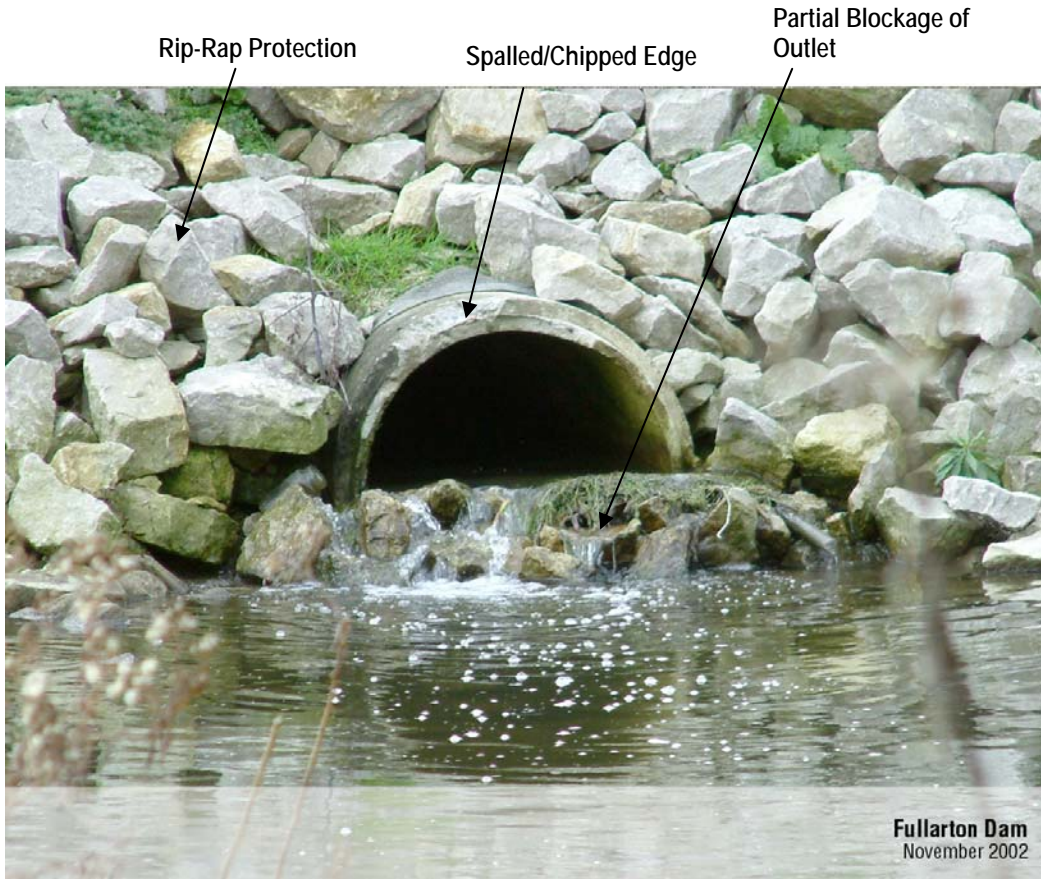
Photo 11 – Close-Up of Outlet Pipe

Flow Over Stop Logs

Erosion Pocket

Erosion of Concrete Face

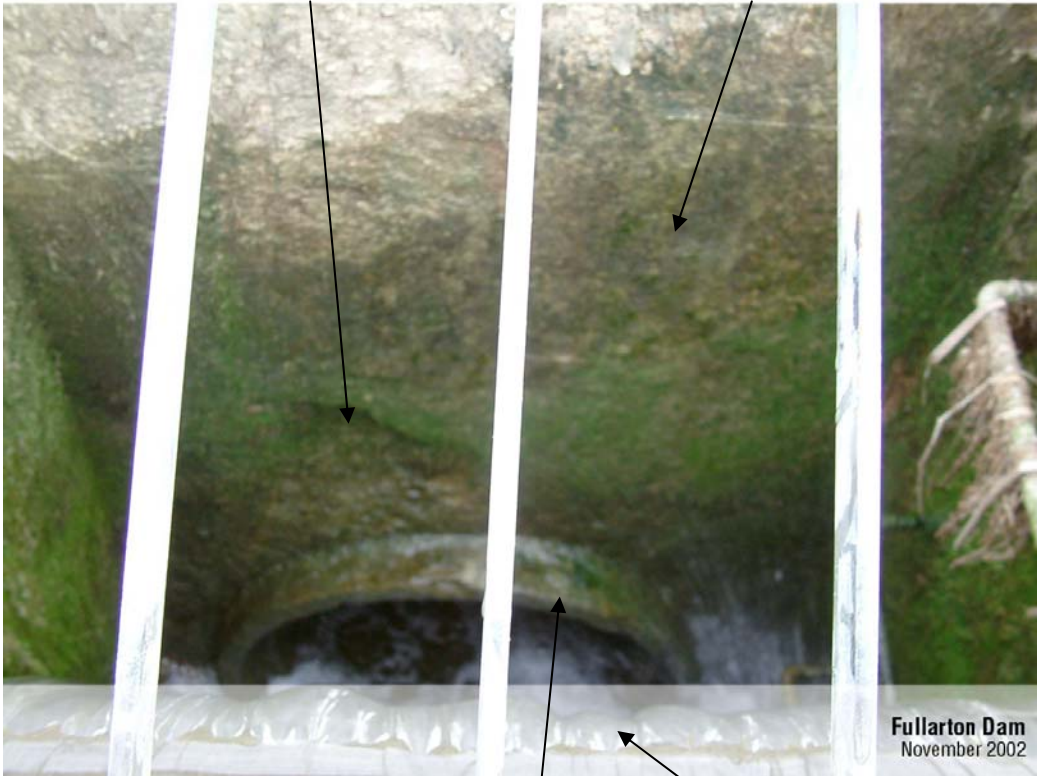
Photo 13 – Inside of Drop Inlet Structure

Outlet Pipe
