**GEOTECHNICAL INVESTIGATION
FULLARTON DAM EMBANKMENT STABILITY ASSESSEMENT
MUNICIPALITY OF WEST PERTH, ONTARIO
for
UPPER THAMES RIVER CONSERVATION AUTHORITY**

6031G1.R01
February 2006

**Re: Geotechnical Investigation
Fullarton Dam Embankment Stability Assessment
Municipality of West Perth, Ontario**

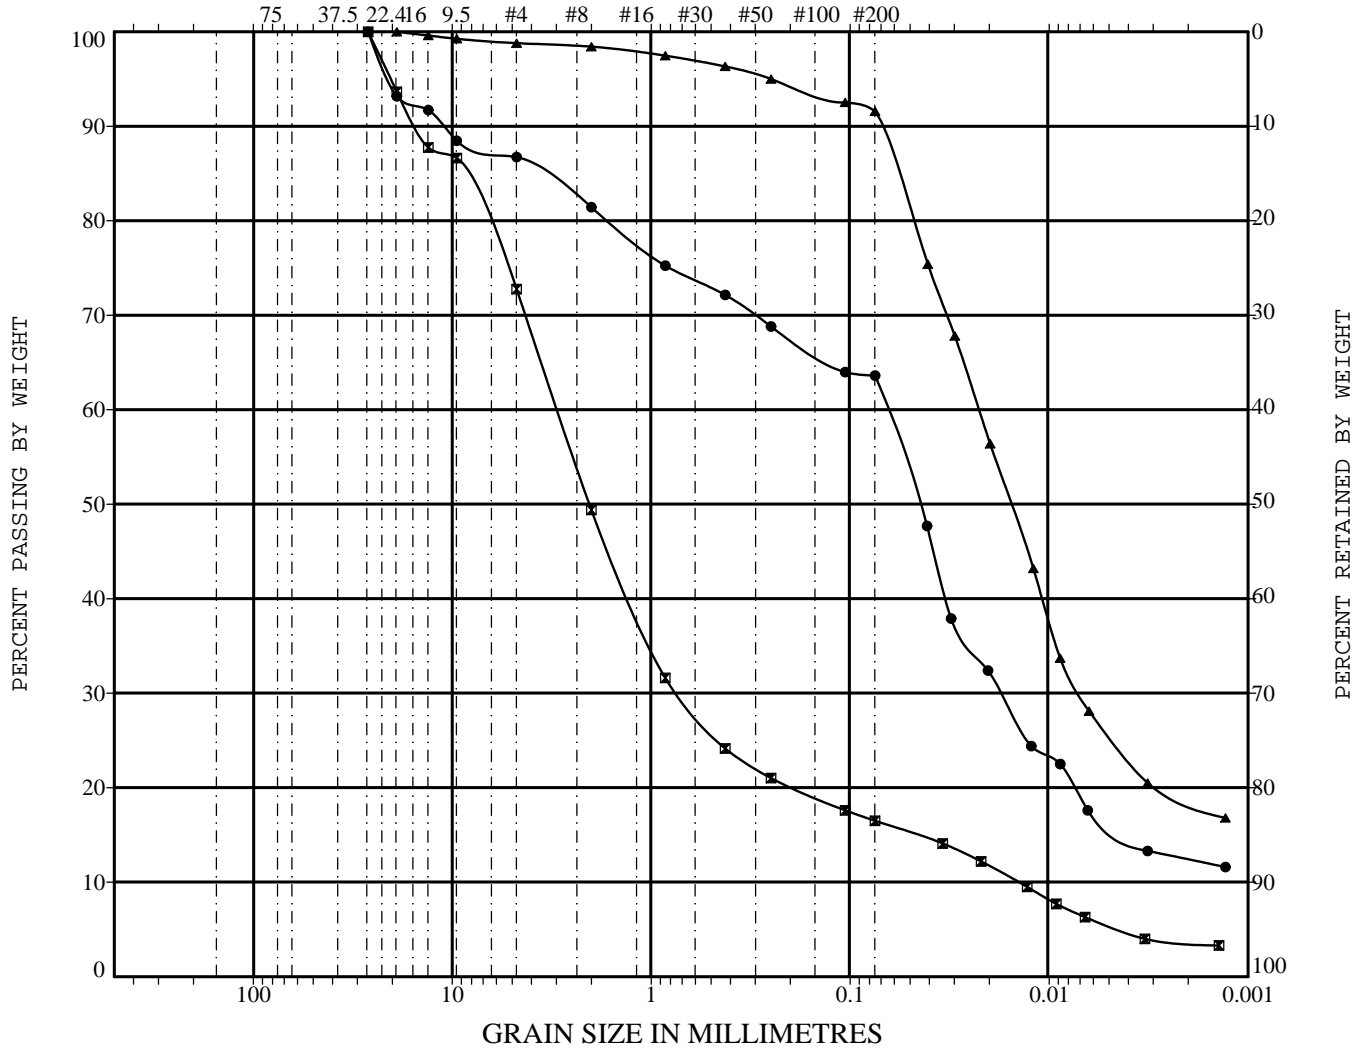
Fill material was encountered in Boreholes 101 and 102 that were drilled on the crest of the dam. The fill is about 2.0 m thick and typically comprises silt with some clay, trace to some sand and trace to some gravel. The results of two particle size distribution analyses carried out on samples of the fill are plotted on Figure 1 and reveal the samples contain 1 to 13% gravel, 9 to 23% sand, 51 to 73% silt, and 13 to 17% clay. Pocket penetrometer tests carried out on cohesive samples of the fill indicate shear strengths of between 100 and 200 kPa. The moisture content of the fill ranges from 10 to 24% indicating moist to wet conditions.

The results of a particle size distribution analysis carried out on a sample of the sand are plotted on Figure 2, appended and indicates that the sample contains 17% silt, 56% sand and 27% gravel. The sand deposit is saturated and the natural moisture content is about 10%.

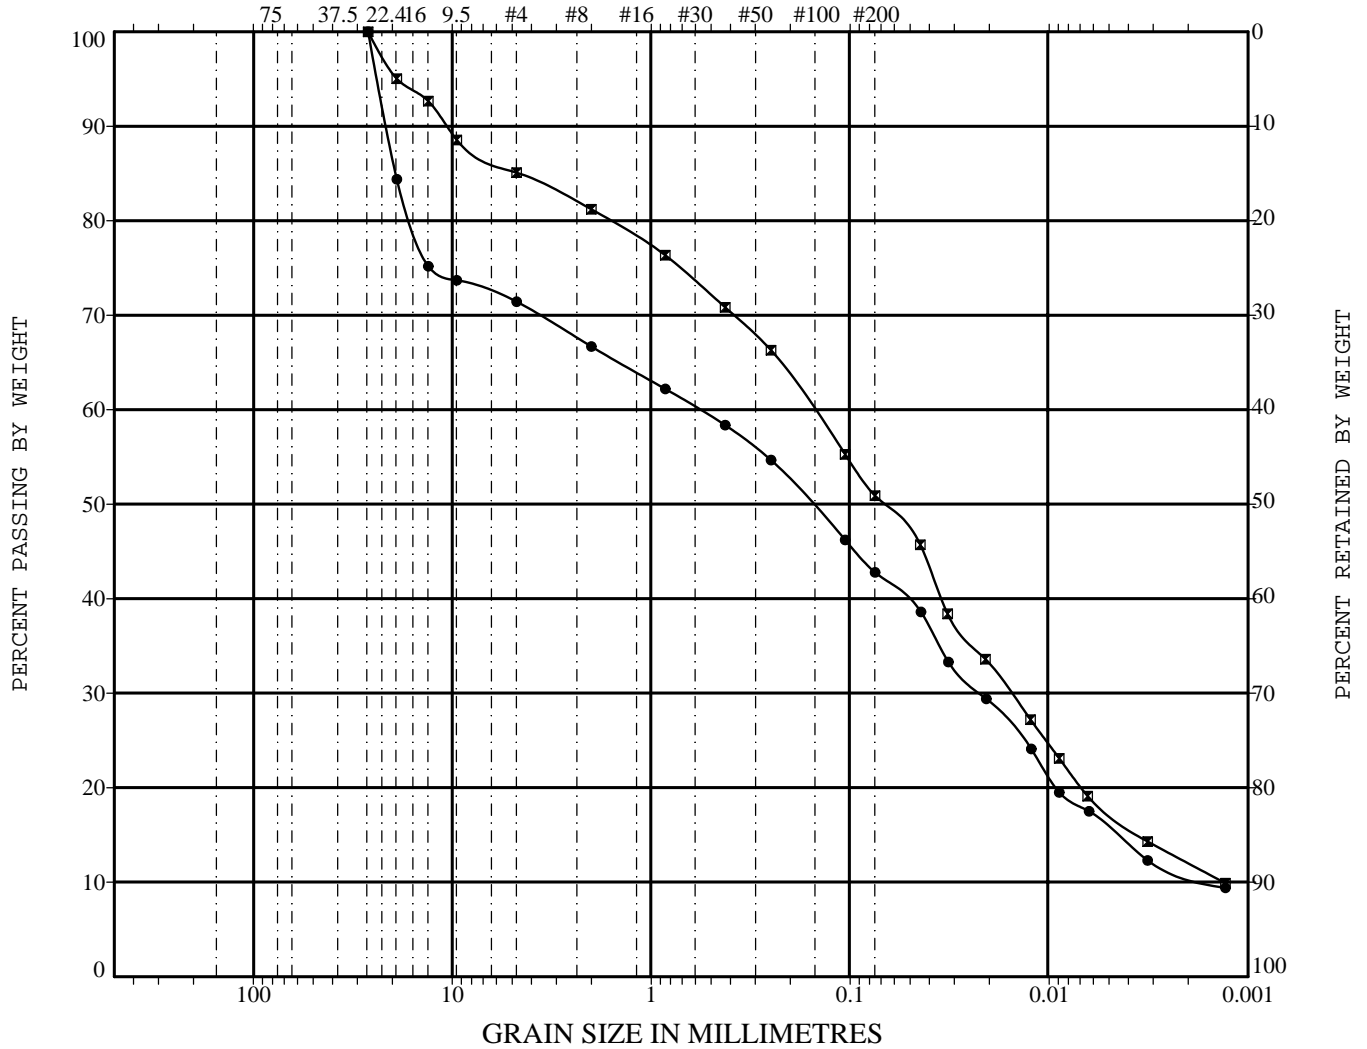
The texture of the glacial till is typically silt and sand with some clay and gravel. The results of two particle size distribution analyses carried out on samples of the glacial till are plotted on Figure 2 and indicate that the samples contain 10 to 12% clay, 34 to 40% silt, 28 to 33% sand and 15 to 28% gravel.

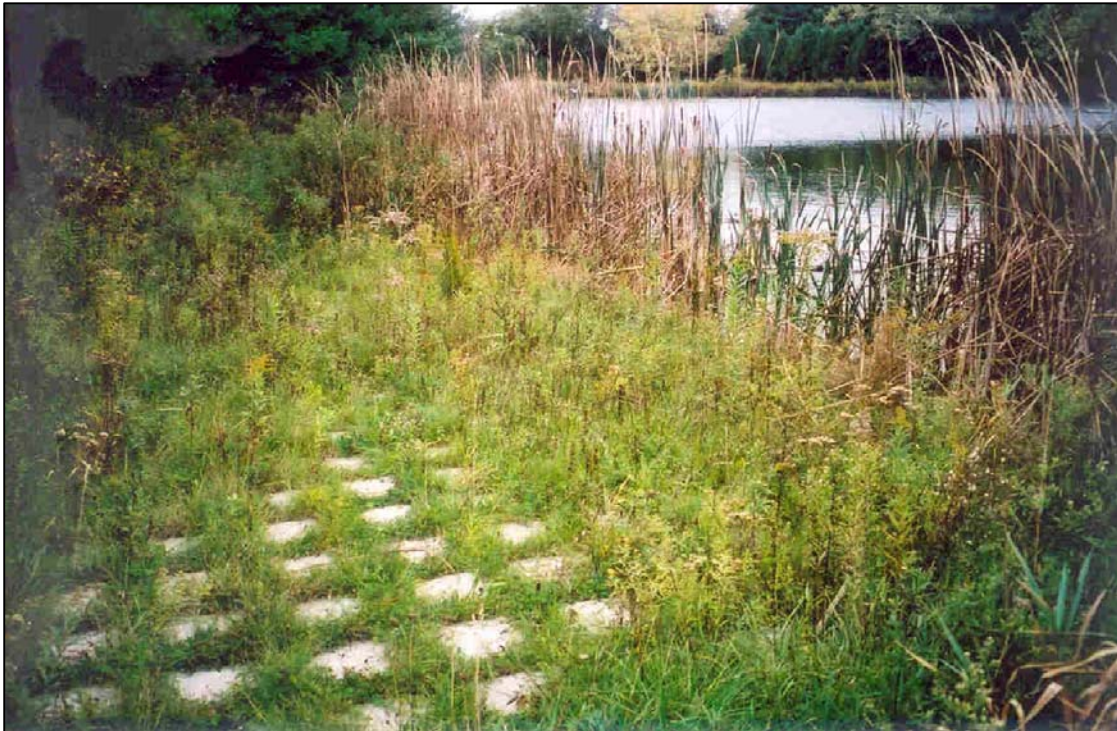
Photo 2: Overflow spillway located southeast of the dam.

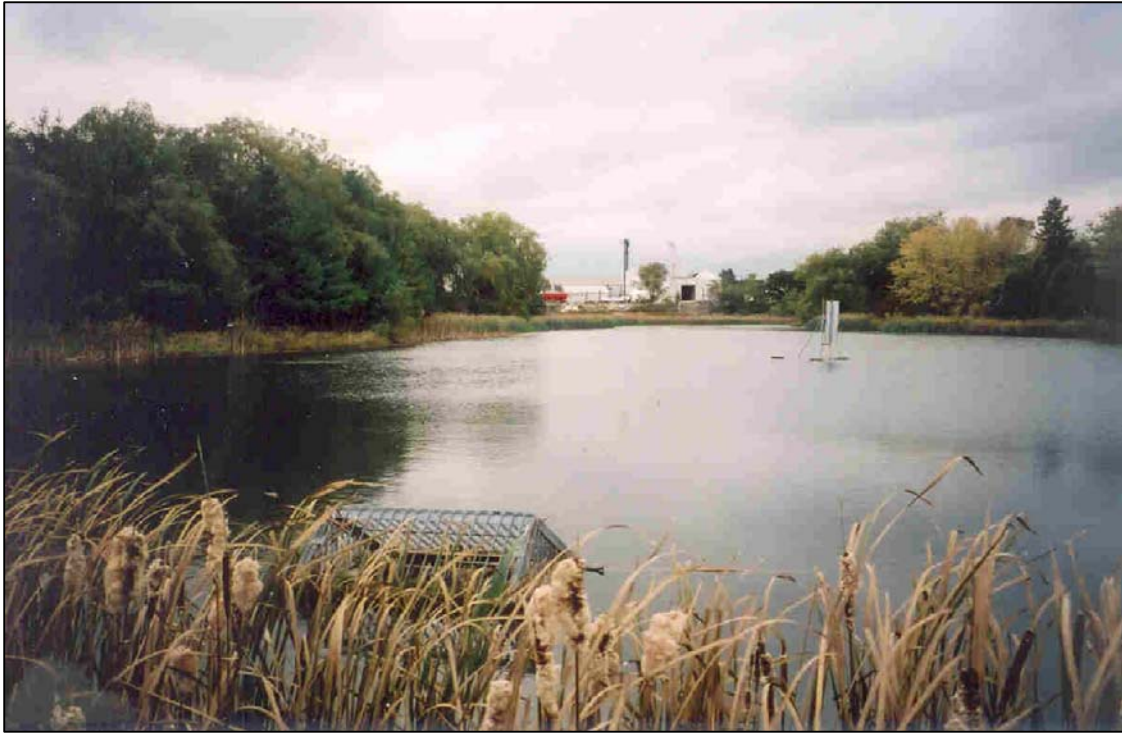
Photo 3: Looking south towards the pond and the drop inlet structure.

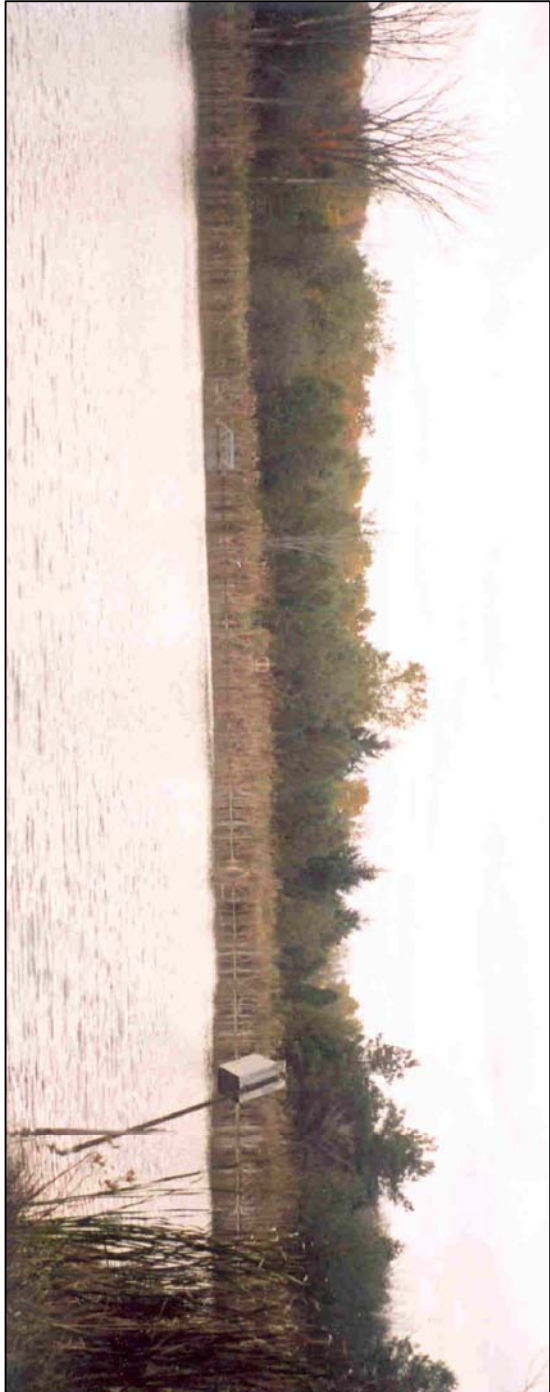
The downstream slope of the dam is inclined at between 2 and 3 horizontal to 1 vertical with the outer thirds flatter than the centre third. The centre third in the area of the outlet pipe is covered with loose rip-rap. No seepage areas were noticed on the downstream slope although the rip-rap appears to have settled unevenly around the outlet.

Photo 5: Looking north towards the dam.
