# Harrington Dam and Conservation Area

## Existing Geomorphic Conditions

December 2015, Draft

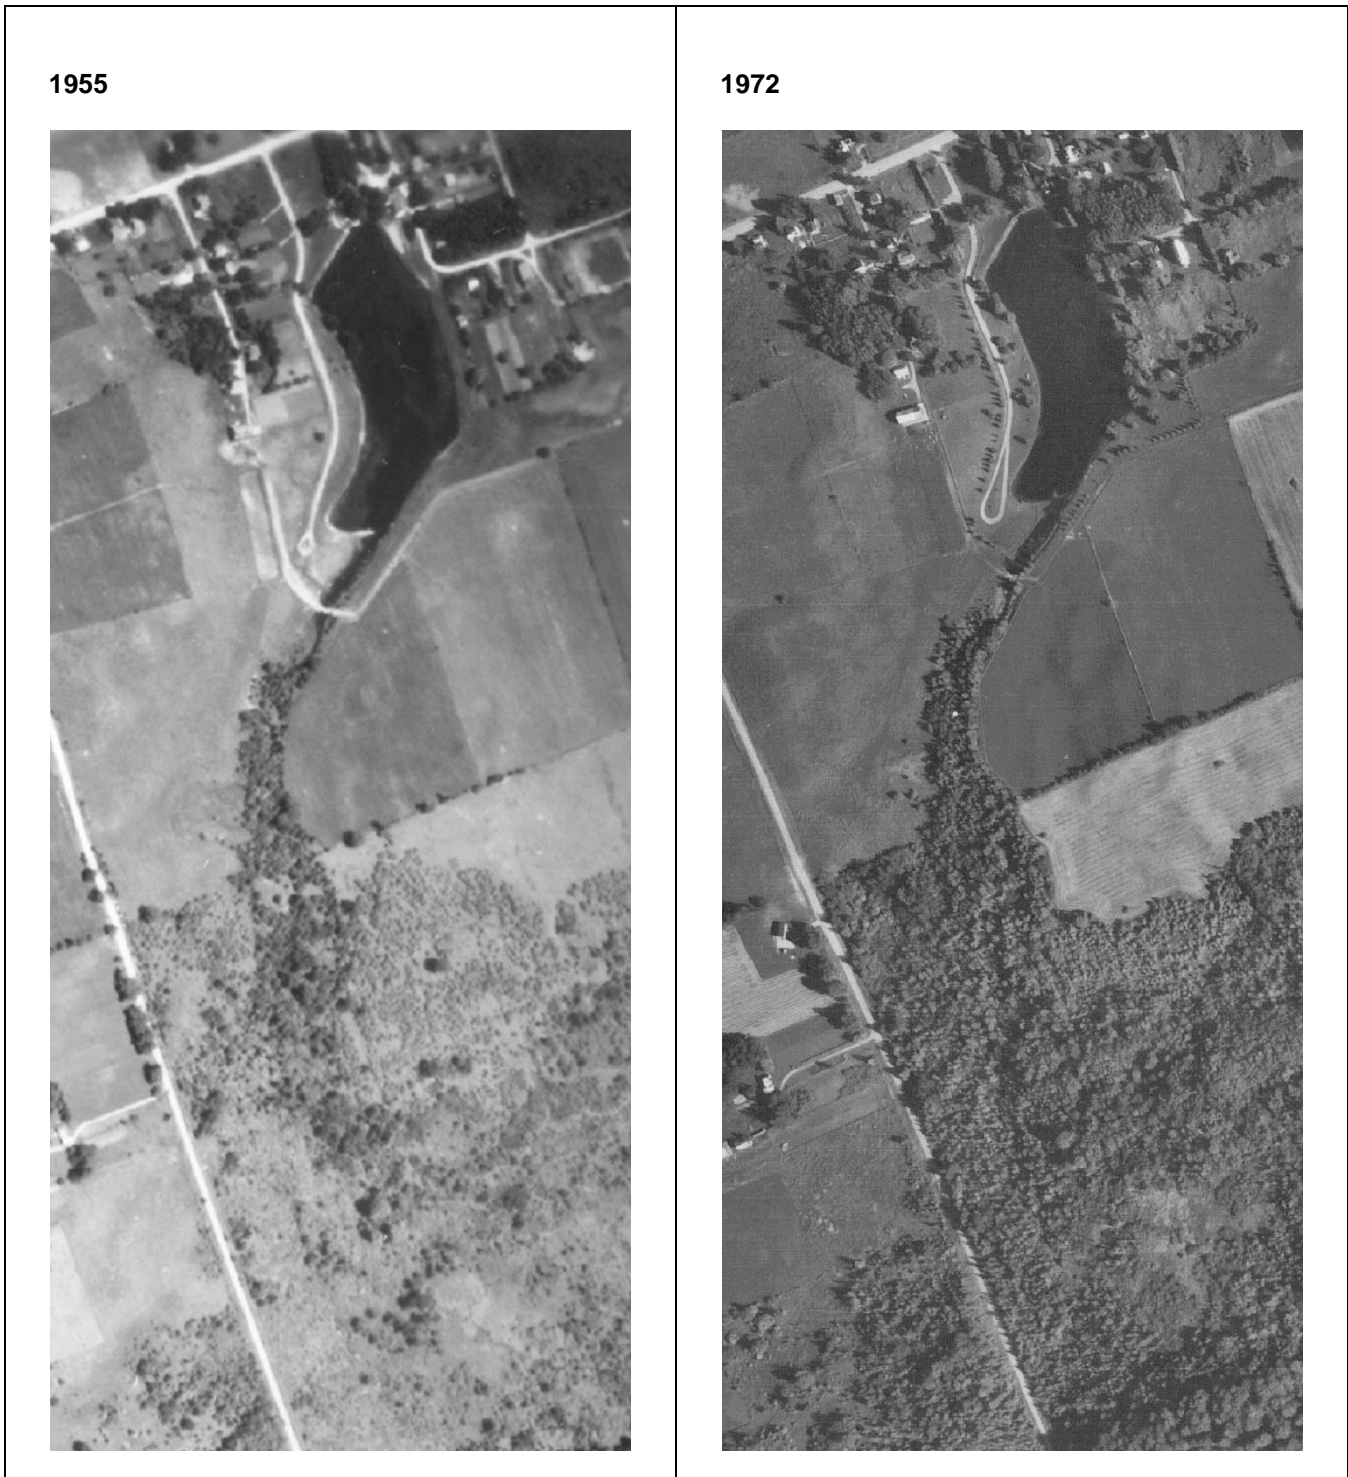
Figure 1-1a. Overview of historical channel change along Harrington Creek in proximity to Harrington Pond.

Year	Observation
1955	<ul style="list-style-type: none"> <li>Harrington pond was clearly visible in the airphoto</li> <li>Downstream of the Harrington pond outlet, Harrington Creek appeared to have been straightened and was situated along a hedgerow.</li> <li>Upstream of Harrington pond, a trail/bridge exists over the creek; backwater conditions appear to extend somewhat upstream of the bridge. In general, Harrington Creek was slightly sinuous and appears to be situated in an agricultural field within a wooded creek corridor.</li> <li>Low density residential housing occurs to the east of the pond, and downstream of the outlet structure</li> </ul>
1972	<ul style="list-style-type: none"> <li>Portions of Harrington Creek are obscured from view on the photo.</li> <li>Upstream of Harrington pond, the tree density within the creek corridor appears to have increased; this may also reflect a time of year difference between the 1955 and 1972 photos.</li> <li>No change in creek or pond planform configuration is evident in comparison to the 1955 image.</li> </ul>

1989	<ul style="list-style-type: none"> <li>No change in creek or pond planform configuration is evident in comparison to the 1972 image.</li> </ul>
2000	<ul style="list-style-type: none"> <li>The upstream west end of Harrington pond appears to have been modified. Shading within the pond may reflect wind on the water or draw-down.</li> <li>No change in creek planform configuration is evident in comparison to the 1989 image.</li> </ul>
2010	<ul style="list-style-type: none"> <li>Harrington pond size has decreased in length since the 2000 image; this results in a longer backwater channel that extends into the pond. The smaller pond size may reflect time of year and/or drought conditions.</li> <li>No change in planform configuration is evident in comparison to the 2000 image upstream of the bridge.</li> </ul>
2013	<ul style="list-style-type: none"> <li>Harrington pond size has increased, similar to the 2000 configuration.</li> <li>No change in creek planform configuration is evident in comparison to the 2000 image upstream of the bridge.</li> </ul>

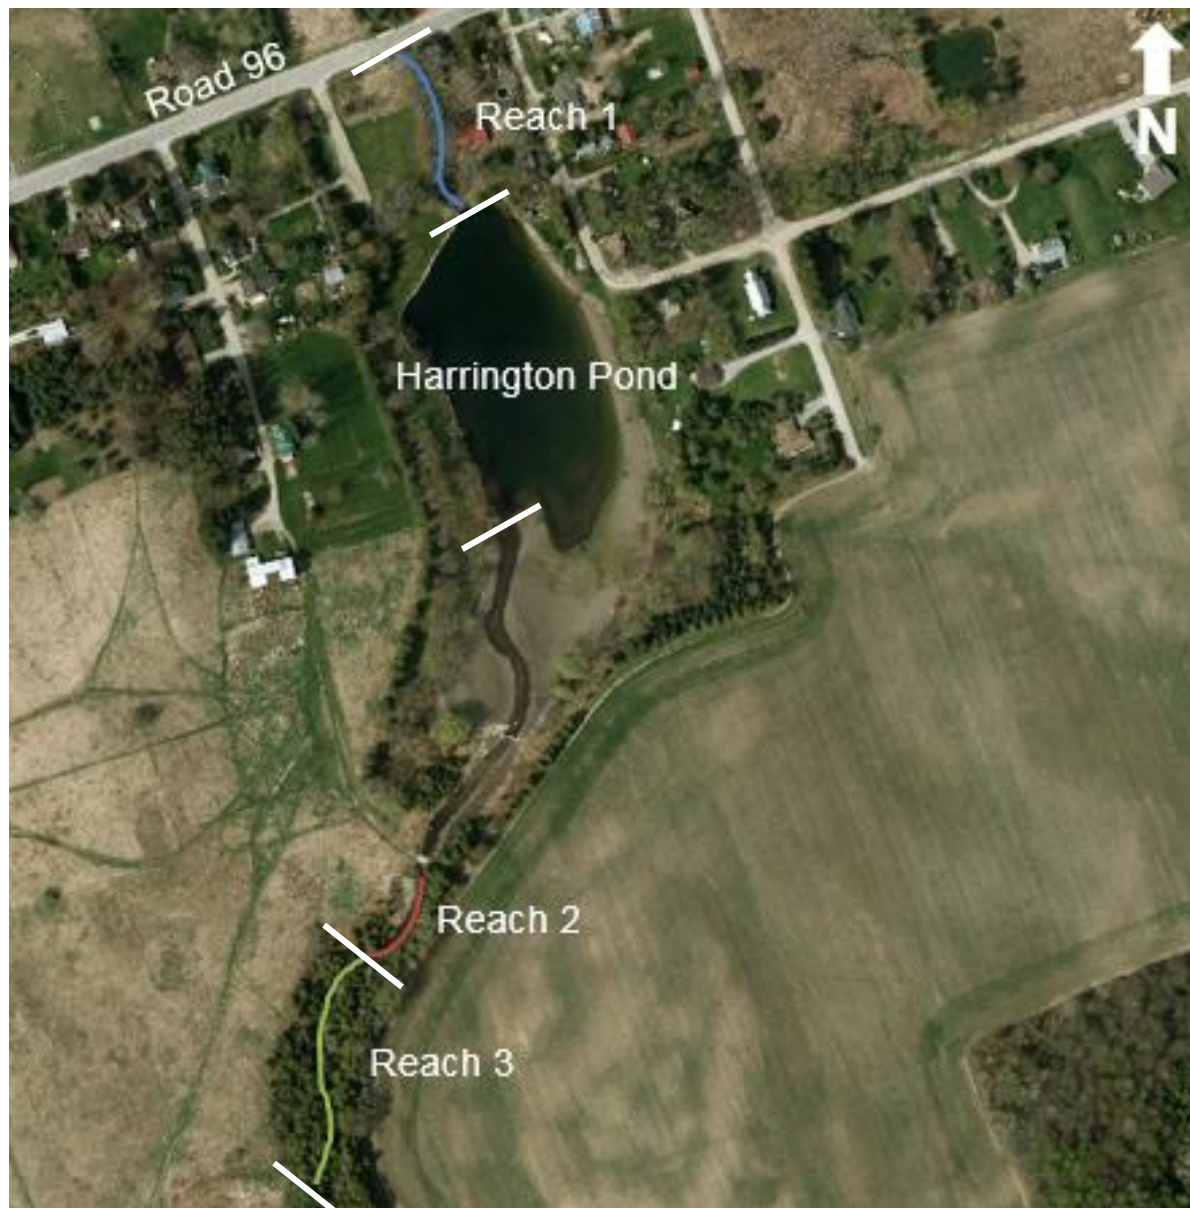
Figure 1-2. Reach delineation along Harrington Creek.

During the field assessment, three reaches were identified (see **Figure 1-2**). Reaches are defined as lengths of channel along which there is relative homogeneity of controlling and modifying influences and thus channel form and processes are similar. A description of dominant channel characteristics is provided by reach below. Although intended for urban watercourses, the Rapid Geomorphic Assessment (RGA) was applied to gain insight into overall channel stability and to identify dominant channel processes.

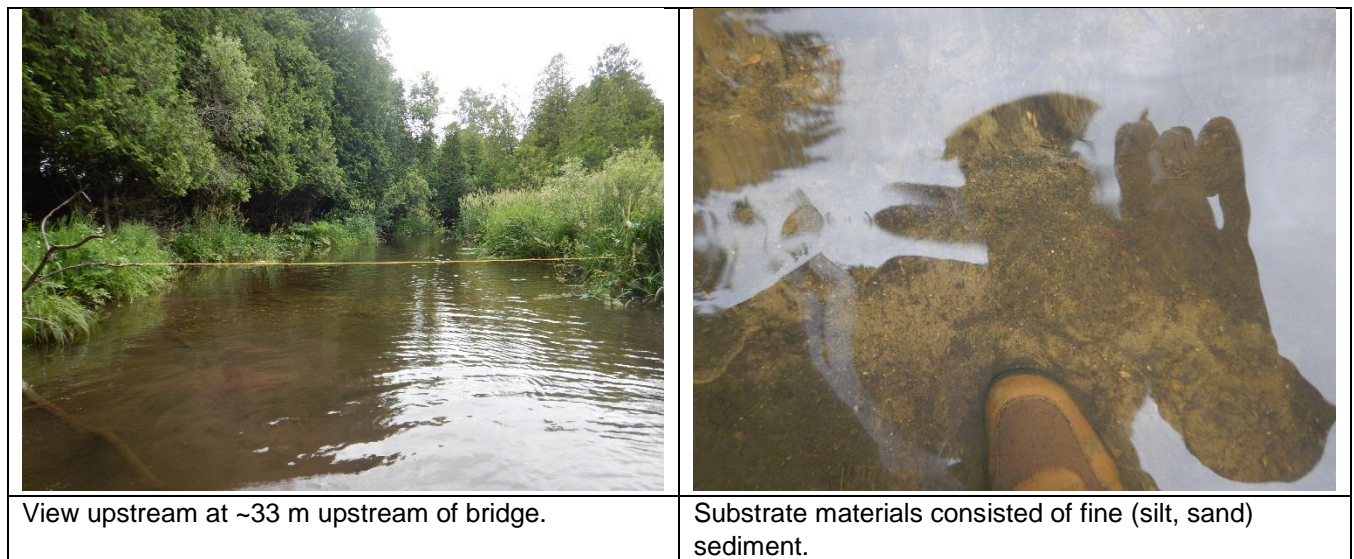
The bed morphology through this reach was poorly defined and little variability in water depth occurred (i.e., 0.42 to 0.51 m). Bed materials consisted entirely of fine sediment (silt, sand) that had been sculpted into ripples by the flow; the thickness of this sediment ranged from 5 to 20 cm. Further upstream, occasional cobbles and branches/logs were observed on the channel bed. A vegetated (grass) bar was observed in the channel, towards the upstream limit of the backwater influence.

Overall, the reach was considered to be stable. Given the low energy grade (see **Figure 1-3**), both aggradation and channel widening processes are gradually affecting channel form and processes.
