DAM SAFETY ASSESSMENT REPORT FOR  
**Harrington Dam**  
Final  
July, 2007

DAM SAFETY ASSESSMENT REPORT FOR  
**Harrington Dam**

Final  
July, 2007

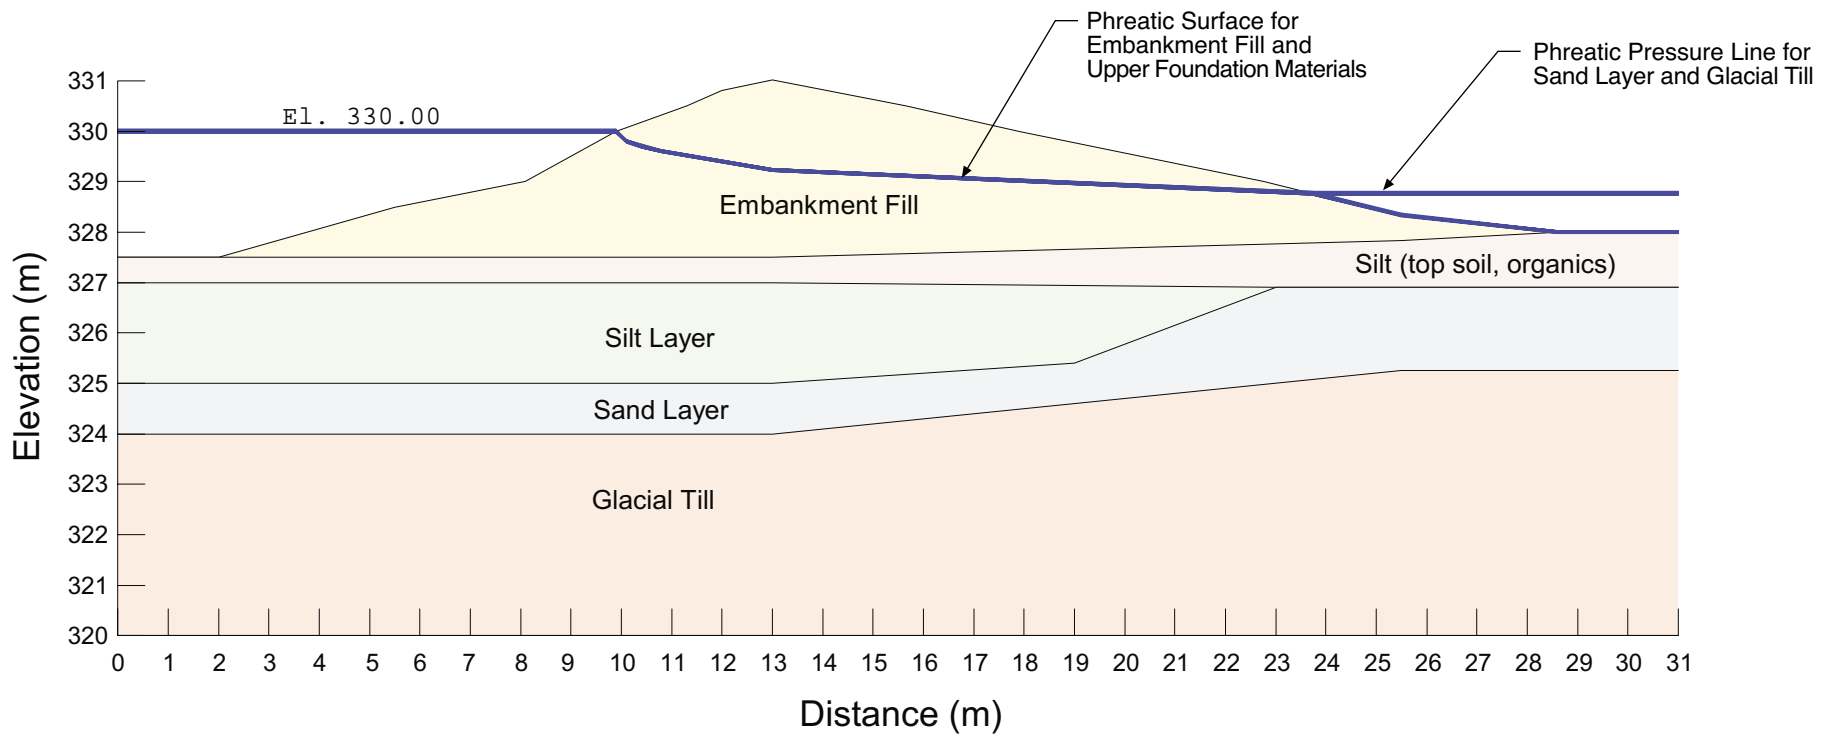
Figure 8.1  
 Upper Thames River Conservation Authority  
 Dam Safety Assessment Report - Harrington Dam  
**Stability Section**

Stability analyses were done for the left earth embankment. The section location taken for the stability analyses is through the highest portion of the dam at about its midpoint. At this section, the embankment is about 3.5 m high. Figure 8.1 shows the section used in the stability analysis.

It was deemed necessary to consider two piezometric pressure lines, as shown in Figure 8.1. A phreatic surface, deduced from piezometric readings, represents pore pressures within the embankment fill and the clay, silt and sand upper foundation material. The second piezometric pressure line applies to the underlying silt/sand layer and reflects its possible artesian condition (Section 8.3.7).

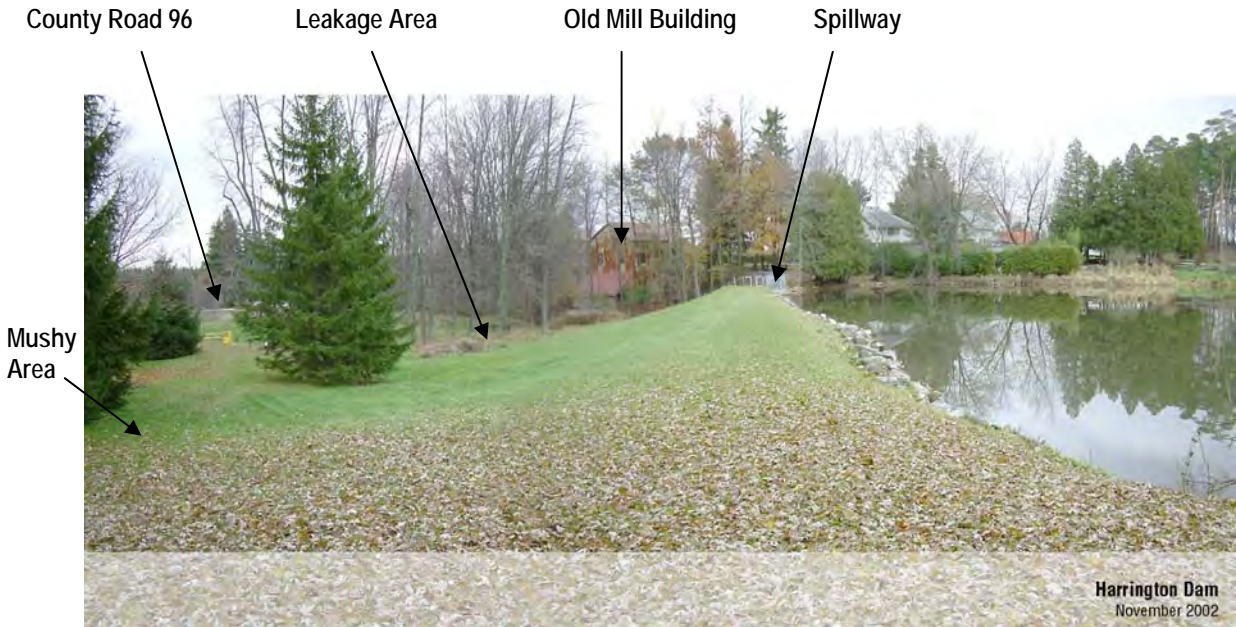
The Harrington Dam comprises a 60-m long (approximate) embankment dam, on the left\* side (Photo 1) and a short embankment dam on the right side (Photo 2); these are separated by a concrete spillway structure (Photo 3). The head across the dam on November 12, 2002 was 3.3 m and freeboard at the embankment dams was of the order of 1 m. An abandoned millrace is

Photo 1 – View of Dam from Right Bank

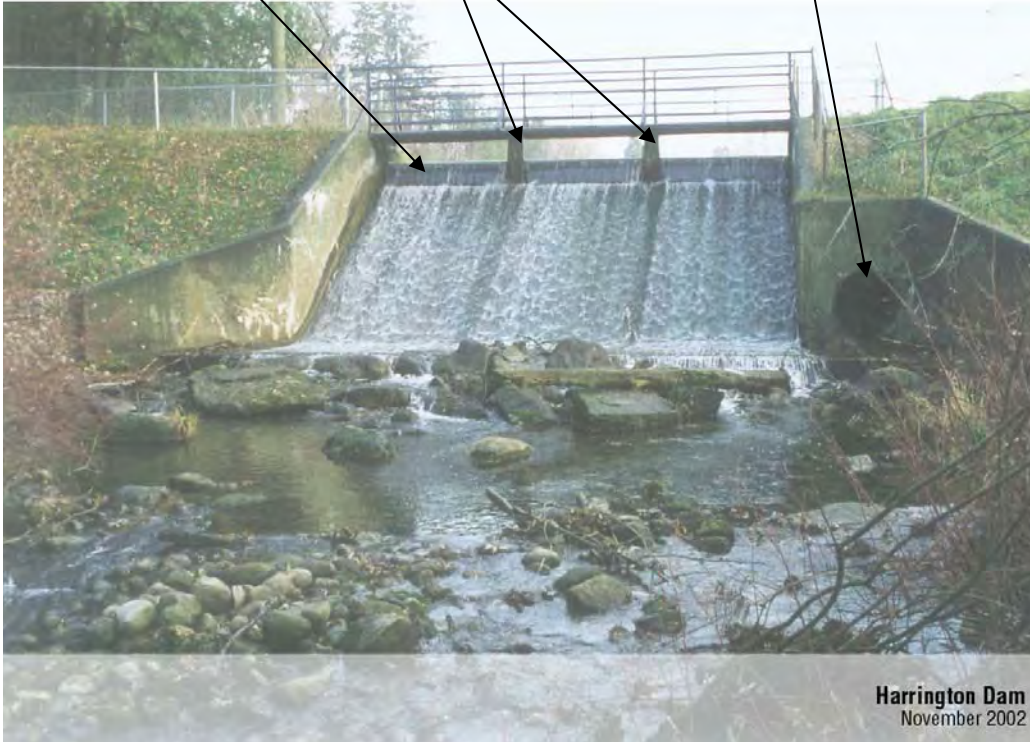
Photo 3 – Downstream View of Spillway

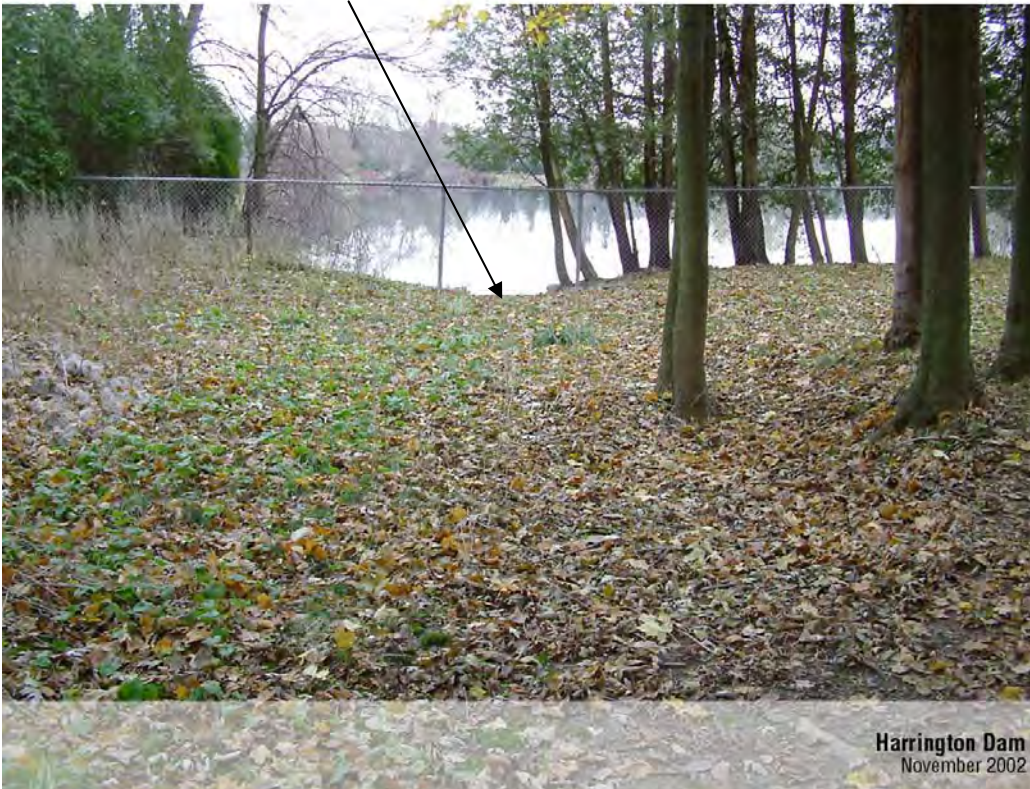
situated on the right embankment (Photo 4) and provides additional discharge capacity at the site.

Photo 4 – Abandoned Mill Raceway

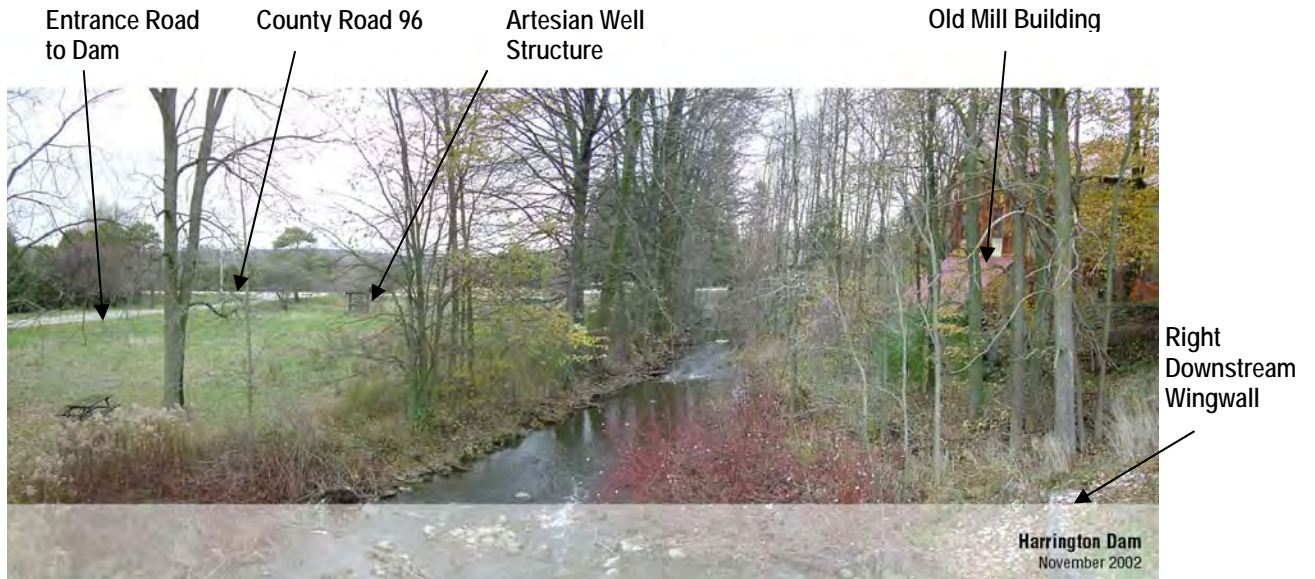
The dam is located on Harrington Creek, a tributary to Trout Creek. The dam and reservoir are currently used for recreational purposes and are adjacent to County Road 96. A local road from Road 96 transverses the area on the left side of the reservoir and crosses it at its upstream extremity and leads into a cultivated farm. The entrance to the dam, reservoir and park area is from Road 96. There is an old unused mill located on the right or east bank immediately downstream from the damsite (Photo 5).

Photo 5 – Area Downstream of Dam

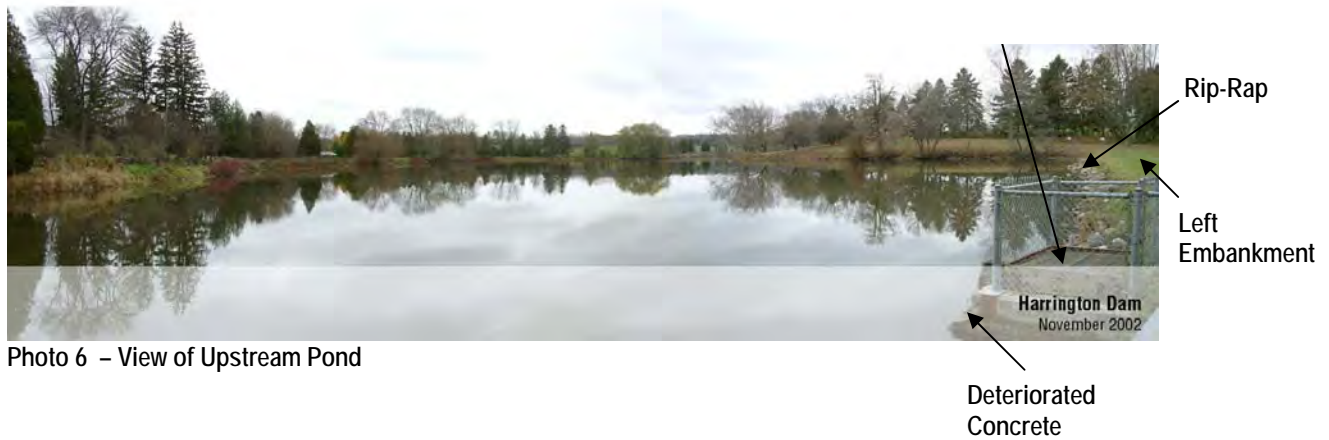
The Harrington Pond has a limited fetch and, therefore, has negligible wind-generated waves. The upstream shorelines are well-vegetated with grasses and bushes with trees along some sections (Photo 6).

Photo 6 – View of Upstream Pond

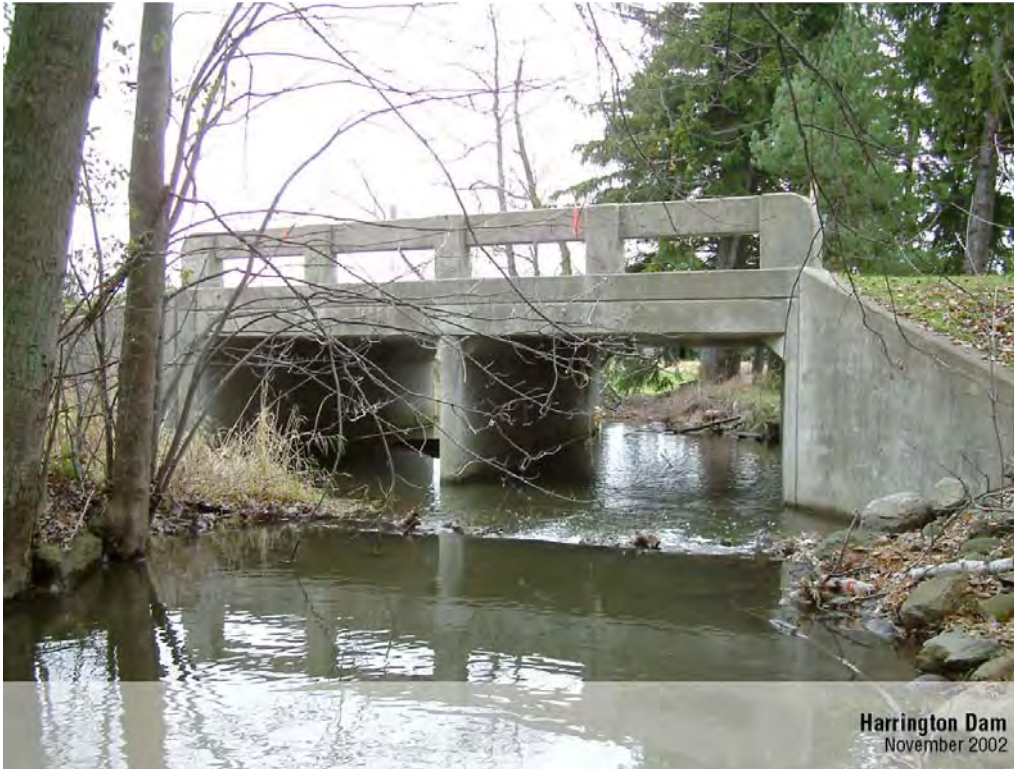
Photo 7 – Twin Box Culverts Under County Road 96

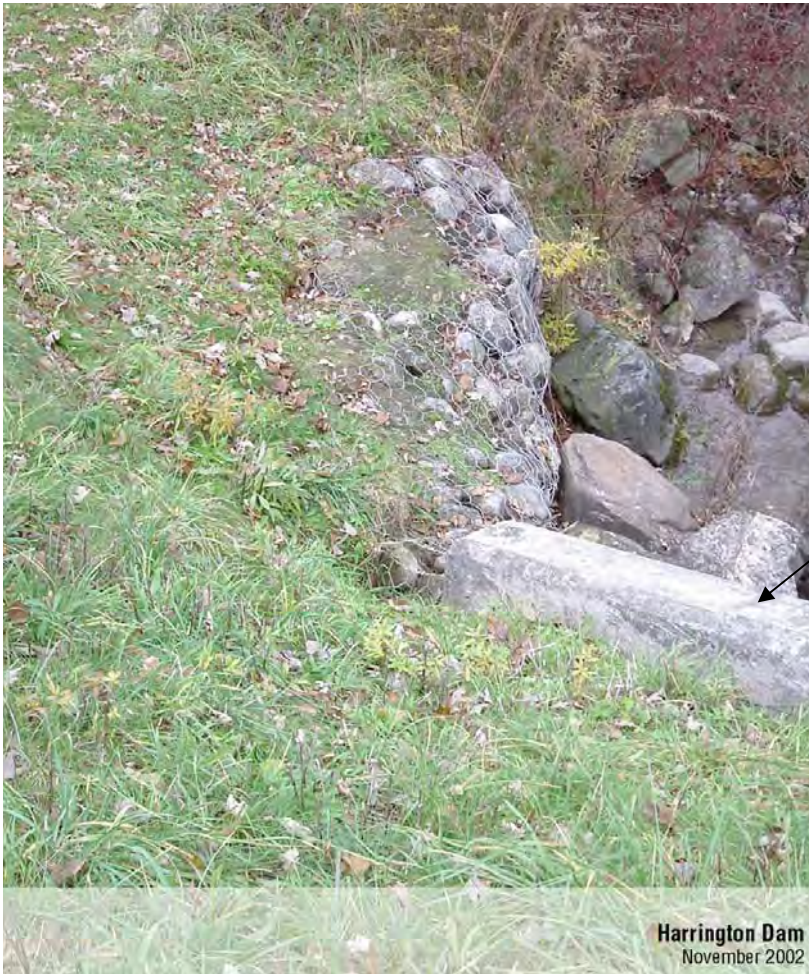
Photo 8 – Gabion Baskets, Left Downstream Side of Spillway

Left Downstream  
Wingwall

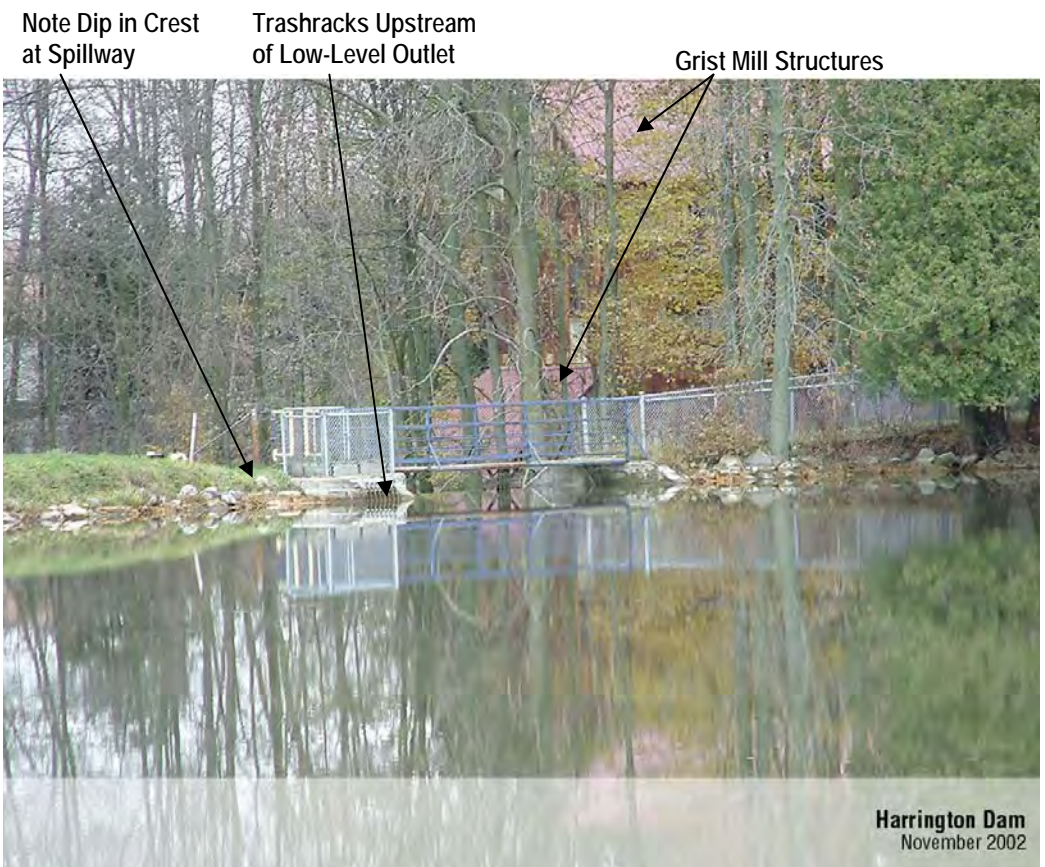
Photo 13 – Upstream View of Spillway

The condition of the upstream slope of the right embankment (Photo 13) is similar to that on the left embankment.

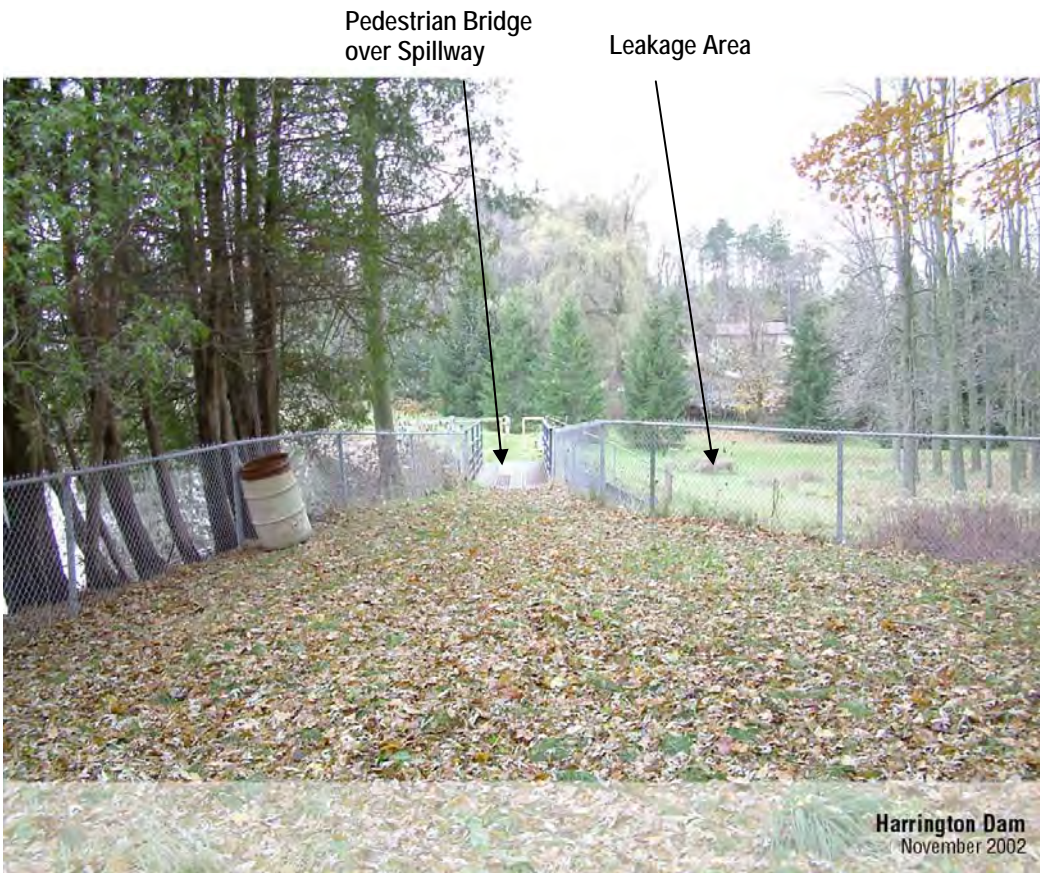
Photo 14 – Crest of Right Embankment

The crest is grassed and shows no cracking, displacement, sinkholes or settlement (Photo 14).

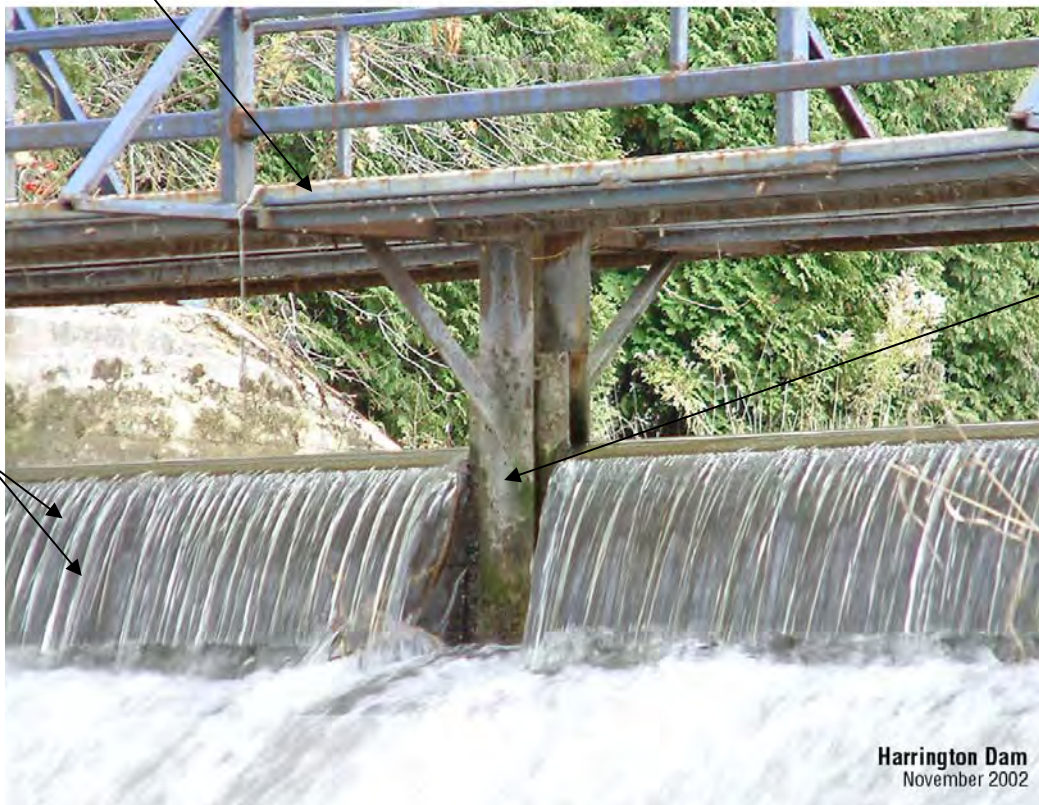
Photo 18 – Intermediate Piers of Spillway

Piers 2 and 3 consisted of steel stanchions, which also supported the deck assembly (Photo 18). Existing stop log gains are modified versions of the originals in order to accommodate more recently fabricated stop logs. The steel plate assemblies that are welded into the existing gains appear to be in good condition. A slight twisting of the new plates towards downstream was observed in the abutment slots. Stop logs are constructed of 38-mm x 191-mm (2-in. x 8-in.) boards fastened together and placed vertically in the gains. No stop logs were observed on shore. Due to the high water levels, inspection of the stop logs in place was not performed. Two rows of stop logs were in place with the third row removed in 2000. No lifting equipment was located on-site.
