Corporation of the City of London

Environmental Assessment Report **Springbank Dam Rehabilitation**

December 2003

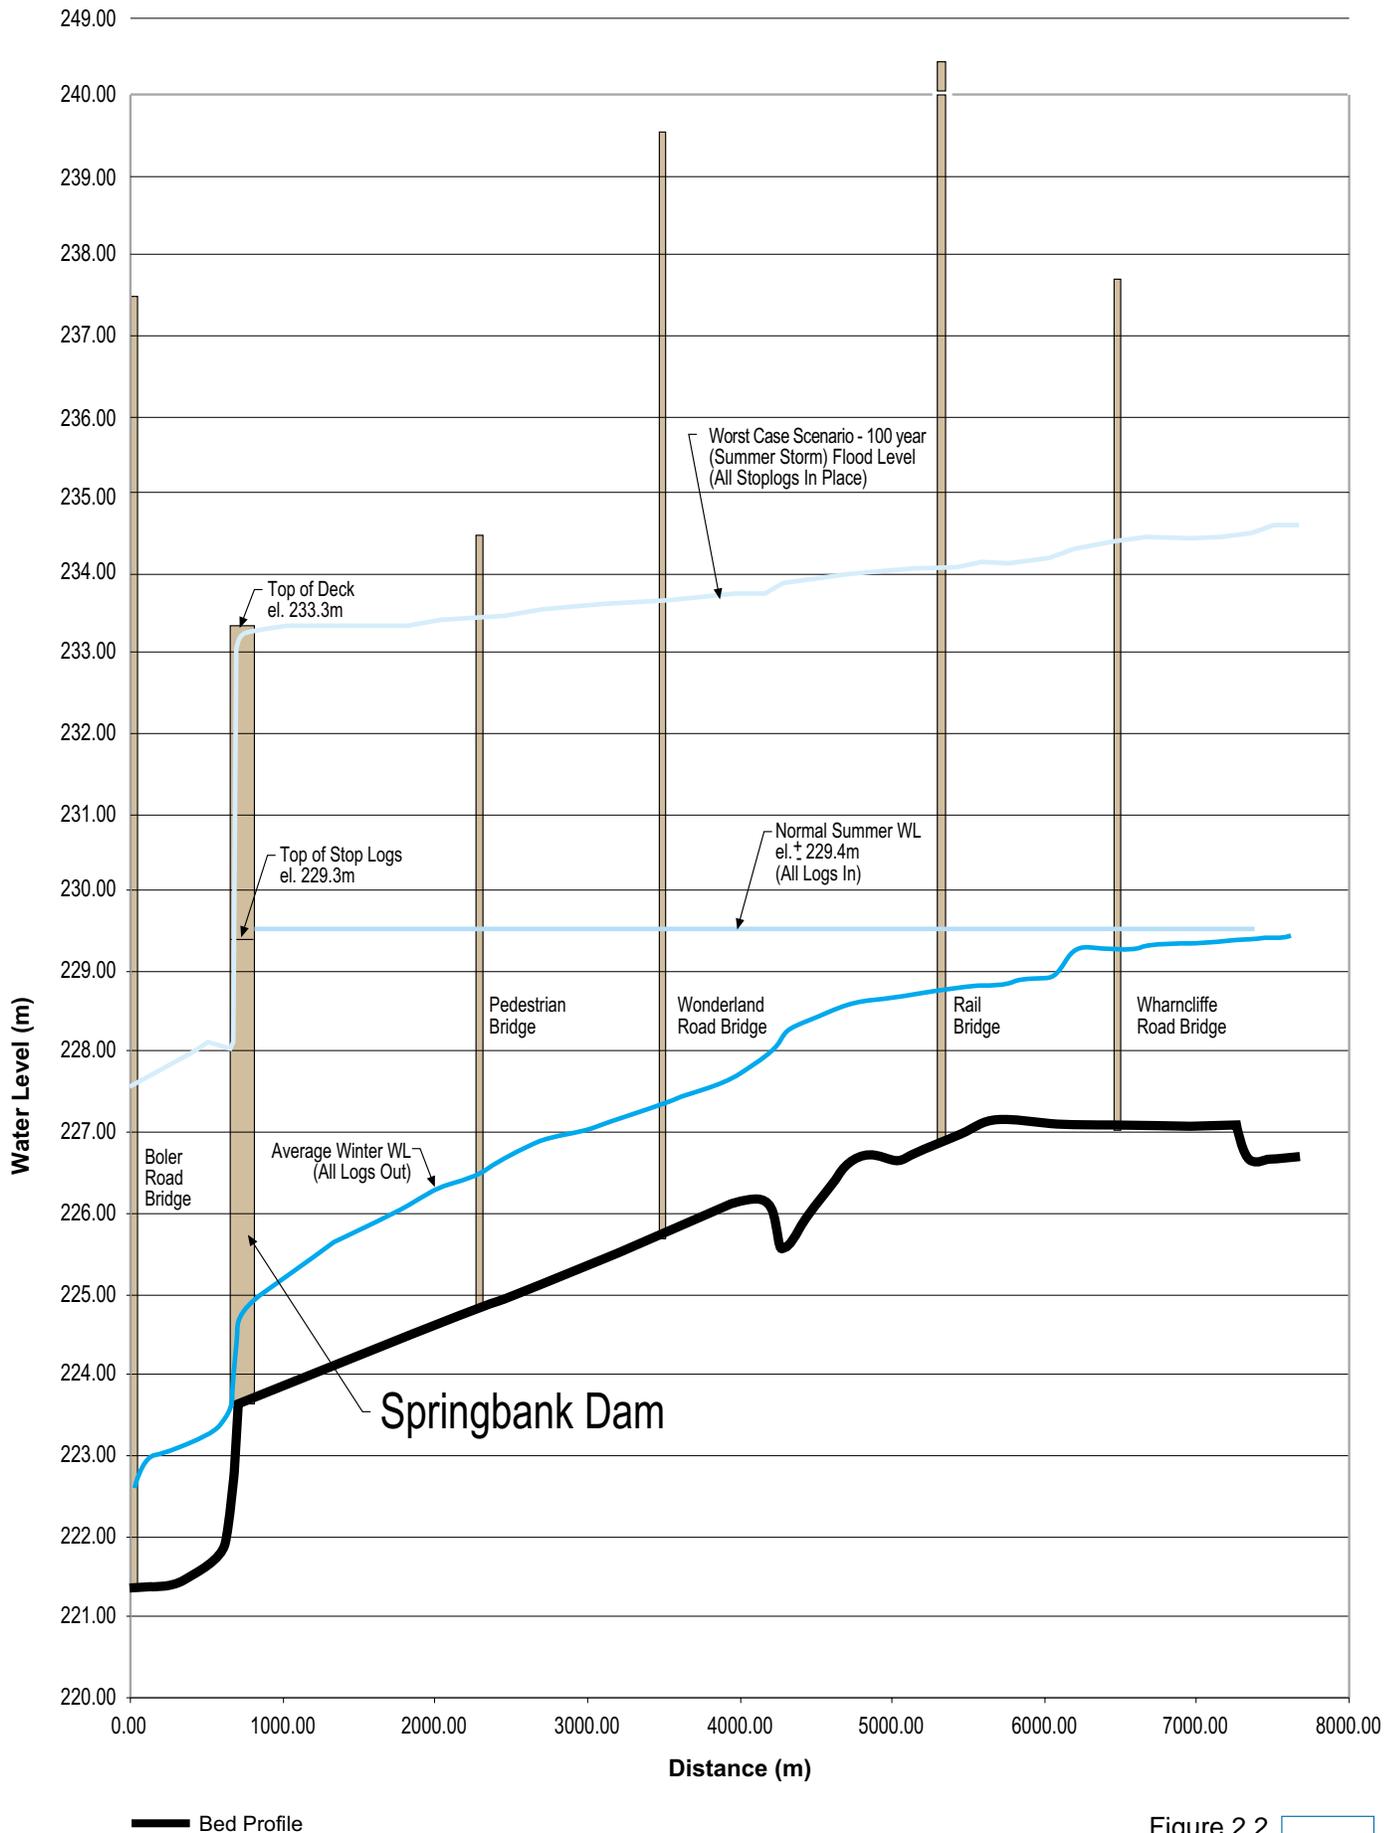
Figure 2.2
 Corporation of the City of London
 Springbank Dam Rehabilitation Class EA
Longitudinal Profile of Thames River Through Study Area

— Bed Profile

Figure 2.2 depicts a longitudinal profile of the 7.3-km long Thames River study reach through the study area based on the results of HEC-2 computer modeling (Acres, 2002). The figure shows the various water surface profiles along the waterway for the following scenarios:

- Normal summer regulated water level with all stop logs installed in the dam and the vertical lift gate closed.
