Embryo Dam Class Environmental Assessment

Public Information Centre #2

Upper Thames River Conservation Authority

Class Environmental Assessment Process and Problem Statement

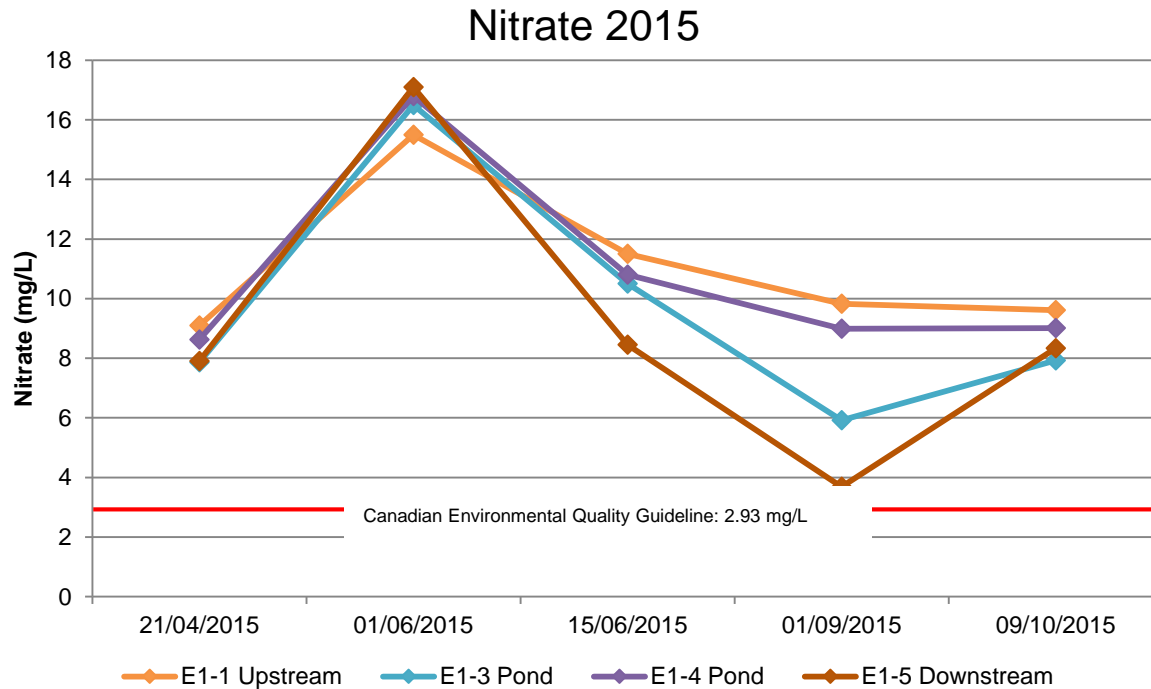
- Nitrate concentration is above MOE CEQG standard
- Concentration varies seasonally

- 4 sampling locations (1 upstream of pond, 2 in pond, 1 downstream of pond), 5 samples were collected at each site
- Results (2015):
 - Lows levels of contaminants,
 - except Nitrate (i.e., above the Canadian Environmental Quality Guideline (CEQG), historically and currently, but similar to the rest of the Middle Thames River watershed)
 - Similar results to the historic data with E. coli

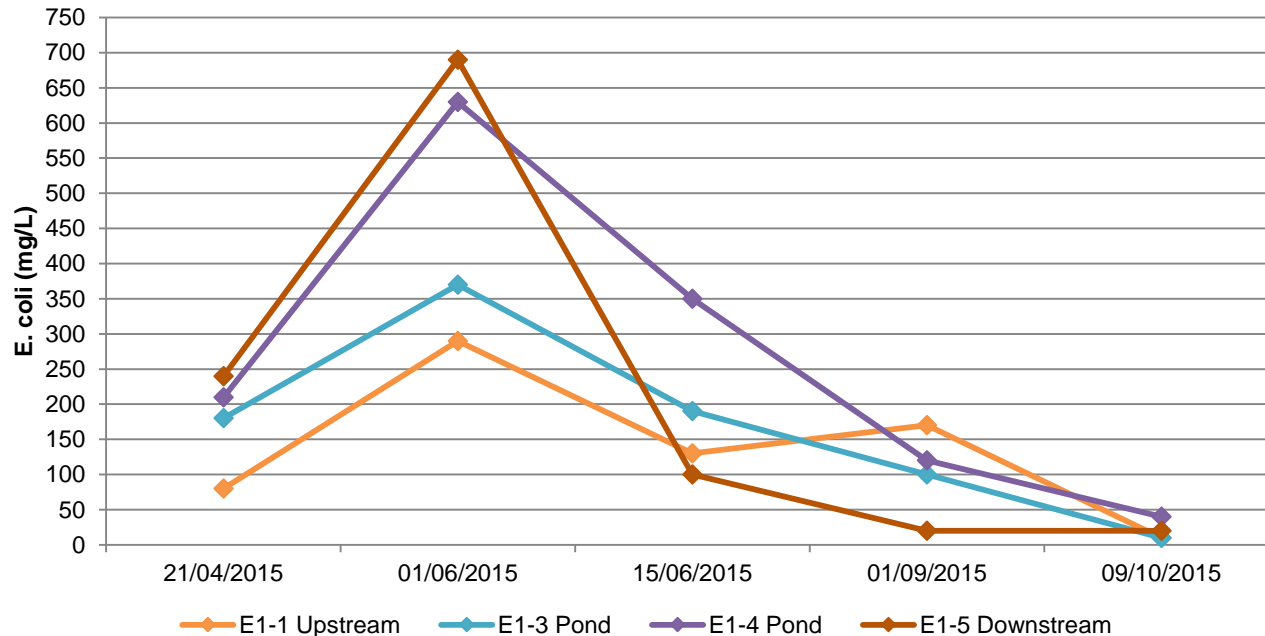
E. coli 2015

- E. Coli levels increase downstream of dam in summer
- E.Coli levels are generally higher in pond than upstream or downstream

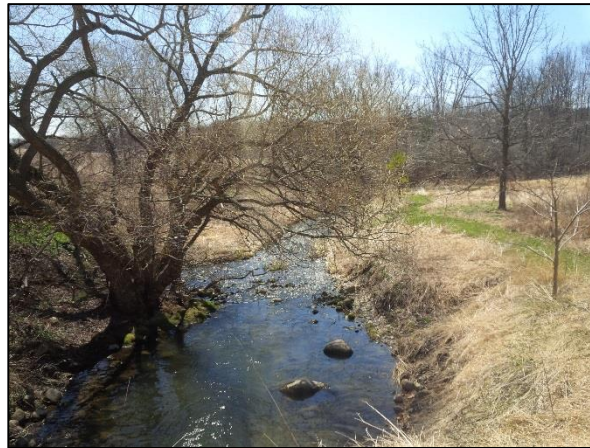
Flow Characteristics

- Flow downstream of the pond contributes between 3.5 – 6.5% of the total flow downstream of Thamesford
- Flow contribution to Mud Creek (downstream) could not be estimated (no monitoring stations)
- Flow rates downstream of the dam are resilient to drought
- Groundwater input to the increases baseflow from upstream to downstream of the dam by 8%

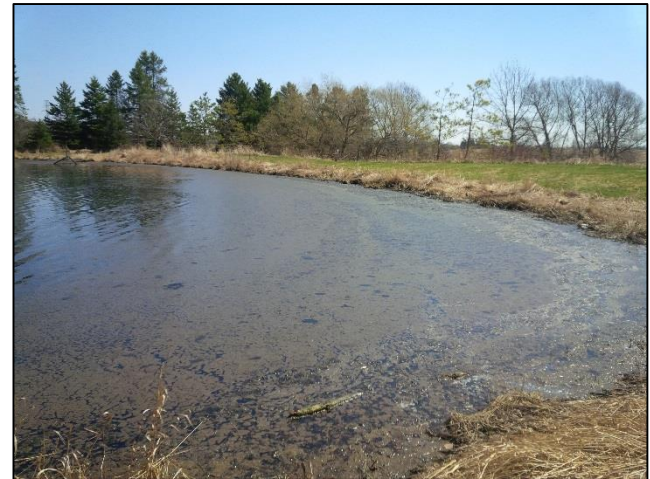
- Soil is characterized as fill overlying silt and clay deposits, and native glacial till
- Groundwater generally occurs in the fill above the glacial till
- Groundwater flow gradient is towards the south side of the pond; a possible seepage zone is located on the south side of the dam
- Water level in the fill is ~ 0.4 m below the pond water level

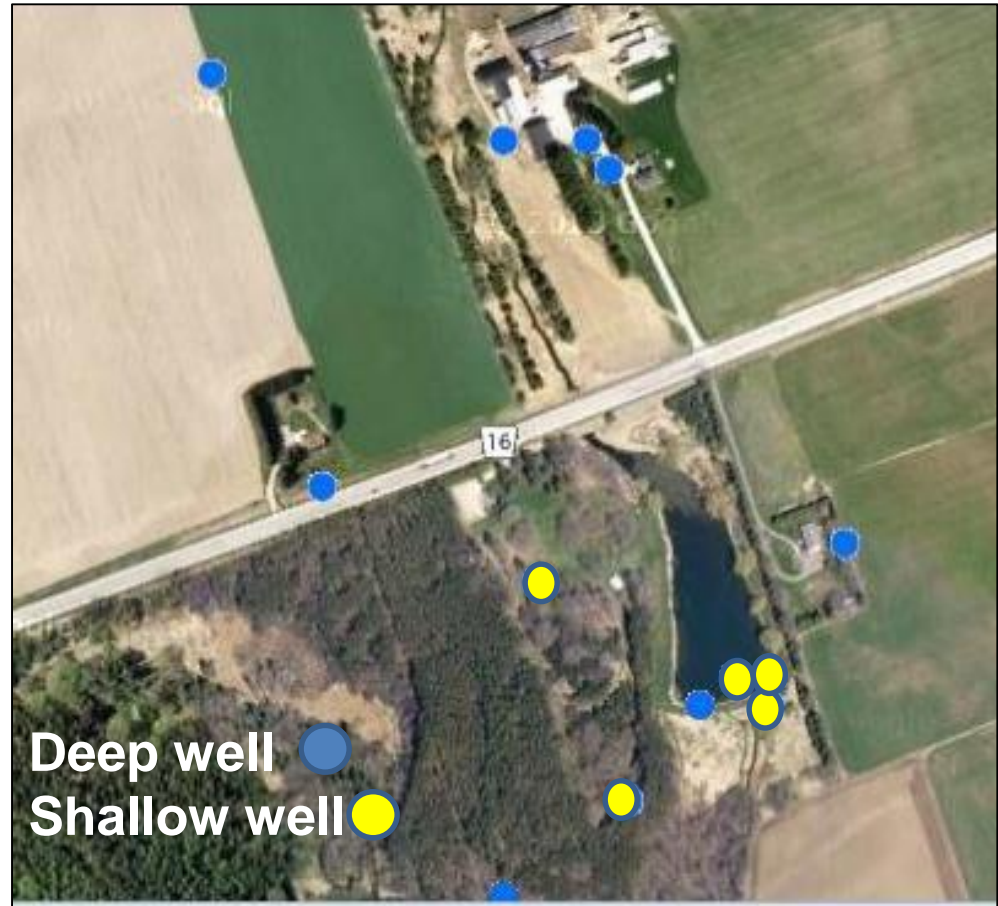
Well Information

- Approximately 13 wells exist in the vicinity of Embro Pond
- Installation dates range from 1959 to 2008
- Well depths range from 3.8 to 50.3 m
- Water depths range from 2 to 49 m below the top of well

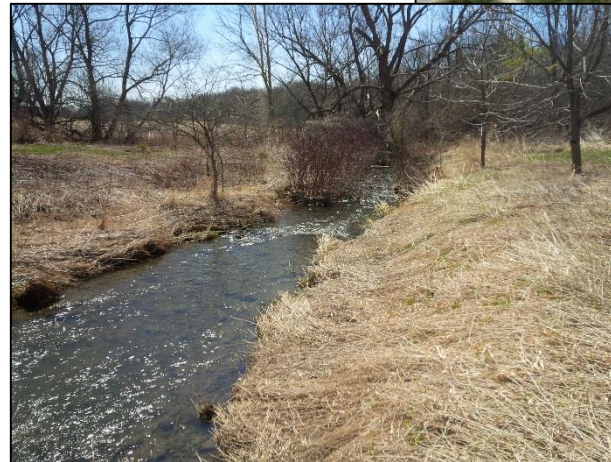
Reach 1 (Downstream of dam):

- Relatively straight, slight meander
- Cross sections: symmetrical and trapezoidal and confined
- Bed morphology: riffles/runs with shallow pools
- Bed material: cobbles and gravel
- Riparian vegetation: dense grasses and herbaceous plants with some shrubs

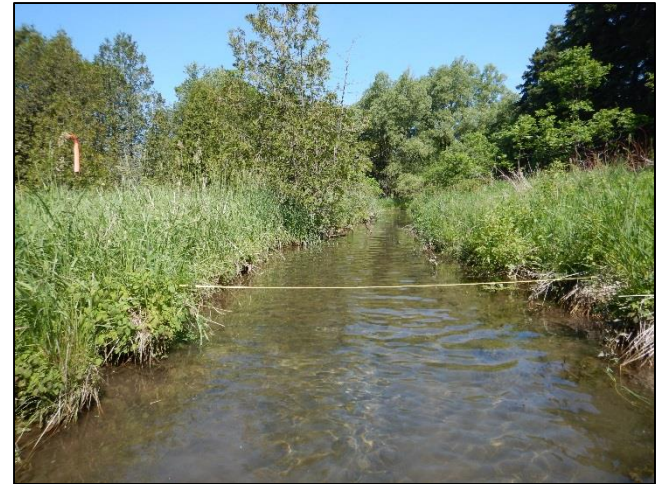
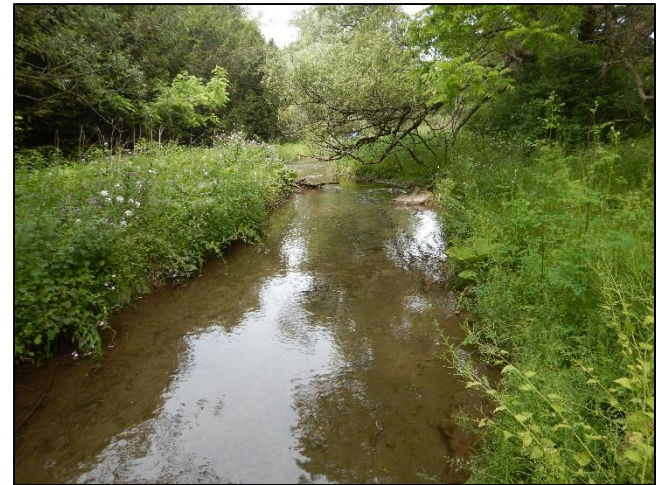
Reach 2 (Backwater area (85 m long)):

- Straight channel with poorly developed bed forms
- Cross section: generally trapezoidal
- Bed material: silt and sand, some gravel
- Riparian vegetation: well vegetated with grasses and herbaceous plants

Reach 3:

- Riparian vegetation: grasses, herbaceous plants, and cedar trees
- Cross section: generally uniform in shape
- Bed morphology: riffles/runs with shallow pools
- Bed material: fine sand and silt with some large boulders/cobbles and gravel on riffles

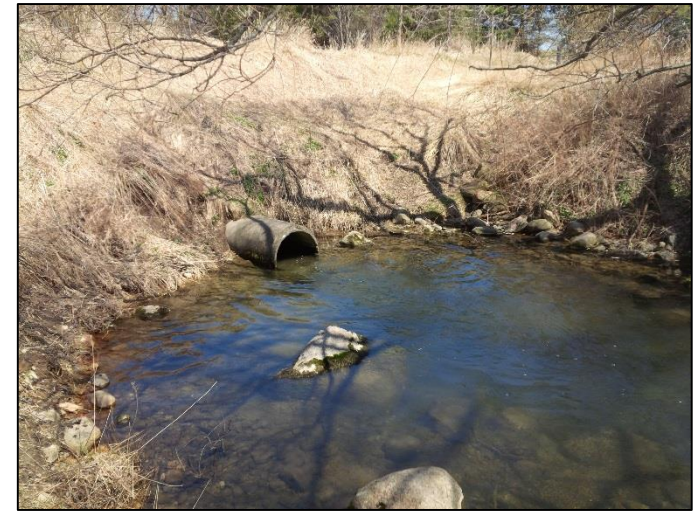
Structural

- Dam impounded volume: 30,000 m³ (small dam based on storage volume)
- Dam height ~4.5 m
- 100 m long earth embankment
- Inflow design flood (IDF) criteria: 50 year, 8 day spring snowmelt event

- Spillway does not have current capacity to pass the IDF
- Insufficient freeboard
- Upstream and downstream embankment slopes do not meet slope stability acceptance criteria
- Flood flows are not adequately conveyed by the emergency spillway
- Date of last repair is unknown

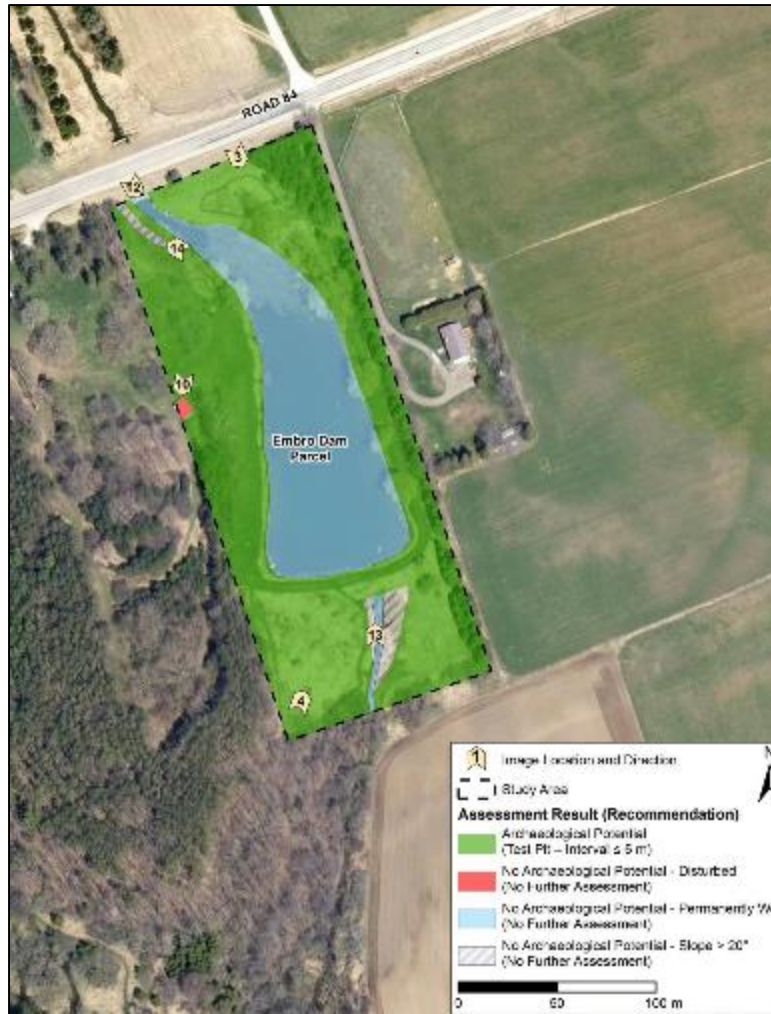
66.8% of the site has archaeological potential,

- requires test pit survey before any potential construction works in area
