Harrington Dam Class Environmental Assessment

Public Information Centre #2

Upper Thames River Conservation Authority
Harrington Hall and Library
May 12th, 2016 7:00 p.m. to 9:00 p.m.

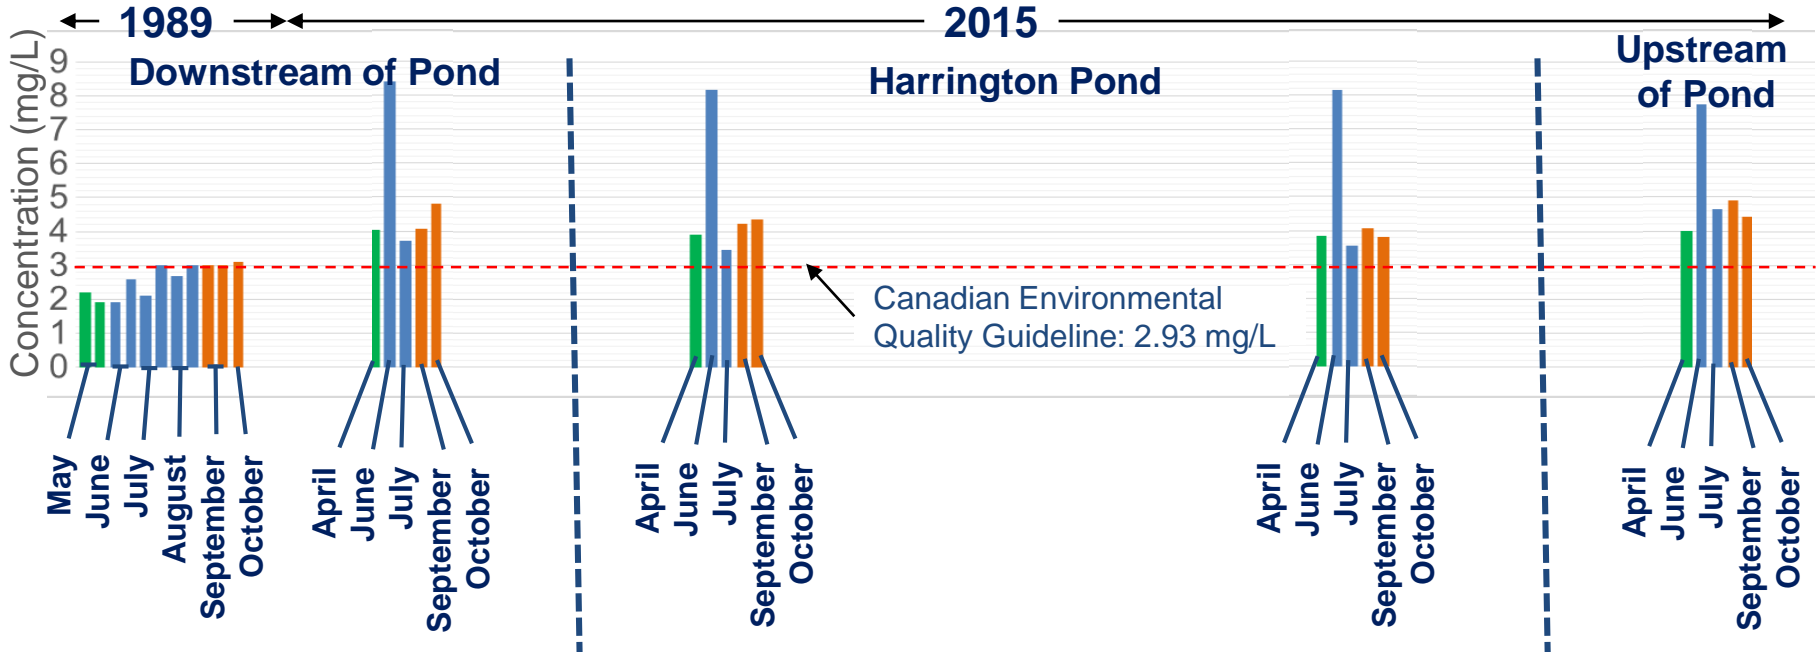
Nitrate

- That all nitrate levels are all higher than the CEQG
- That levels are highest in June
- That summer levels are higher downstream compared to upstream
- This indicates that the pond has an impact on nitrate levels at certain times of the year

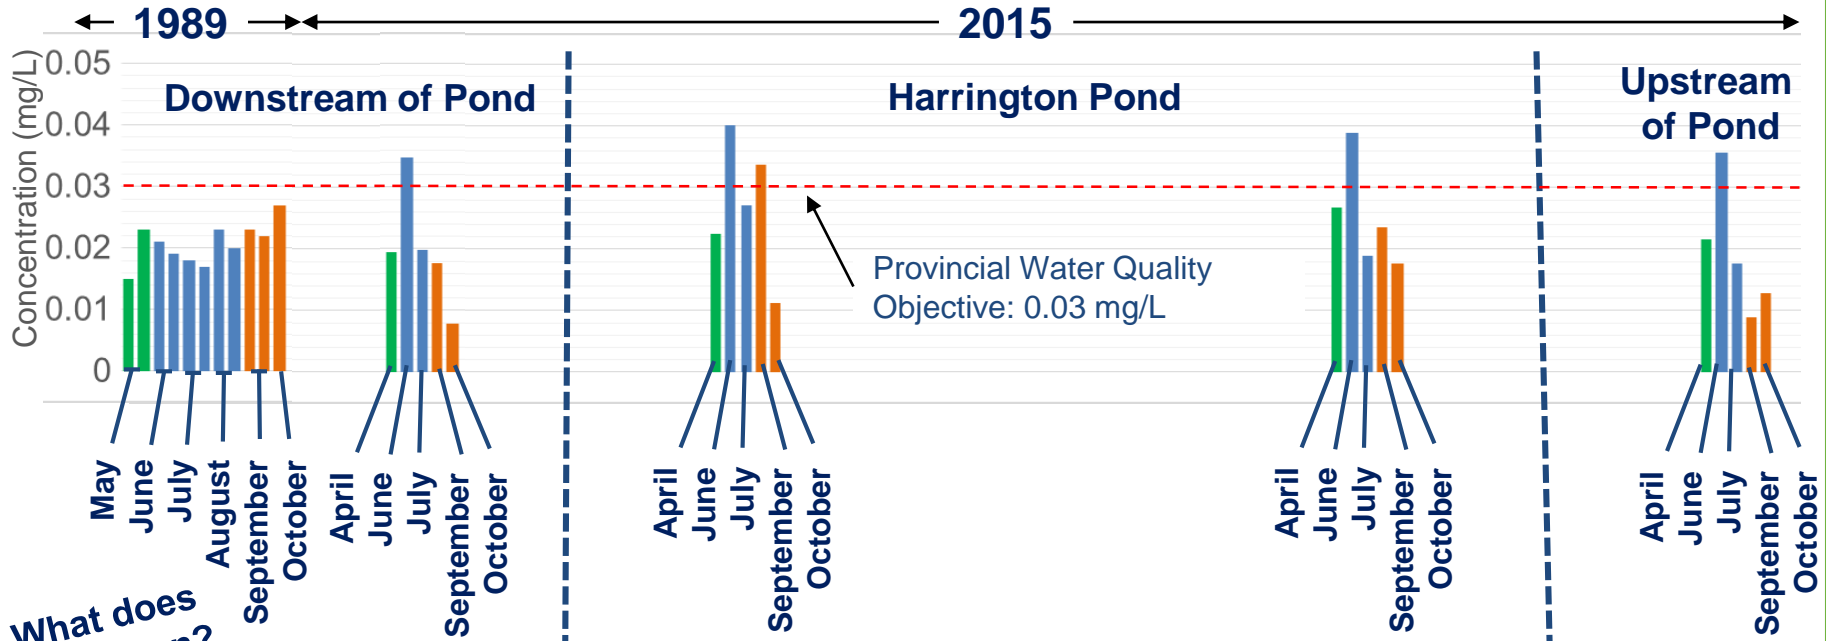
Information Highlights Total Phosphorous

- That Phosphorous levels are all higher than the PWQO targets in June
- That levels are highest in June
- That summer levels are highest in the pond
- This indicates that the pond has an impact on Phosphorous levels overall during the year

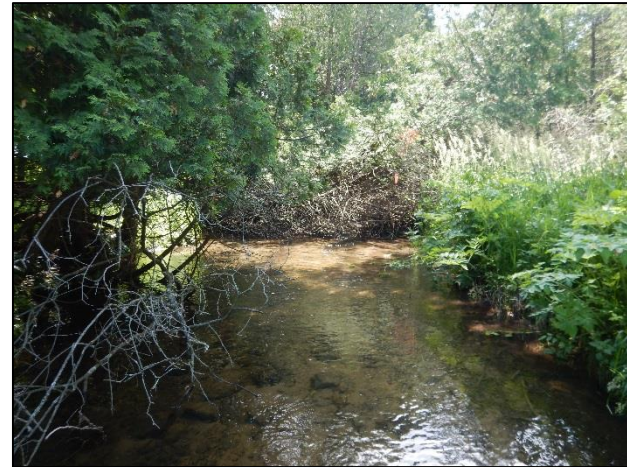
Flow Characteristics

- Outflow contributed on average 10% of the total flow out of the Trout Creek Subwatershed
- Flow rates downstream of the dam are resilient to drought
- Groundwater input to the pond increases baseflow output downstream of the dam (i.e., base flow increases ~ 7% between upstream and downstream of pond)

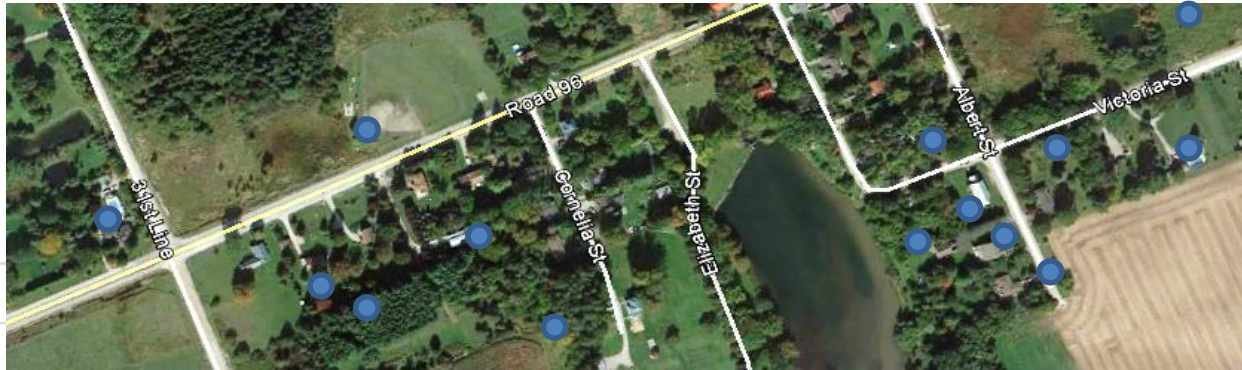
Well Information

- Approximately 22 wells exist in the vicinity of Harrington Pond
- Well water level data were plotted to determine the relative water levels in the area
- Additional work to inventory/map shallow wells will proceed after alternative selection

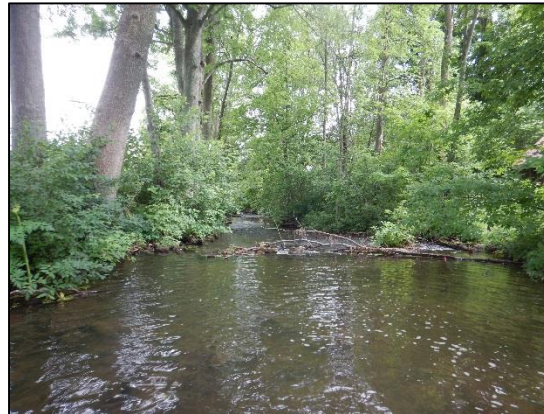
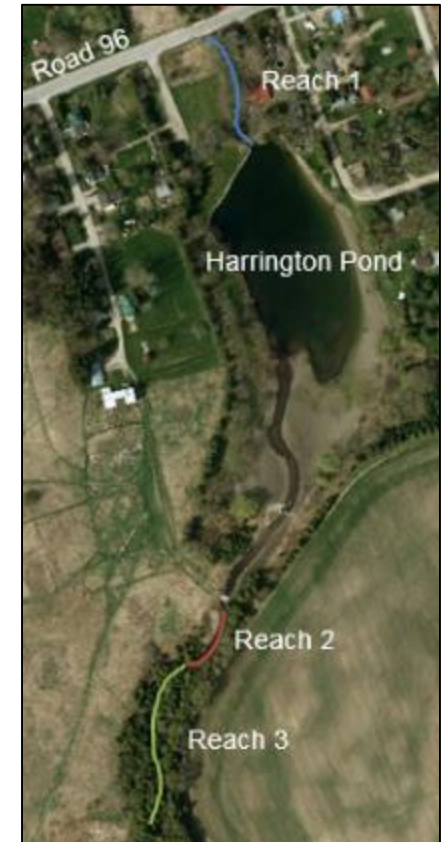
Reach 1 (Downstream of dam):

- Trapezoidal cross sections set within deeper channel
- Riffle and pool bed sequences
- Cobble and gravel bed materials
- Well vegetated steep banks

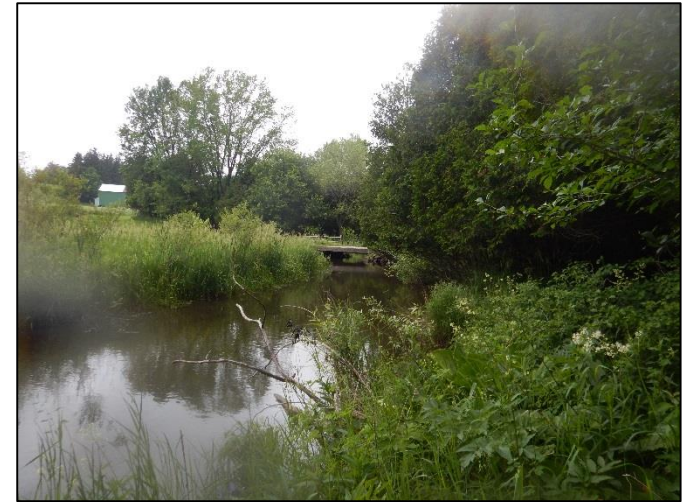
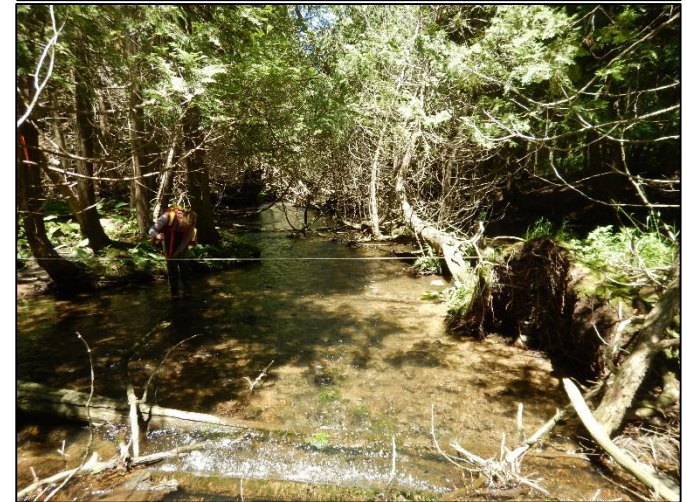
Reach 2 (Backwater area):

- Backwater influences from the pond extend ~ 80 m upstream
- Sediment covered bed ~ 56 m upstream of trail bridge
- Cross-sections were uniform in configuration
- Banks well vegetated with grasses and herbaceous plants

Reach 3 (Cedar forest):

- Cross-sections relatively wide and shallow
- Channel bed has riffles and shallow pools
- Planform is somewhat sinuous
- Banks well vegetated banks with herbaceous plants, mosses and cedar trees; woody debris in channel

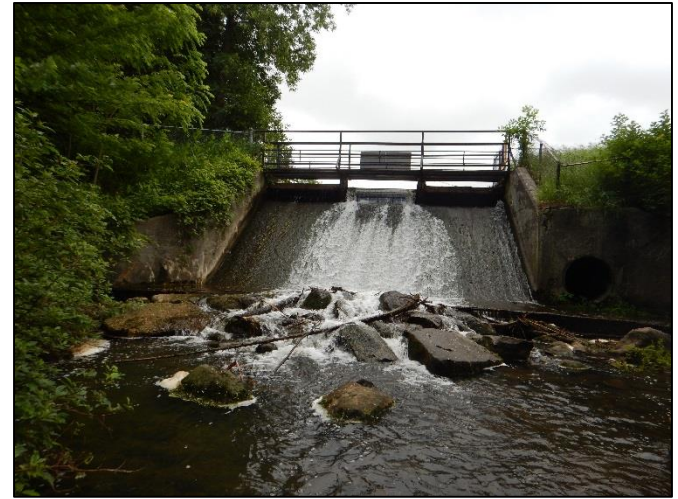
- Dam impounded volume: 20,000 m³ (small dam based on storage volume)
- Dam height ~ 4 m
- 65 m embankment on left side, 20 m embankment on right side
- Inflow design flood (IDF) criteria: 50 year, 3 day summer storm

- Spillway does not have current capacity to pass the IDF
- Spillway structure does not meet stability criteria
- Insufficient freeboard at embankment crests and pedestrian bridge
- Right downstream embankment does not meet slope stability criteria
- Concrete spillway is generally in fair condition
- Last repairs were completed in 2000

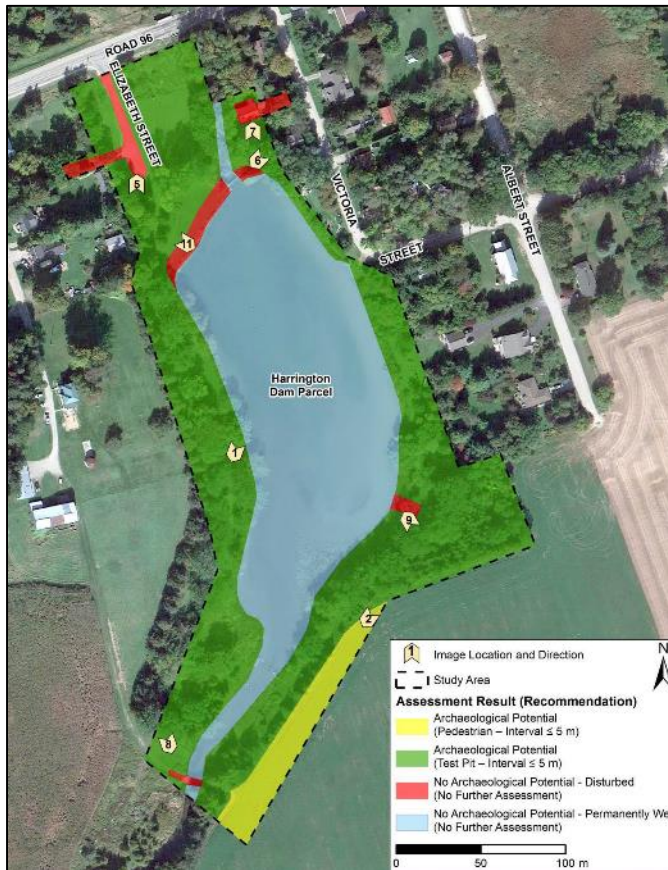
- 56.5% of the site has archaeological potential, requires pedestrian and test pit survey if any work proposed in area
- 43.5% of the site has no archaeological potential (due to disturbance, or permanent water features)
