West London Dyke Master Repair Plan

Public Information Centre #2
Thursday, February 23, 2012 6-9PM

The West London Dyke is 2374 m long, comprises of both a concrete and earthen revetment, and runs along the west bank of the North Branch of the Thames River from Oxford Street to the forks of the Thames River and then along the west bank of the main branch to the west side of the Wharncliffe Road Bridge. The City of London owns the dyke and through an agreement, the Upper Thames River Conservation Authority (UTRCA) undertakes major maintenance activities.

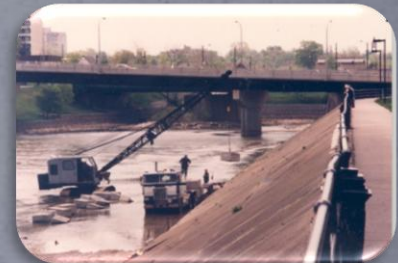
1980's Repair Work

- Geotechnical Investigation undertaken in October 1982 revealed sections of revetment (dyke) in poor condition with noticeable shifting and tilting. Abrupt changes in slope of facing noted with cracking along concrete surface.
- Based on investigations undertaken, repair of select sections of dyke including grouting behind panels and improvements to toe structure were completed between 1983 and 1985.

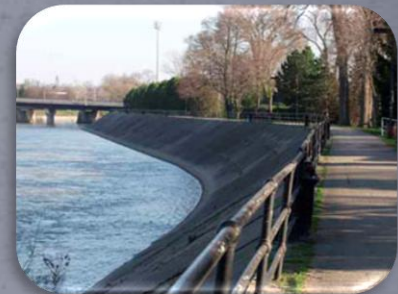
2005 Concrete Repair Program

- In 2005, while undertaking the initial stages of a concrete repair program on the 350 m segment identified in the 2004 study, it was concluded that a significant portion of this section had come to the end of its useful life and needed to be replaced rather than repaired.

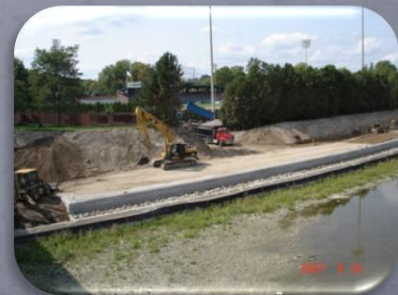
2007 Phase I Dyke Replacement

- The first phase of the project (July to December, 2007) replaced a 300 metre section of the dyke north from Queens Avenue, adjacent to Labatt Park. The new dyke structure is located entirely within the footprint of the previous dyke and provided some improvement to flood height protection.
- Phase 1 was funded by the MNR Water and Erosion Control Infrastructure Program and the City of London. The total cost of the Phase 1 construction project was \$3,600,000.

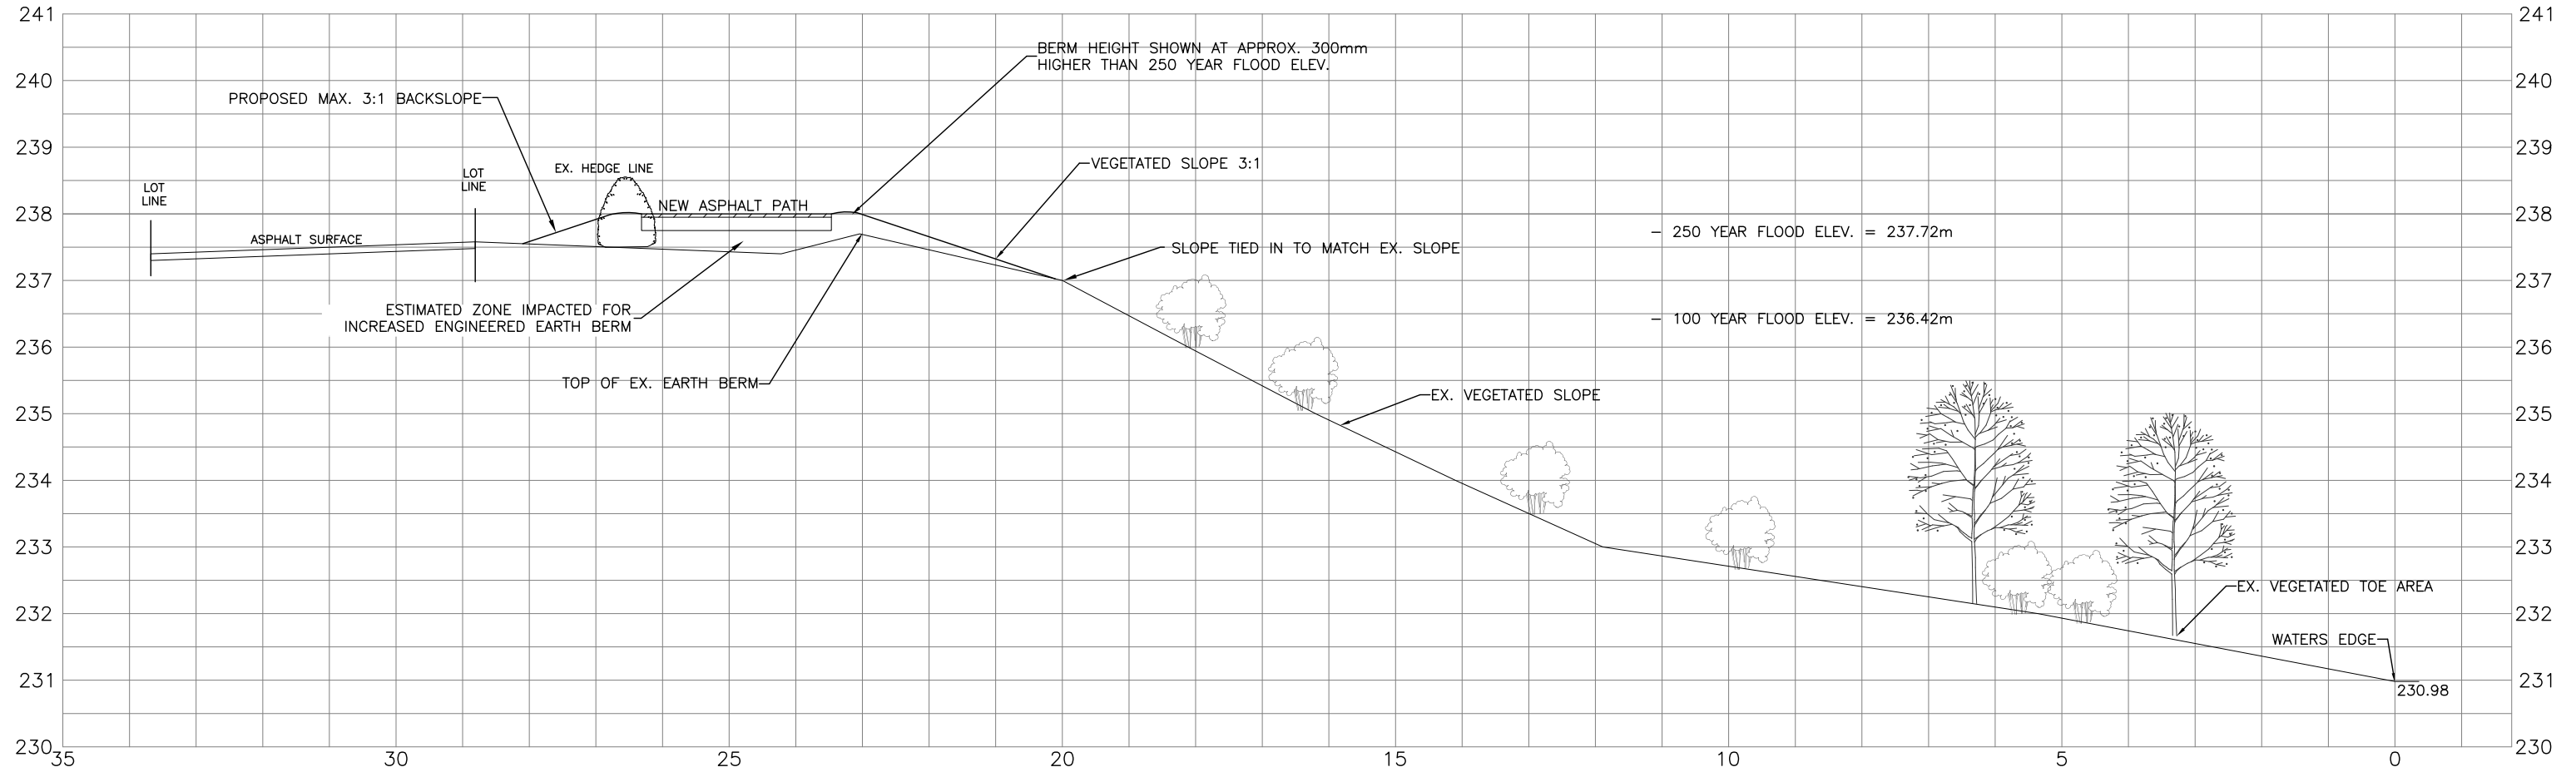
APPROXIMATE STATION -0+015

INFORMATION PROVIDED MAY NOT REFLECT ACTUAL GEOTECHNICAL AND ENVIRONMENTAL SOIL CONDITIONS WHICH MAY IMPACT THE REMOVAL LIMITS.

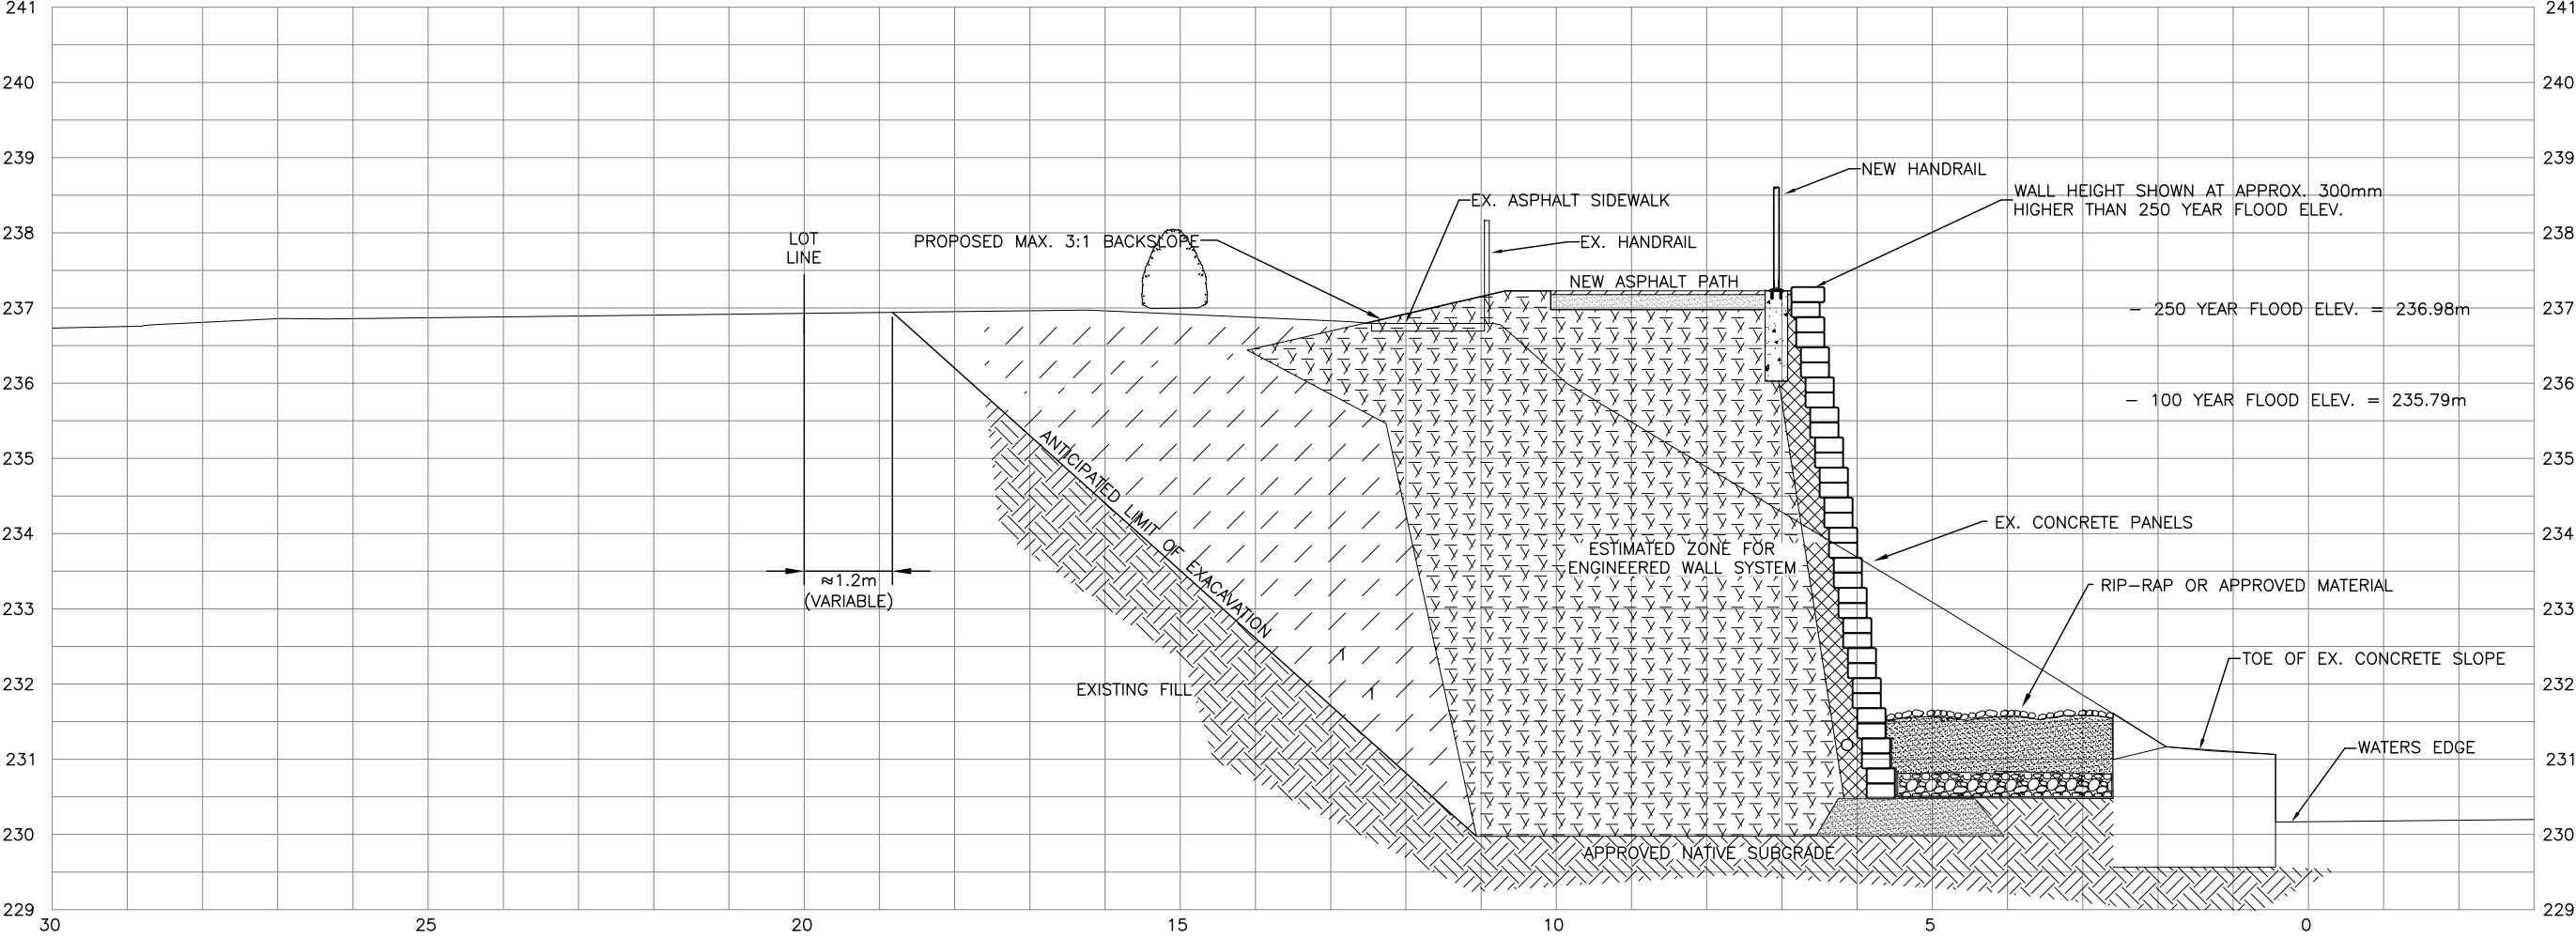
APPROXIMATE STATION 0+565

CONCEPTUAL WALL PLACED IN APPROX. CENTER OF EXISTING STRUCTURE. LOCATION SUBJECT TO CHANGE.
