Case Study: Multiple Erosion Control Structures

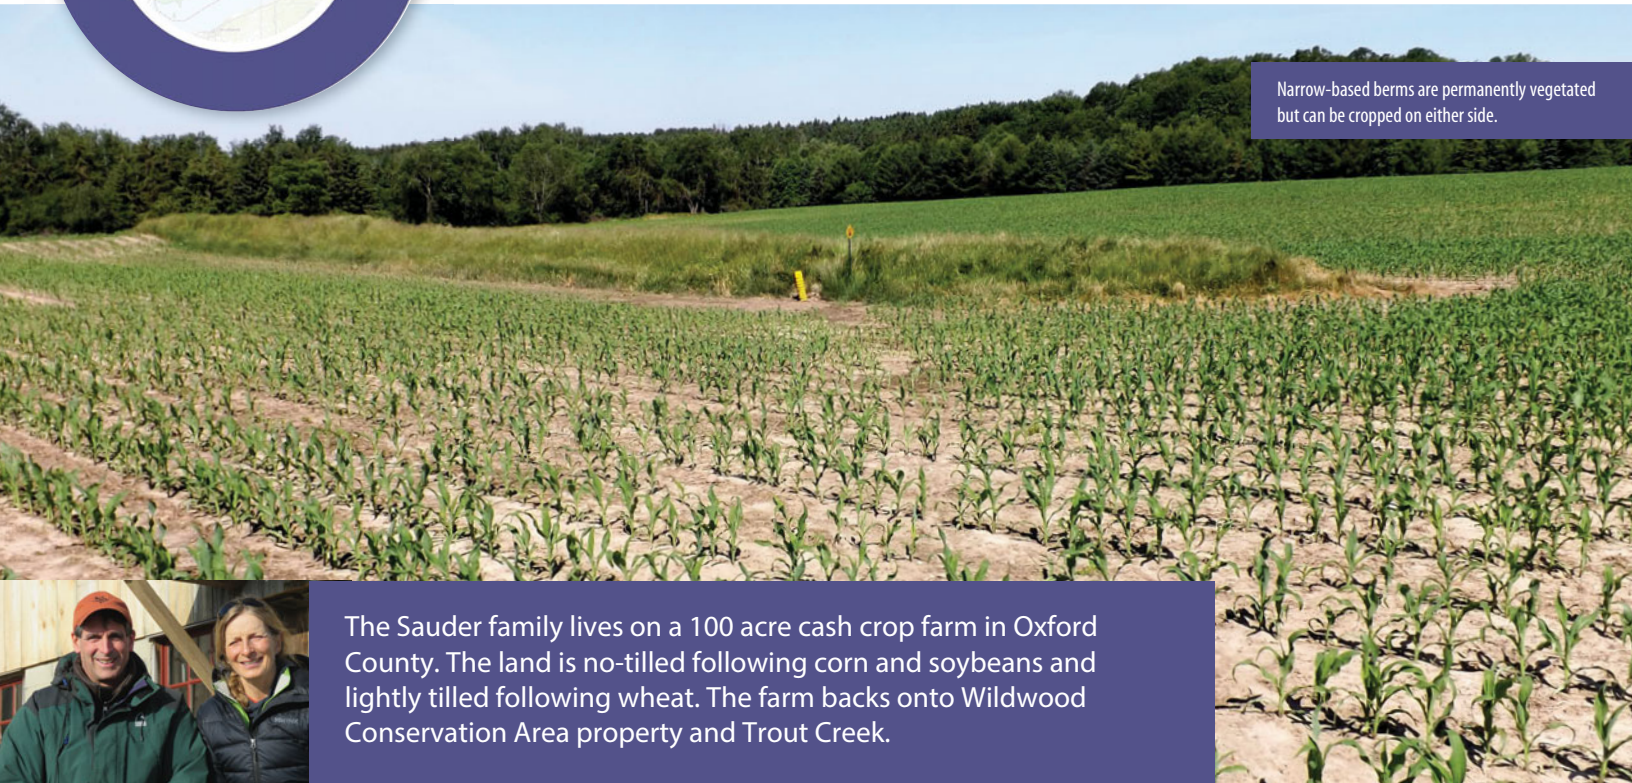
Narrow-based berms are permanently vegetated but can be cropped on either side.

Over the years, the Sauder family has implemented several water and erosion control structures to alleviate erosion problems. A narrow-based berm was constructed in one area of the field in 2009. A broad-based berm, diversion terrace, and grassed waterway were constructed in another area of the field in 2015.

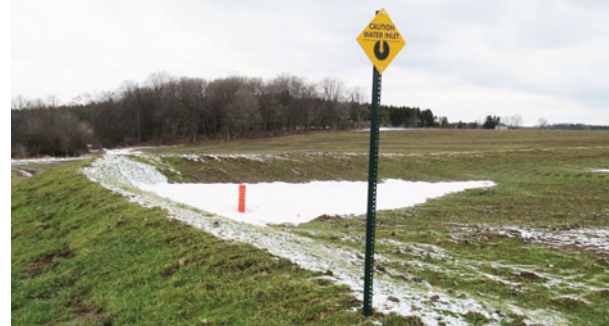
This broad-based berm was constructed in 2015. Signage is useful to notify custom farm operators of the location of erosion control structures.

Take into consideration where you are in your crop rotation when planning the installation of the erosion control structures. Steve took advantage of an early wheat crop harvest in the summer of 2015 to construct his broad-based berm, grassed waterway, and diversion terrace that same fall.

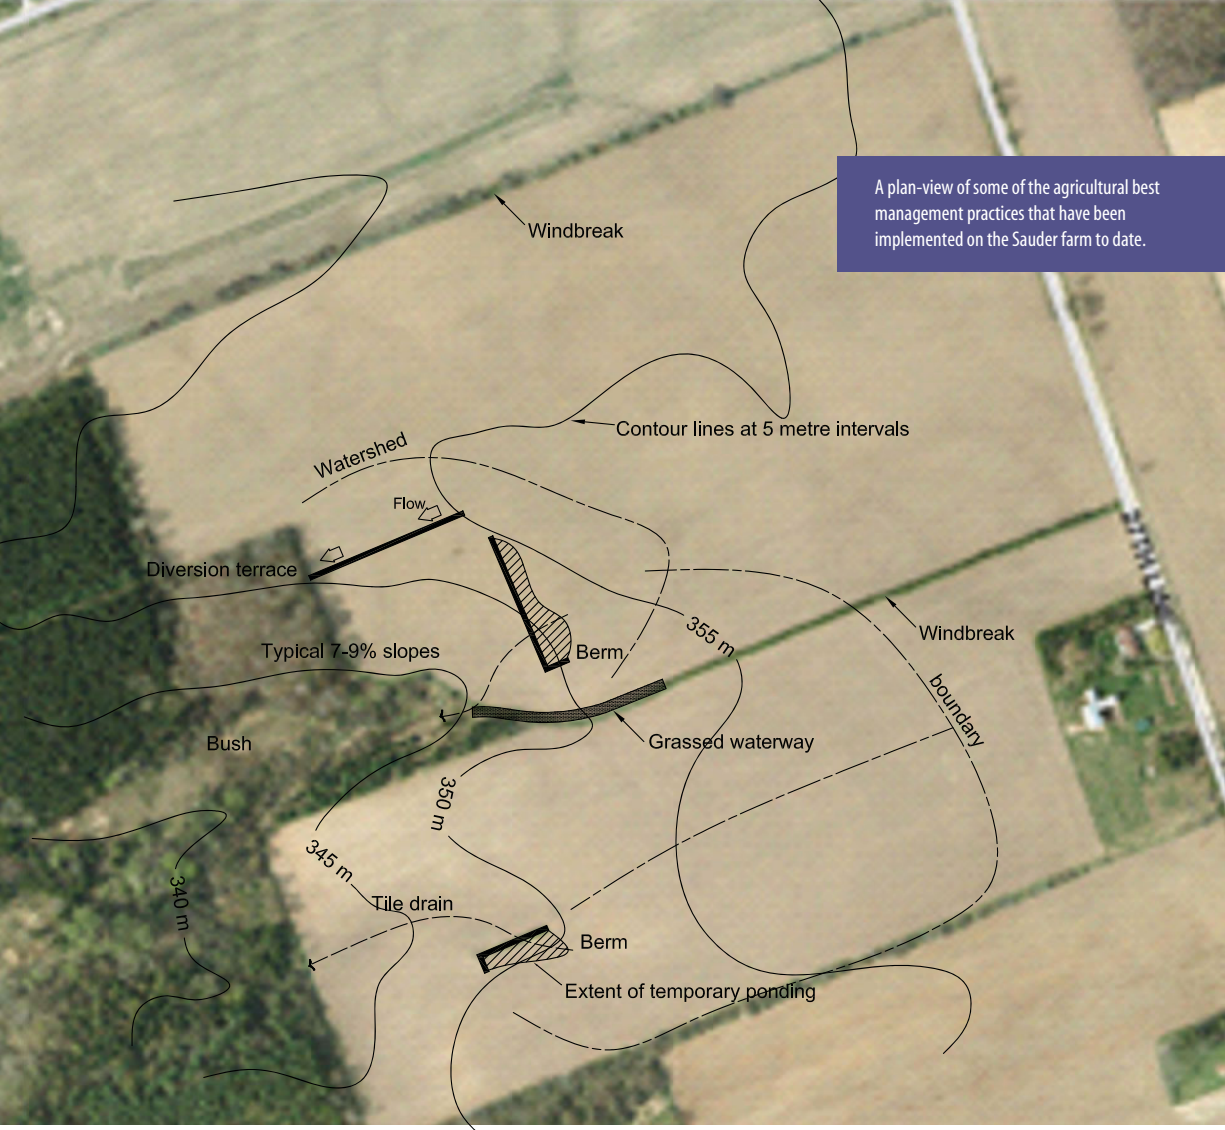
A plan-view of some of the agricultural best management practices that have been implemented on the Sauder farm to date.

- The berms and diversion terrace control erosion by intercepting runoff, temporarily ponding the water and slowly releasing it through the tile drainage system. Rocks placed at the tile outlet reduce the velocity of the tile-drained runoff, preventing scour erosion at the outlet.
- The grassed waterway controls erosion by allowing runoff to move as it normally would across the land, but the vegetative cover slows the flow of the runoff and filters out sediment.
