EXECUTIVE SUMMARY

The UTRCA, in partnership with Zorra Township, initiated a Class Environmental Assessment (EA) under the Conservation Ontario Class EA process due to the significant concerns related to the structural integrity and hydraulic capacity of the Harrington Dam and embankment. The objective of this EA study was to identify, evaluate, and ultimately to recommend an alternative (including Do-Nothing) that will allow the Upper Thames River Conservation Authority (UTRCA) to move forward with a plan to address the Harrington dam and embankment safety concerns.

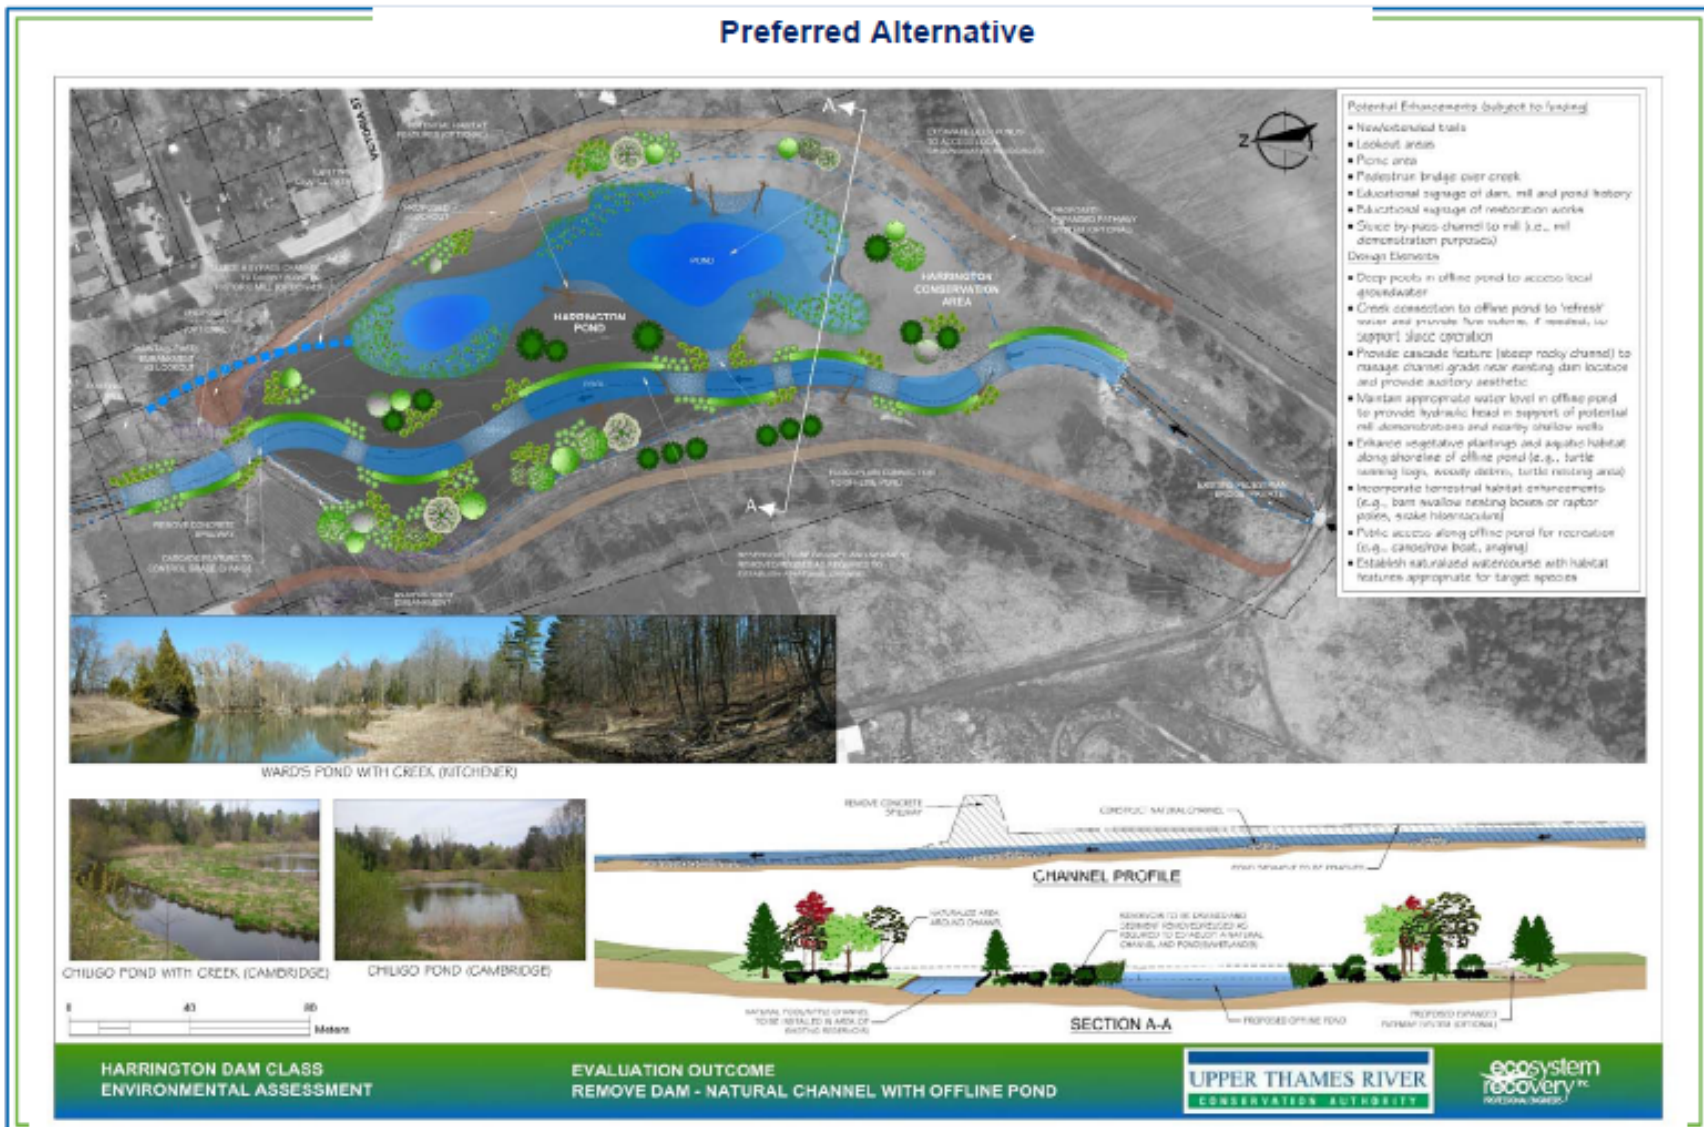
Figure 7-1. Preferred Alternative

The preferred alternative, resulting from both the equal and the weighted evaluation processes, was Alternative 4 (**Figure 7-1**). In this alternative, the dam would be removed and one or more off-line ponds would be created. The channel would be naturalized and flow around the off-line pond. The alternative recognizes the socio-cultural value of the community regarding viewscape of the pond and recreational uses of the area along with environmental benefits that would be achieved with placing a pond off-line (i.e., improved water quality, species diversity, habitat continuity, etc.). The alternative allows for replication and enhancement of the terrestrial environment. Subsequent to the third PIC, an additional alternative was proposed by the community, and considered by the study team. That alternative was a variation of Alternative 7 (i.e., partial rather than full replacement; creation of a spillway at the upstream

end of the pond) and considered a temporary solution rather than long-term. In conjunction with their description of the alternative, the community identified measures for environmental enhancement and recreational potential; many of these would not be exclusive to the variation of Alternative 7. The variation of Alternative 7 was evaluated, informally, to examine how the final scoring would compare to the preferred alternative. While the score, in both the equal and weighted evaluation tables would be higher than Alternative 7, the rank did not increase to be within the top 3 alternatives. Alternative 4 therefore remained the preferred alternative.
