Table 4 – Work Plan for Springbank Dam

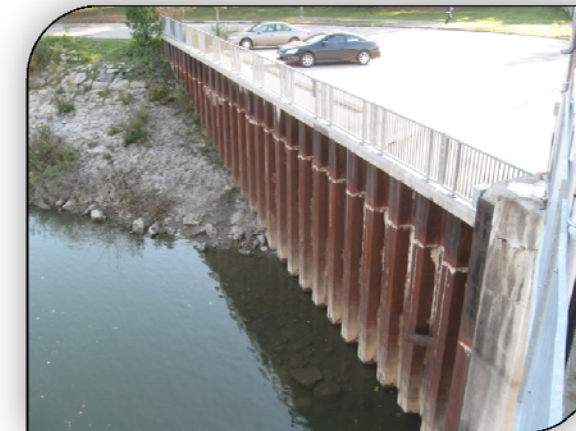
Item No. 1 – Engineering Study

Detailed inspection and reporting on the southeast steel sheet pile retaining wall tie-back system

Reference: Condition Survey Report (2011) Springbank Dam, Appendix A (Inspection Forms), Page 7, Component: Retaining Walls, Description: Sheet pile retaining wall

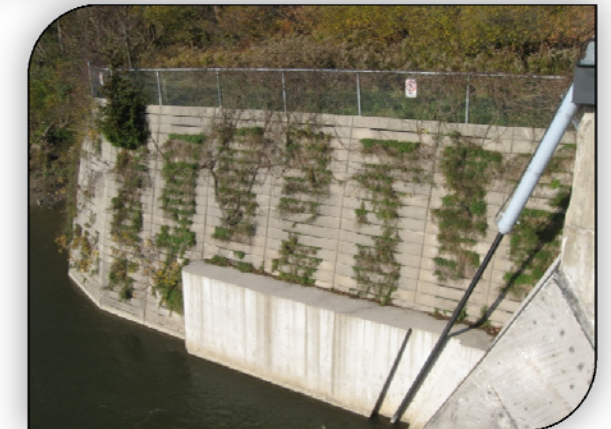
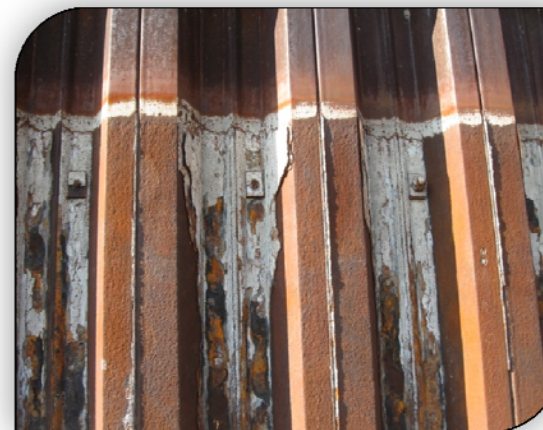
Item No. 2 - Rehabilitation

Reference: Condition Survey Report (2011) Springbank Dam, Appendix A (Inspection Forms), Page 7, Component: Retaining Walls, Description: Precast block retaining wall

Install French drains and re-grade at the top of north retaining walls and miscellaneous other repairs.

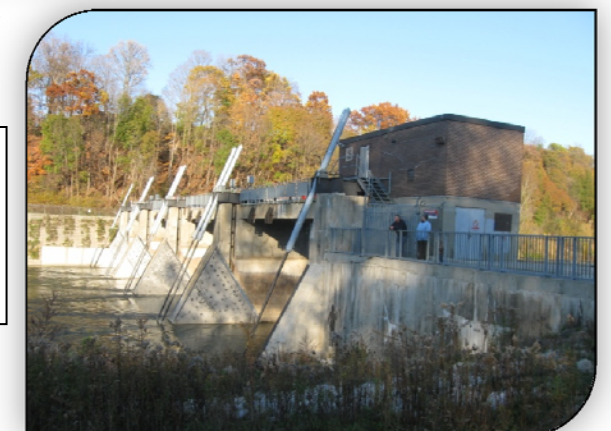
Item No. 4 – Engineering Study

Engineering pre-design report to review modifications to the structure
